LKK Auto Consultants Pte Ltd

ADJUSTMENT ON REPAIR COST FOR VEHICLE NO. SMP 943R

PHOTOGRAPHS FOR VEHICLE NO. SMP 943R

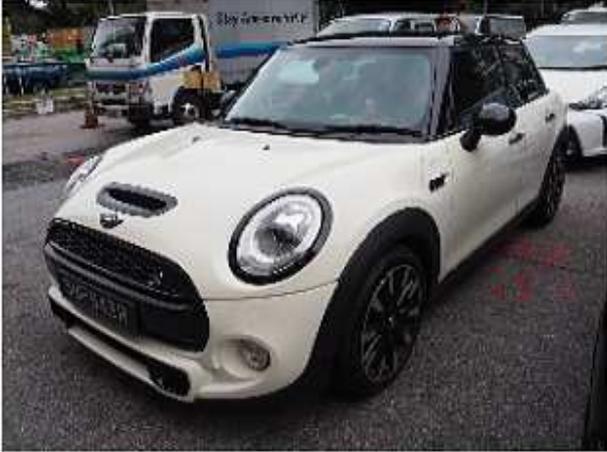
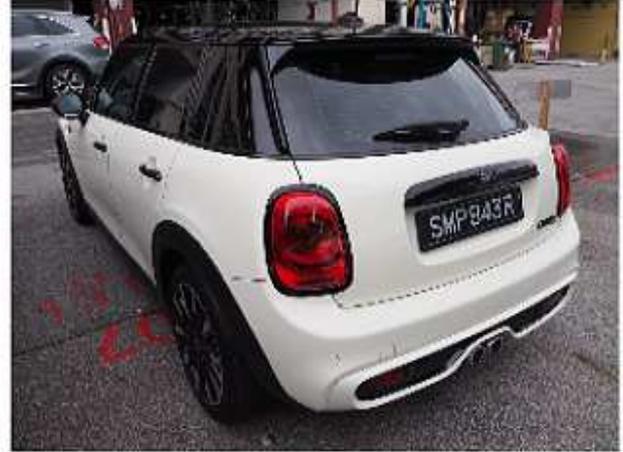
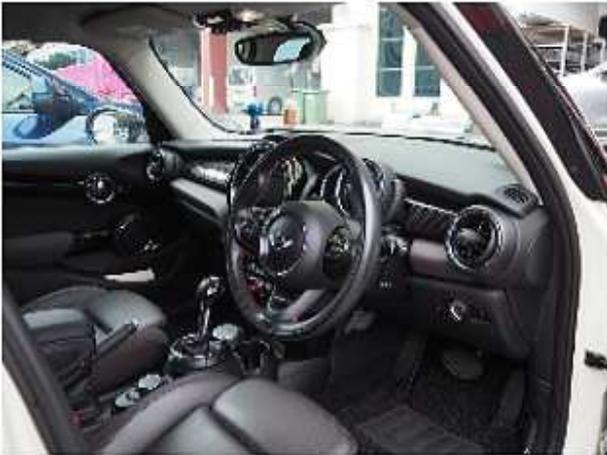
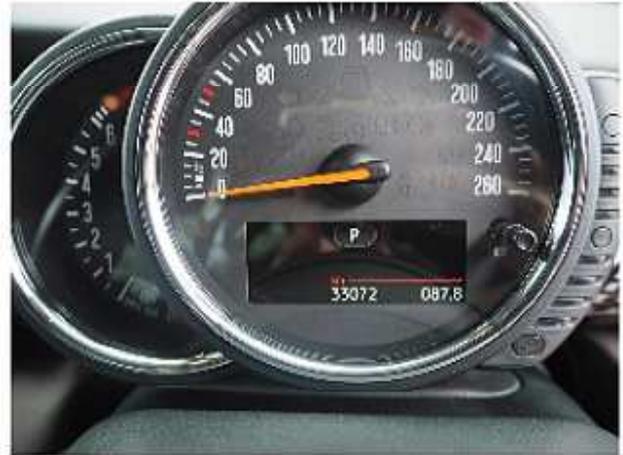
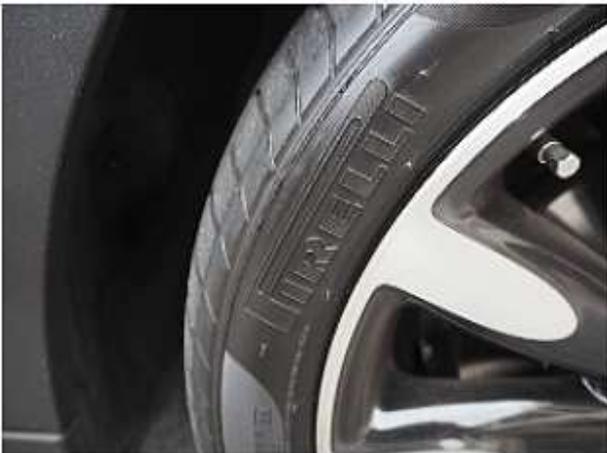
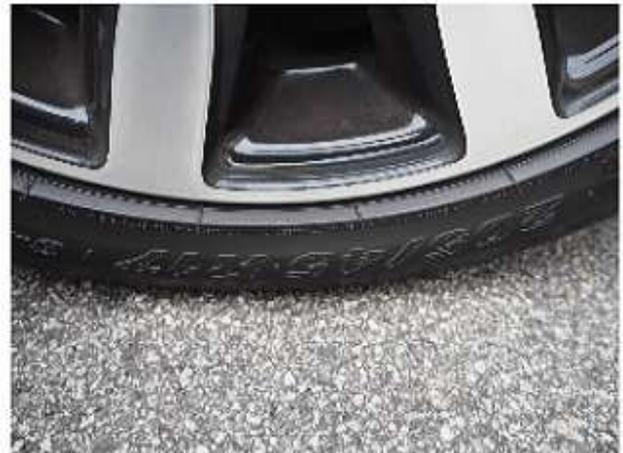
INSPECTION

THE VEHICLE SUSTAINED DAMAGES AT THE N/S BODY.
DAMAGES SEE DETAILS.

Qty	Description of Parts	Condition	Estimate By Workshop (\$)	Our Adjusted (\$)
<u>REPLACEMENT OF PARTS</u>				
1	LH FRONT DOOR	TO REPAIR SEE LABOUR	1,658.65	-
1	LH REAR DOOR	DENTED	1,358.65	1,136.19
1	LH ROCKER PANEL GARNISH	CUT	983.10	786.40
1	LH REAR WHEEL ARCH GARNISH	NOT NECESSARY	241.60	-
	LESS 10% DISCOUNT		-424.20	-192.26
			3,817.80	1,730.33
<u>SPECIAL NETT ITEMS</u>				
1	MISCELLANEOUS (SN)	NECESSARY	150.00	30.00
