Affiliated to Federation Internationale Des Experts En Automobile				
QBE	QBE INSURANCE (SINGAPORE) PTE LTD Ref: CC6/QBE20005507/Aba3q2				
	FFLES QUAY #29 ERSINGAPORE (Date: 20-11-2020 Code: QBE

ADJUSTMENT ON REPAIR COST FOR VEHICLE NO. SJJ 9171J

PHOTOGRAPHS FOR VEHICLE NO. SJJ 9171J

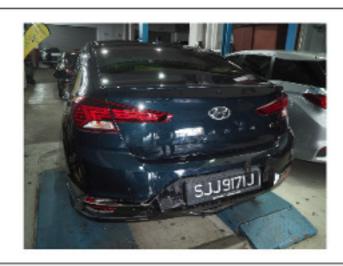
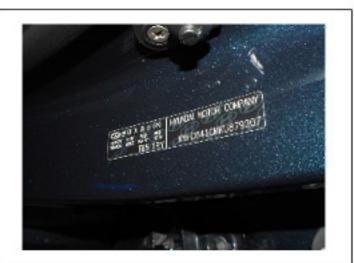
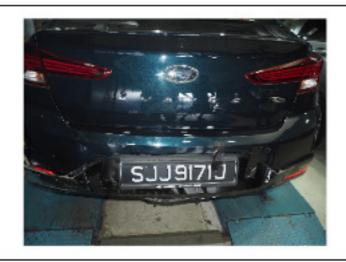
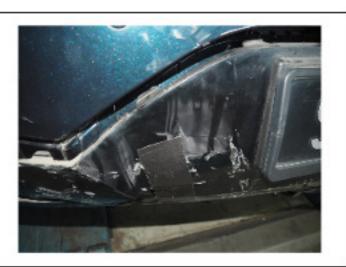
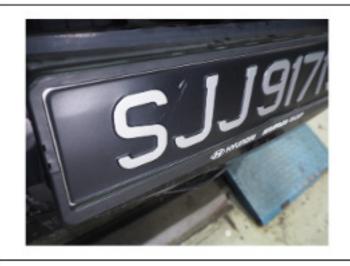
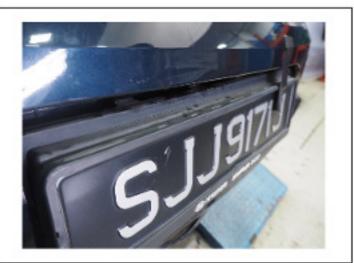
4.		•	on of Damages		
	THE VEHICLE SU	STAINED DAMAGES AT THE REA	AR PORTION.		
	DAMAGES SEE D	ETAILS.			
5.		General	Information		
	Accident Date	24/04/2020	Inspection Date	24/04/2020	
	Survey held at	ADVANCE AUTO GARAGE			
	23 KAKI BUKIT AVENUE 4 #04-01 AAS KAKI BUKIT CENTRE SINGAPORE 415933				
5a.			emarks		
	A)THE INSPECTION WAS CONDUCTED ON A"WITHOUT PREJUDICE" BASIS. B)IN ACCORDANCE TO YOUR INSTRUCTIONS, WE HAVE NOT AUTHORISED REPAIRS.				
5b.					
	ESTIMATED NOR	MAL PERIOD FOR REPAIR:	6 Working Days
