Affiliated to Federation Internationale Des Experts En Automobile							
MS F	IRST CAPITAL IN	SURANCE LTD	Ref : CS/FCI20005608/G	Gsf3n2				
36 ROBINSON ROAD #16-01 CITY HOUSESINGAPORE 068877		Date: 15-05-2020 Code: FCI2

### ADJUSTMENT ON REPAIR COST FOR VEHICLE NO. SMG 1093J

### PHOTOGRAPHS FOR VEHICLE NO. SMG 1093J

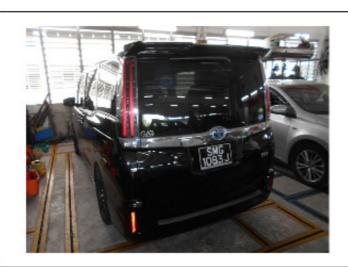
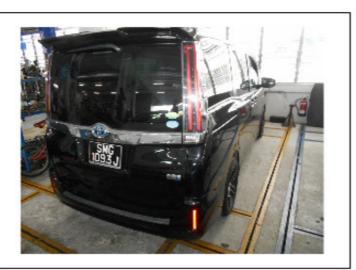
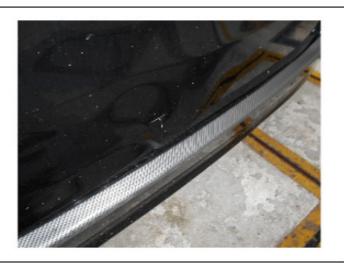
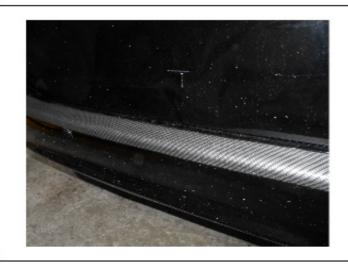
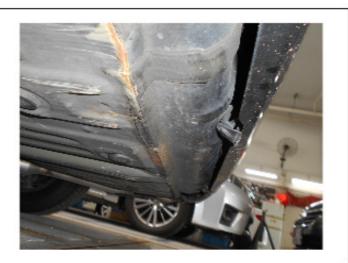
### INSPECTION

4.		Description	on of Damages					
	THE VEHICLE SUS	STAINED DAMAGES AT THE REA	AR PORTION.					
	DAMAGES SEE DI	ETAILS.						
5.		General	Information					
	Accident Date	03/05/2020	Inspection Date	08/05/2020				
	Survey held at	E M SOLUTION PTE LTD						
		BLK 17 SIN MING IND. ESTATE SECTOR A #01-59 SINGAPORE 575675						
5a.	1	Re	emarks					
	A)DAMAGES CONSISTENT TO ACCIDENT REPORT. B)THE INSPECTION WAS CONDUCTED ON A"WITHOUT PREJUDICE" BASIS. C)IN ACCORDANCE TO YOUR INSTRUCTIONS, WE HAVE NOT AUTHORISED REPAIRS.							
5b.	Estimate Days of Repair							
	ESTIMATED NOR	MAL PERIOD FOR REPAIR:	5 Working Days
