LKK Auto Consultants Pte Ltd

ADJUSTMENT ON REPAIR COST FOR VEHICLE NO. SLV 6421X

PHOTOGRAPHS FOR VEHICLE NO. SLV 6421X

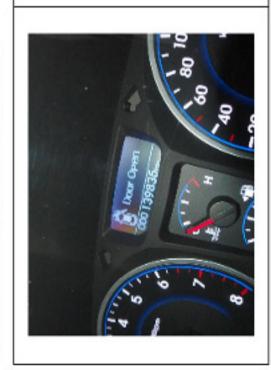
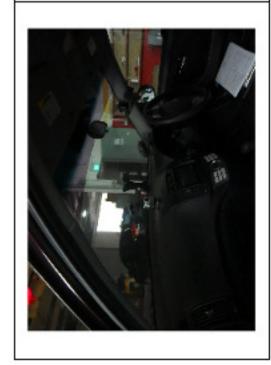
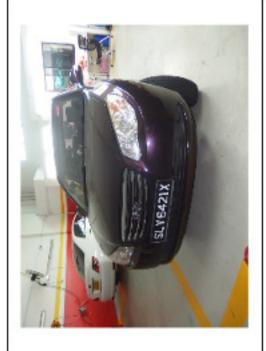
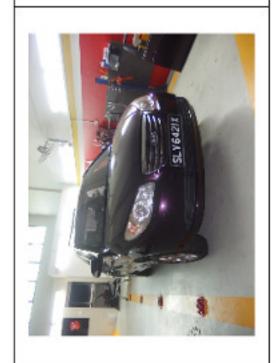
4.		· · · · · · · · · · · · · · · · · · ·	on of Damages		
	THE VEHICLE SUSTAINED DAMAGES AT THE O/S FRONT PORTION AND O/S BODY.THE UNDERCARRIAGE AFFECTED DUE TO COLLISION.				
	DAMAGES SEE DI
