LKK Auto Consultants Pte Ltd

4. Description of Damages

ADJUSTMENT ON REPAIR COST FOR VEHICLE NO. SLS 419J

PHOTOGRAPHS FOR VEHICLE NO. SLS 419J

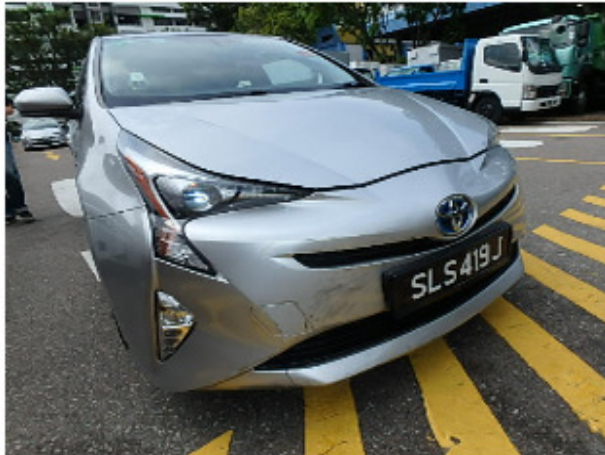
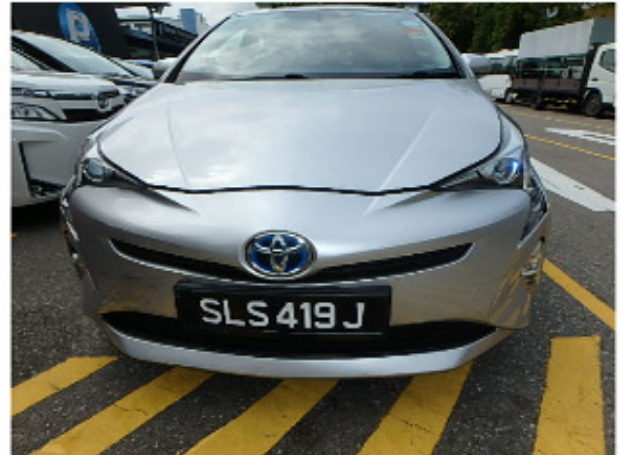
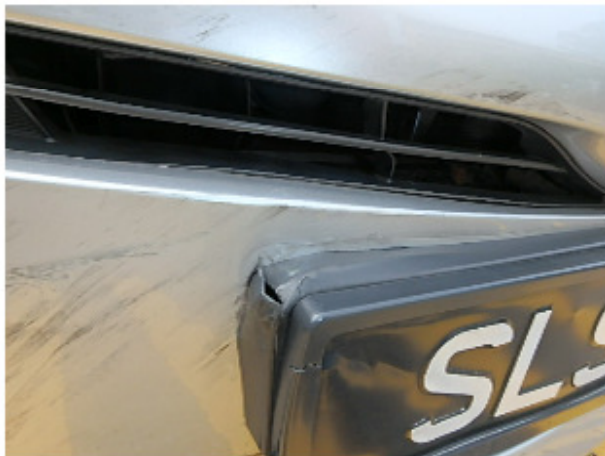
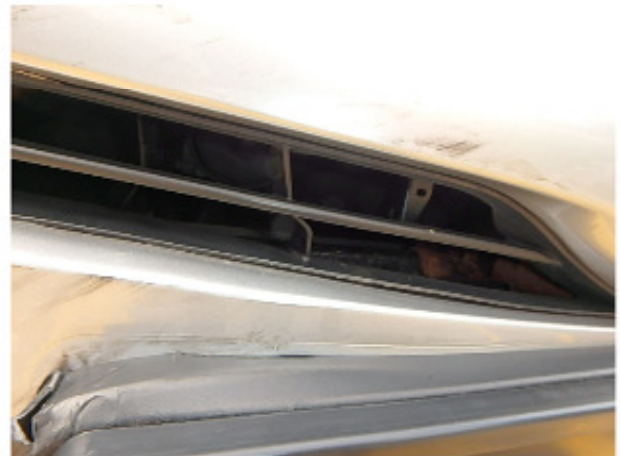
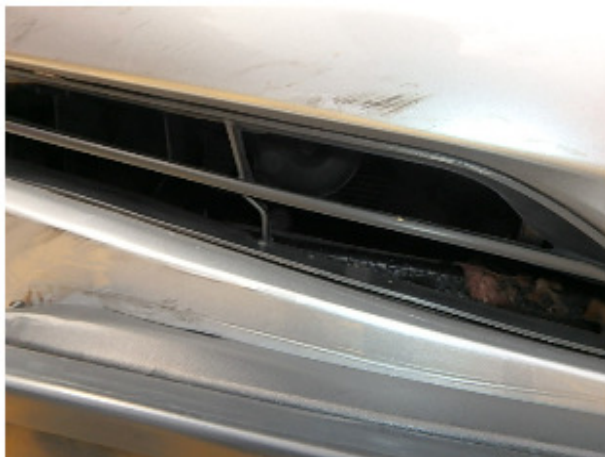
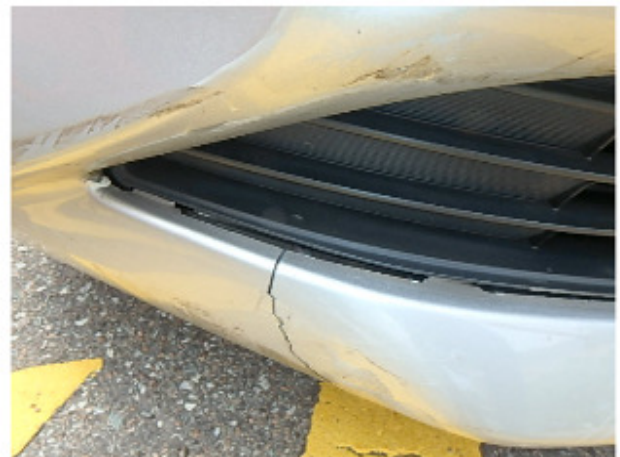
INSPECTION

THE VEHICLE SUSTAINED DAMAGES AT THE FRONT O/S PORTION. DAMAGES SEE DETAILS.

Qty	Description of Parts	Condition	Estimate By Workshop (\$)	Our Adjusted (\$)
	<u>REPLACEMENT OF PARTS</u>			
1	FRONT NUMBER PLATE GARNISH	CRACKED	129.00	129.00
1	FRONT BUMPER	BUCKLED / CRACKED	450.80	450.80
10	FRONT BUMPER CLIP	NECESSARY	40.00	40.00
1	FRONT BUMPER REINFORCEMENT-UPPER	TO REPAIR SEE LABOUR	711.50	-
1	FRONT BUMPER REINFORCEMENT-LOWER	TO REPAIR SEE LABOUR	245.30	-
1	FRONT BUMPER SIDE RETAINER RH	SERVICEABLE	107.20	-
1	FRONT BUMPER SIDE RETAINER LH	SERVICEABLE	107.20	-
1	FRONT BUMPER UPPER GRILLE	DISTORTED	321.90	321.90
1	FRONT BUMPER LOWER GRILLE	SERVICEABLE	148.60	-
1	FRONT BUMPER EMBLEM	NECESSARY	87.10	87.10
1	FRONT BUMPER TOW COVER RH	SERVICEABLE	25.70	-
1	FRONT BUMPER TOW COVER LH	SERVICEABLE	25.70	-
1	FRONT BUMPER SPONGE-UPPER	SERVICEABLE	89.81	-
1	FRONT BUMPER SPONGE-LOWER	SERVICEABLE	135.70	-
1	FOG LAMP RH	SERVICEABLE	910.70	-
1	ENGINE UNDER COVER	SERVICEABLE	198.30	-
10	ENGINE UNDER COVER CLIP	NOT NECESSARY	35.00	-

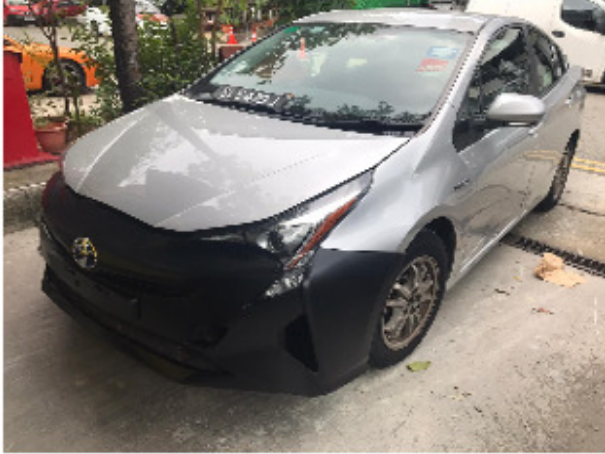
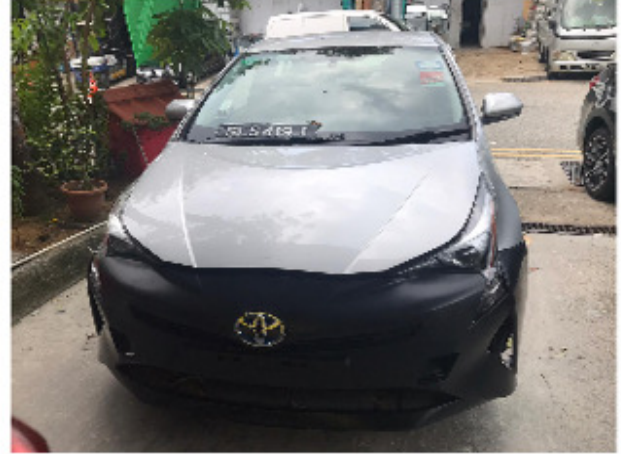
RE-INSPECTION

PHOTOGRAPHS FOR VEHICLE NO. SLS 419J
