## LKK Auto Consultants Pte Ltd

### ADJUSTMENT ON REPAIR COST FOR VEHICLE NO. SLP 3644X

PHOTOGRAPHS FOR VEHICLE NO. SLP 3644X

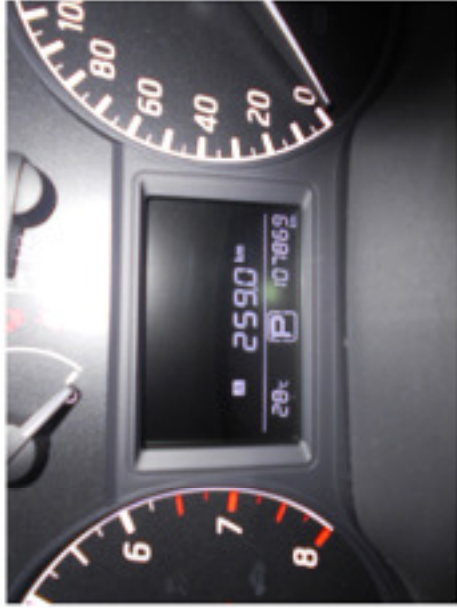
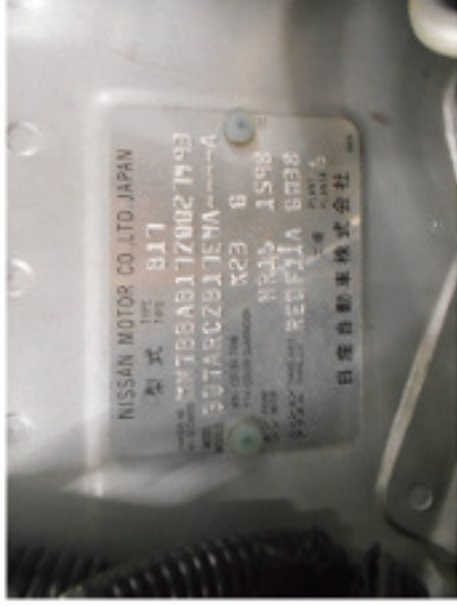
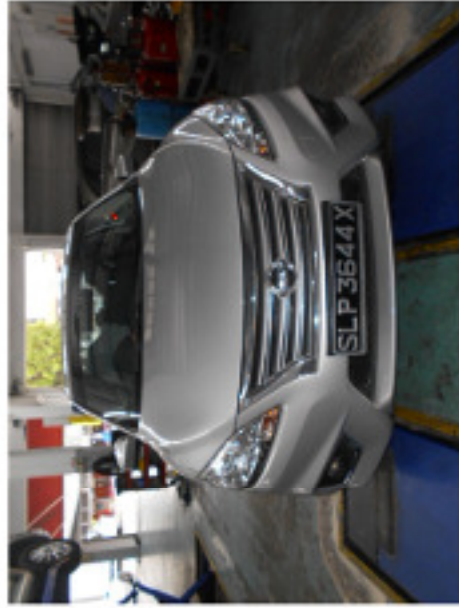
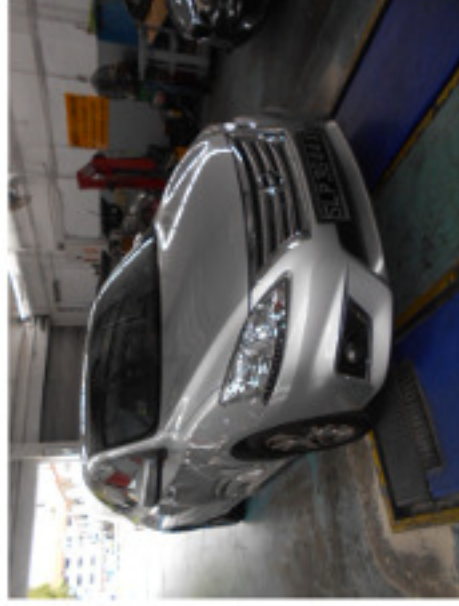
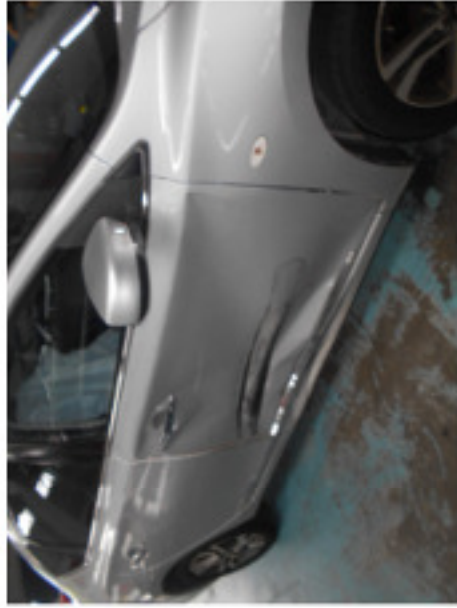
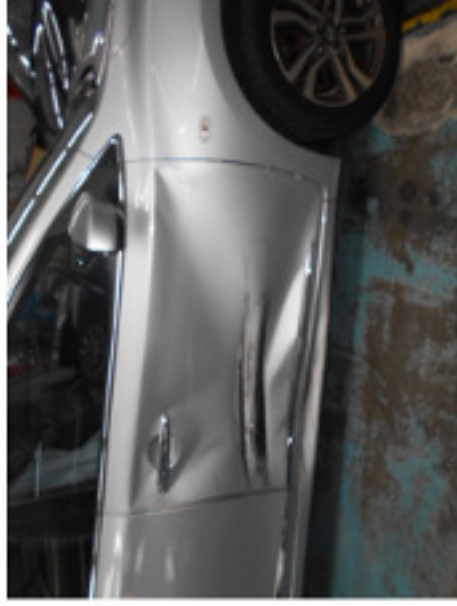
THE VEHICLE SUSTAINED DAMAGES AT THE O/S BODY. DAMAGES SEE DETAILS.
--

INSPECTION

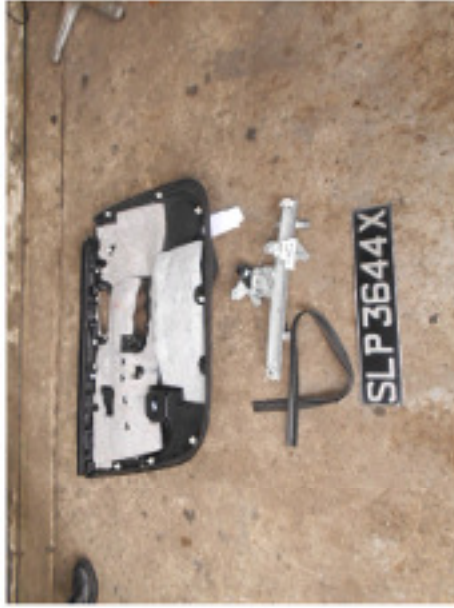
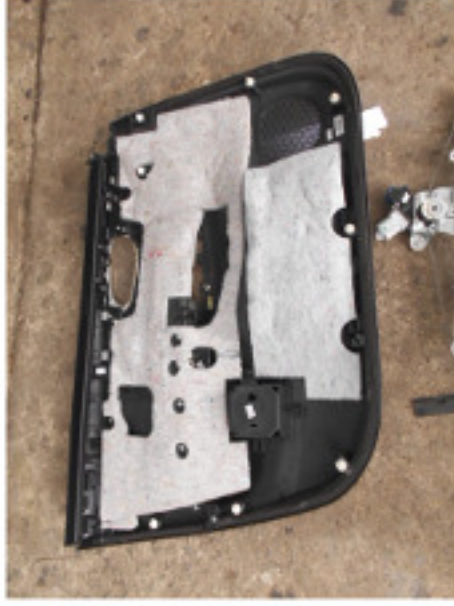
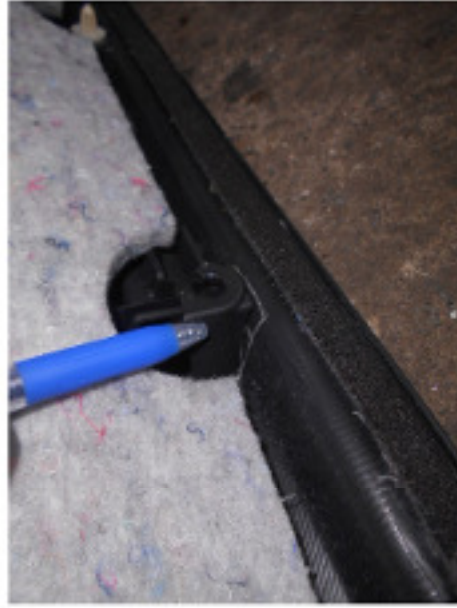
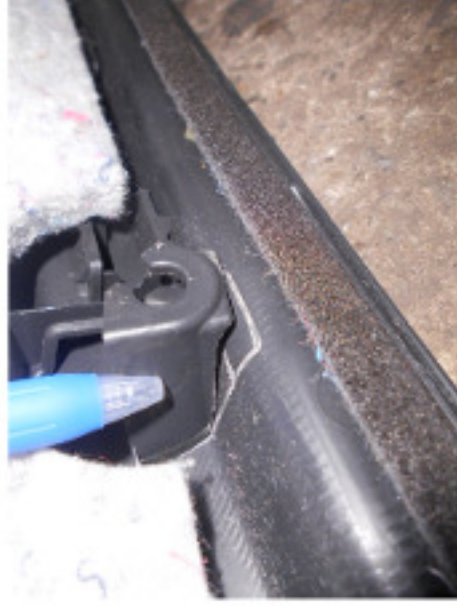
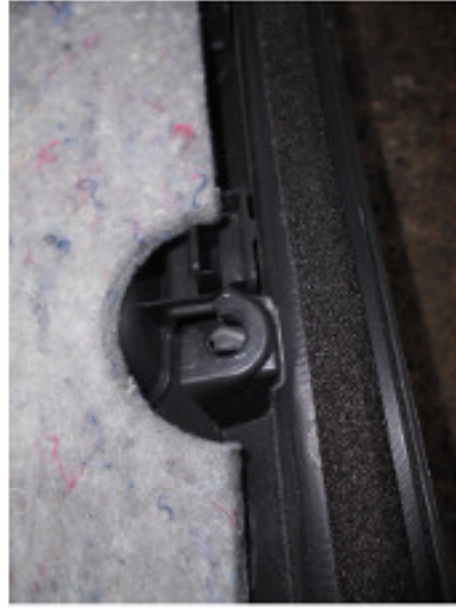
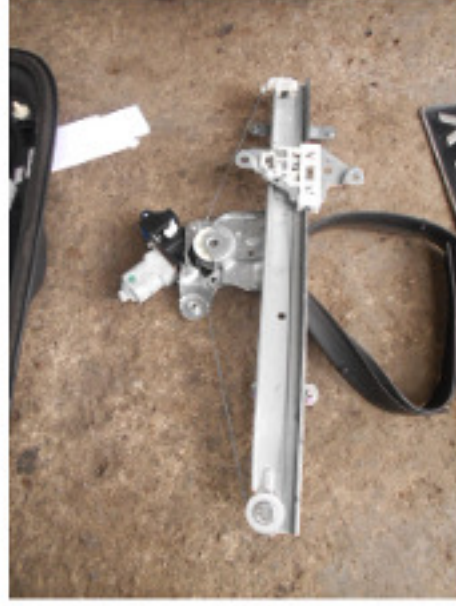
PHOTOGRAPHS FOR VEHICLE NO. SLP 3644X

RE-INSPECTION
