Vehicle No. SME 38L
Insured Veh. SLR 6020R
Claim No. SNM20D201990
Policy No. DMPCSN1932191900
Accident Date 22/05/2020
Inspection Date 26/05/2020

LKK Auto Consultants Pte Ltd

ADJUSTMENT ON REPAIR COST FOR VEHICLE NO. SME 38L

PHOTOGRAPHS FOR VEHICLE NO. SME 38L

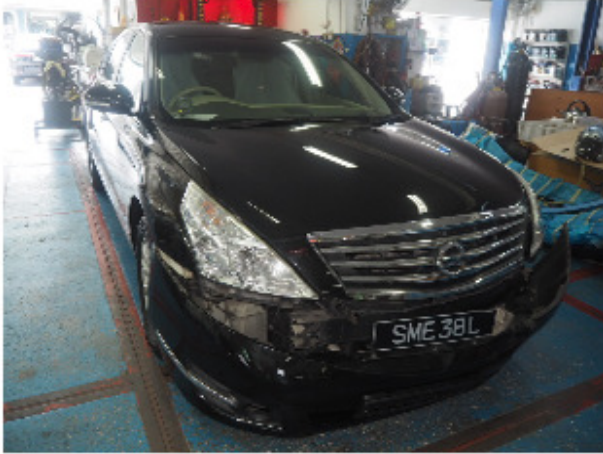
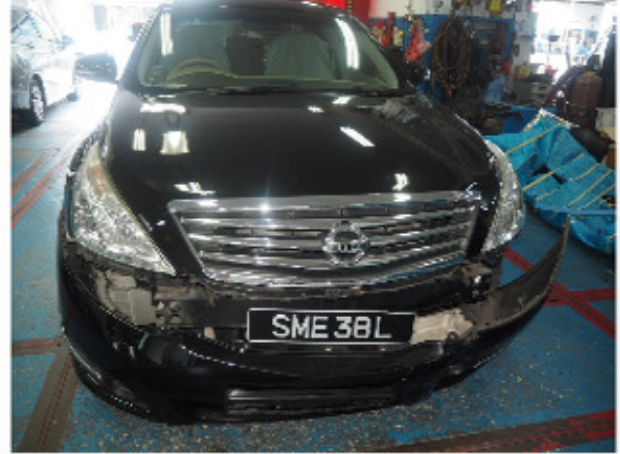
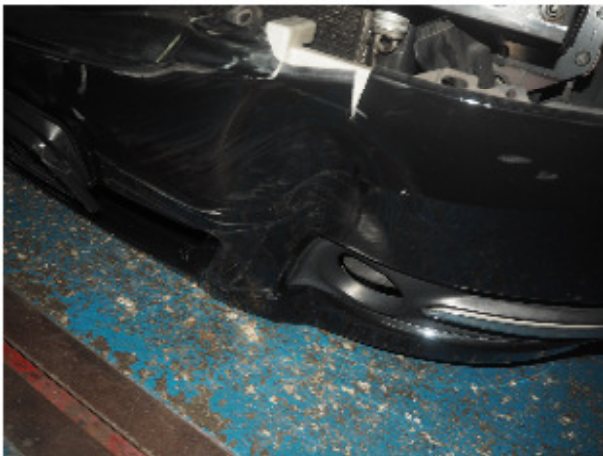
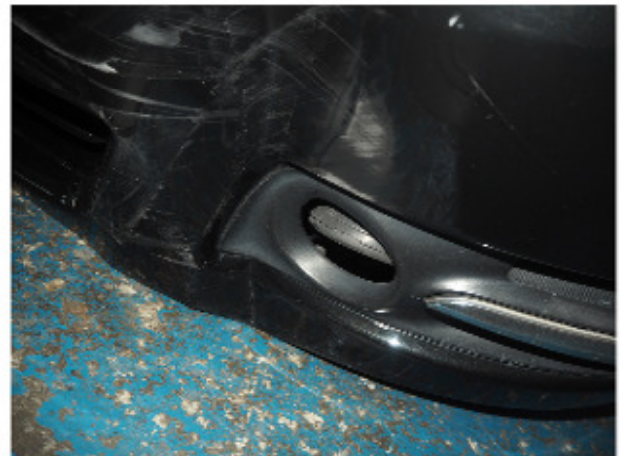
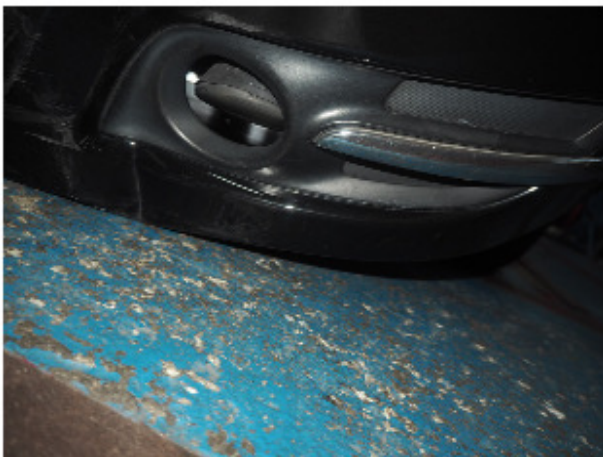
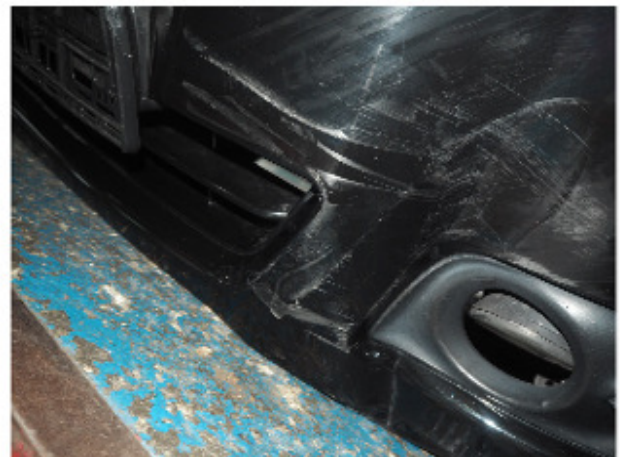
INSPECTION

THE VEHICLE SUSTAINED DAMAGES AT THE FRONT PORTION. DAMAGES SEE DETAILS.
