# LKK Auto Consultants Pte Ltd

### 1. Policy Particulars :- THIRD PARTY CLAIM

## ADJUSTMENT ON REPAIR COST FOR VEHICLE NO. SGY 6507B

PHOTOGRAPHS FOR VEHICLE NO. SGY 6507B

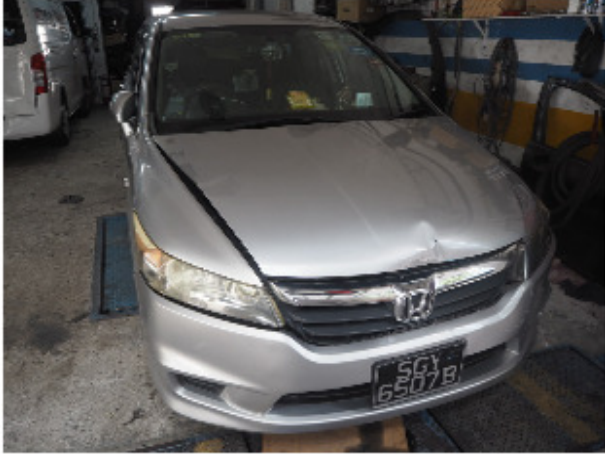
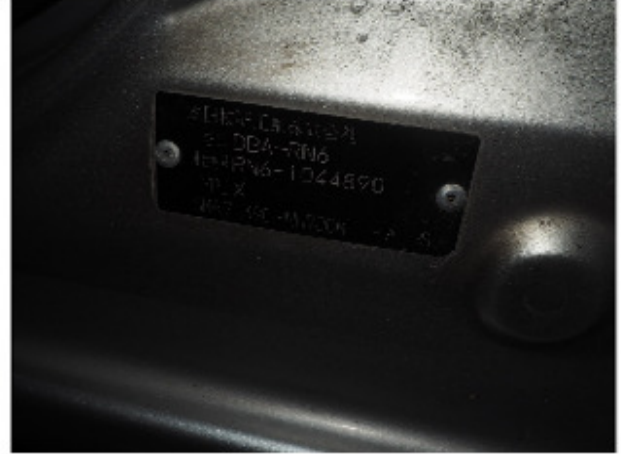
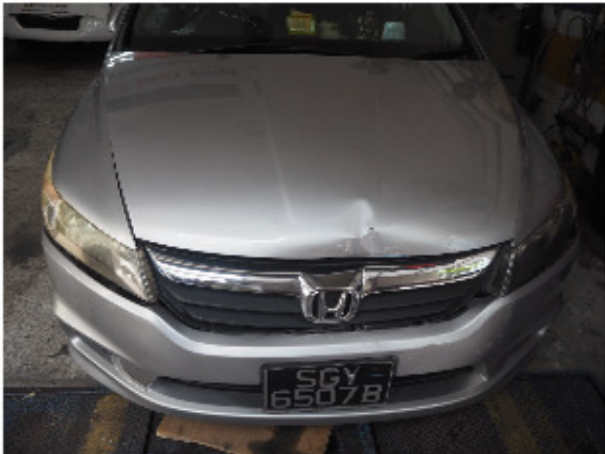
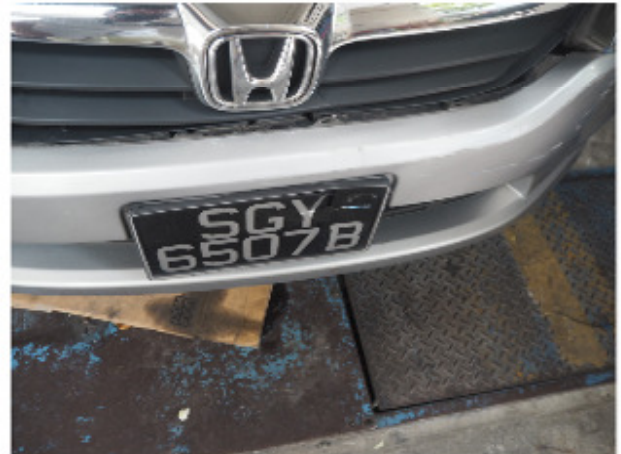
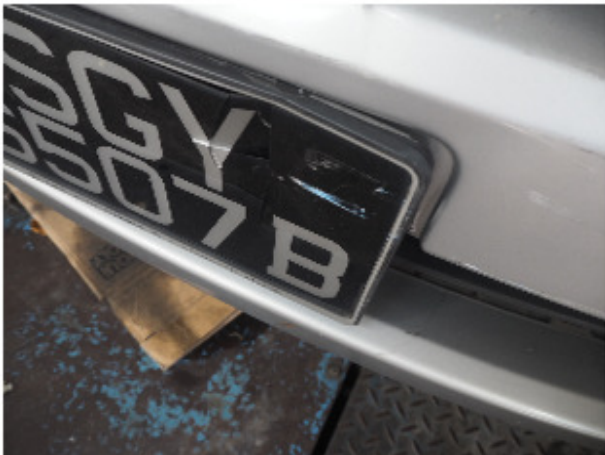
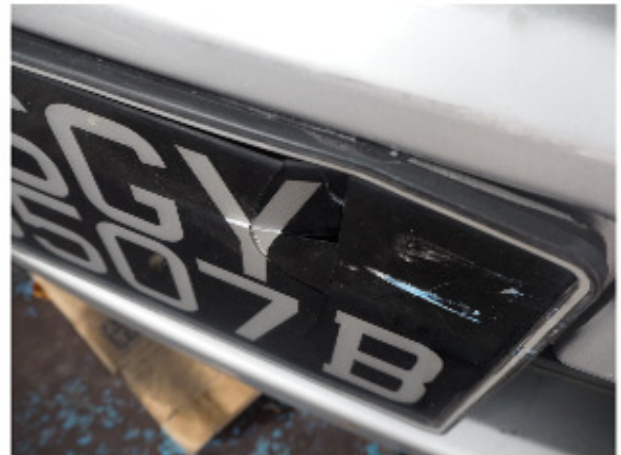
THE VEHICLE SUSTAINED DAMAGES AT THE FRONT PORTION.

INSPECTION

Qty	Description of Parts	Condition	Estimate By Workshop (\$)	Our Adjusted (\$)
	<b><u>REPLACEMENT OF PARTS</u></b>			
1	BONNET	DENTED	866.90	685.20
1	BONNET LOCK	DAMAGED	155.00	155.00
1	FRONT GRILLE	CRACKED	428.00	285.40
1	FRONT GRILLE CHROME	CRACKED	255.90	255.90
1	FRONT GRILLE EMBLEM	NECESSARY	48.80	48.80
2	FRONT R/H FENDER @\$637.00	TO REPAIR SEE LABOUR	1,274.00	-
2	FRONT R/H FENDER TOP GARNISH @\$350.80	NOT NECESSARY	701.60	-
2	RH/LH HEADLAMP @\$1850.00	CRACKED	3,700.00	1,378.60
2	RH/LH HEADLAMP LOWER BRACKET @\$51.60	CRACKED	103.20	103.20
1	FRONT BUMPER	DEFORMED	1,285.00	689.00
1	FRONT BUMPER REINFORCEMENT	BENT	440.00	239.70
2	FRONT BUMPER SIDE RETAINER LH/RH @\$97.00	NECESSARY	194.00	68.00
10	FRONT BUMPER CLIPS @\$5.00	NECESSARY	50.00	30.00
1	FRONT BUMPER LOWER GRILLE	NOT NECESSARY	220.00	-
1	FRONT SUPPORT PANEL	BUCKLED	728.80	466.30
1	FRONT SUPPORT PANEL TOP GARNISH	DEFORMED	108.50	108.50
1	AIR CON CONDENSER	DENTED	1,550.00	826.60

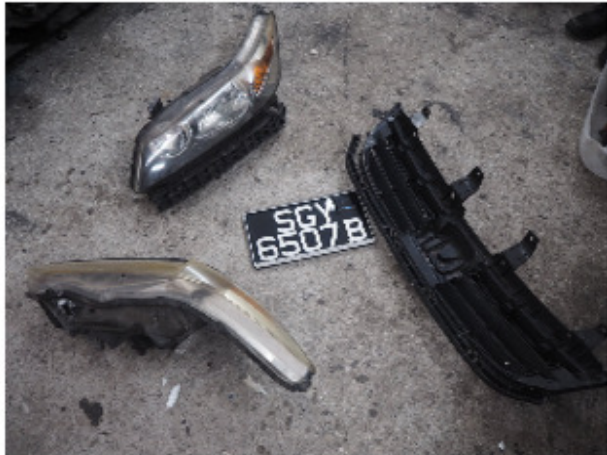
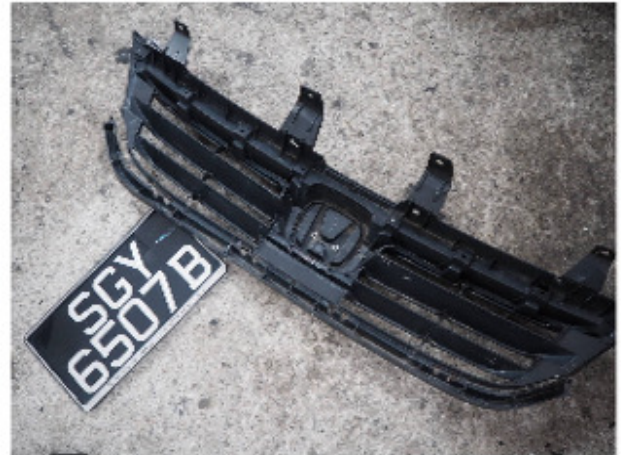
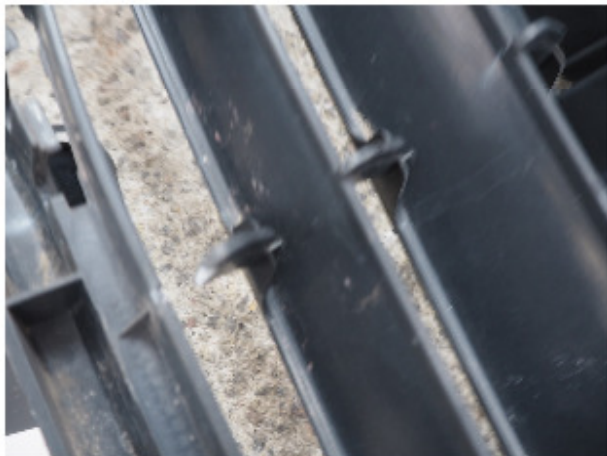
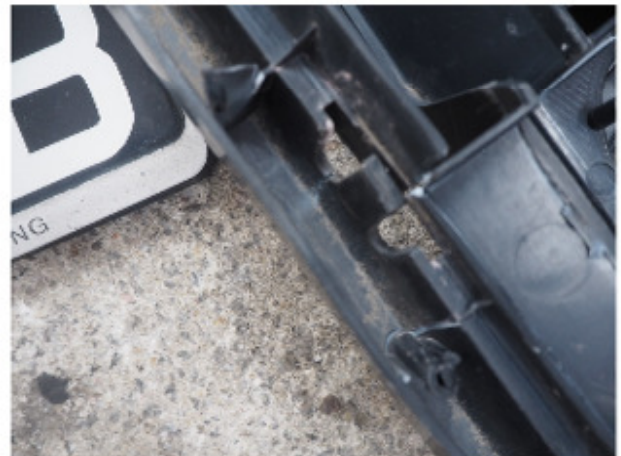
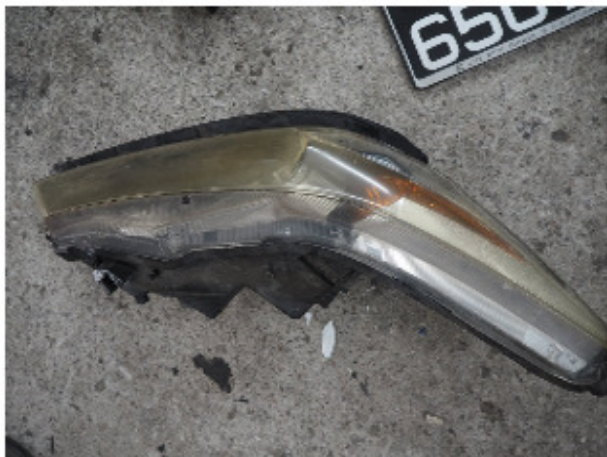
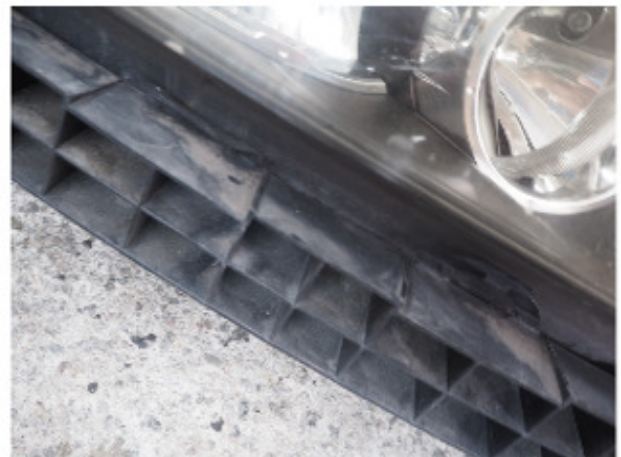
PHOTOGRAPHS FOR VEHICLE NO. SGY 6507B

RE-INSPECTION
