LKK Auto Consultants Pte Ltd

ADJUSTMENT ON REPAIR COST FOR VEHICLE NO. SKQ 3661C

PHOTOGRAPHS FOR VEHICLE NO. SKQ 3661C

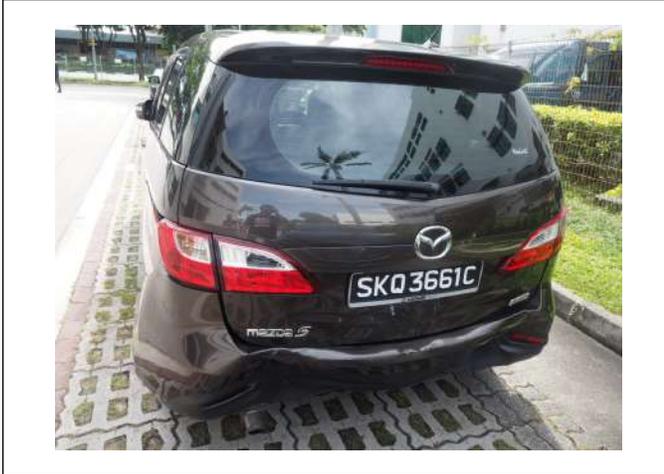
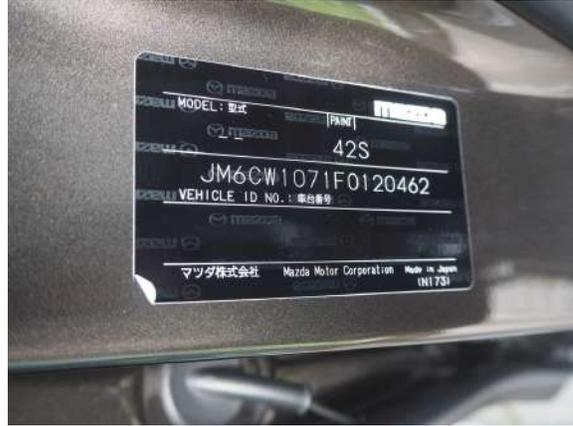
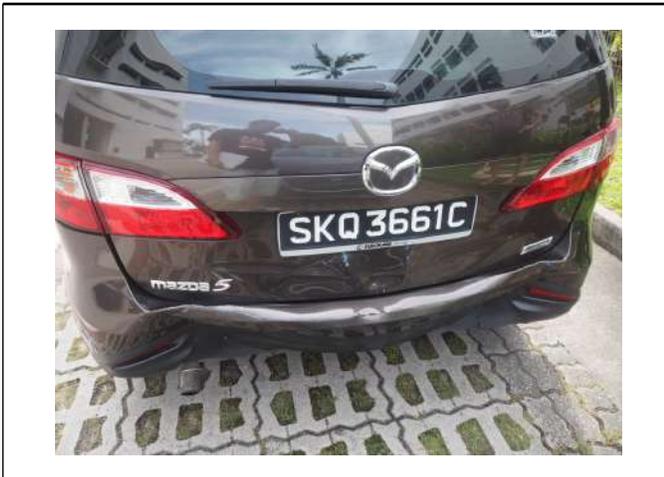
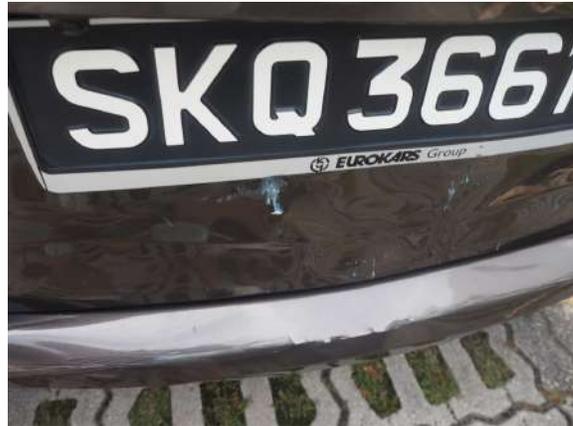
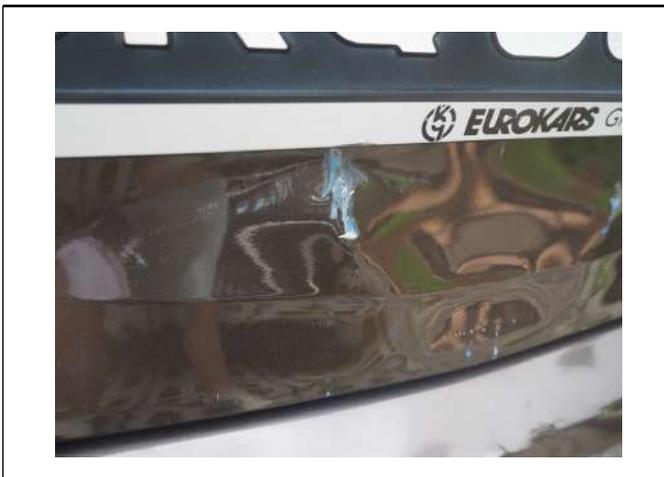
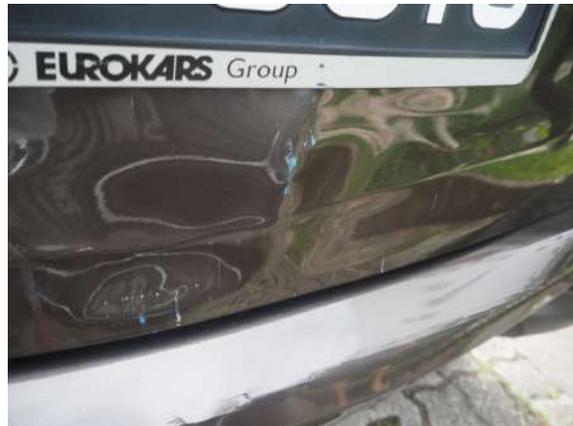
4. Description of Damages			
THE VEHICLE SUSTAINED DAMAGES AT THE REAR PORTION. DAMAGES SEE DETAILS.			
5. General Information			
Accident Date	01/06/2020	Inspection Date	04/06/2020
Survey held at	TRANS EUROKARS PTE LTD 12 SUNGEI KADUT AVE SINGAPORE 729648		
5a. Remarks			
A)THE INSPECTION WAS CONDUCTED ON A"WITHOUT PREJUDICE" BASIS. B)IN ACCORDANCE TO YOUR INSTRUCTIONS, WE HAVE NOT AUTHORISED REPAIRS.			
5b. Estimate Days of Repair			
ESTIMATED NORMAL PERIOD FOR REPAIR:		5 Working Days

INSPECTION

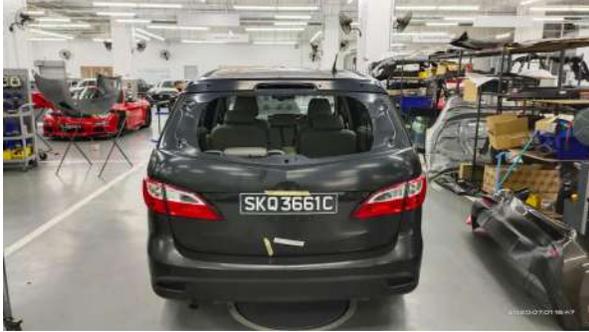
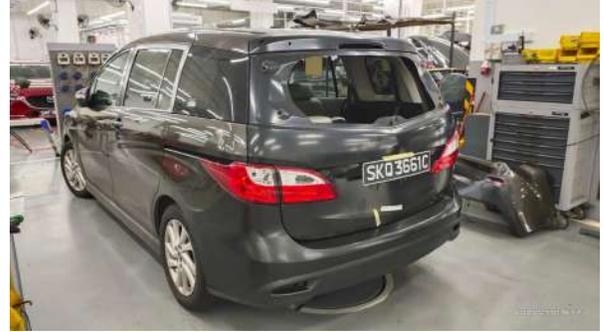
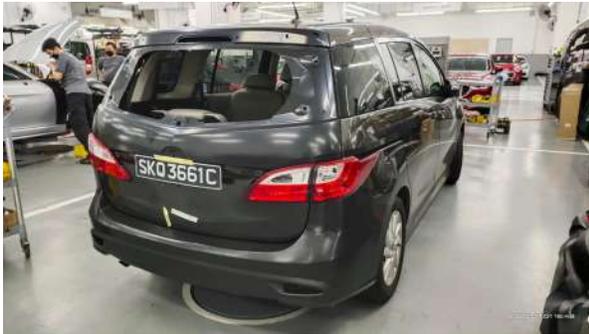
PHOTOGRAPHS FOR VEHICLE NO. SKQ 3661C

RE-INSPECTION
