LKK Auto Consultants Pte Ltd

Vehicle No. SLC 6908J
Insured Veh. SHA 8517Z
Claim No. D20002273MFSH
Policy No. D-18088937MFSH
Accident Date 30/05/2020
Inspection Date 08/06/2020

4. Description of Damages

ADJUSTMENT ON REPAIR COST FOR VEHICLE NO. SLC 6908J

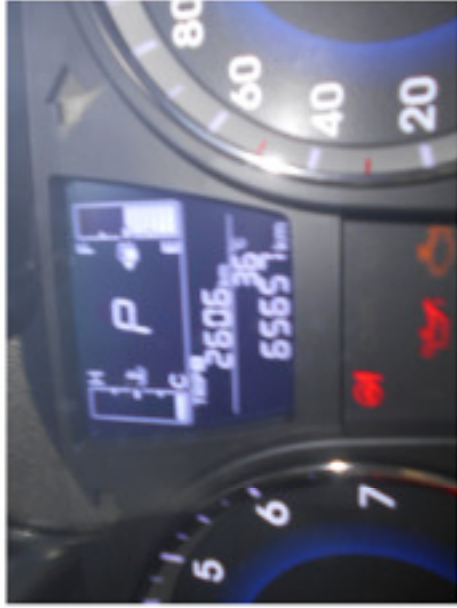
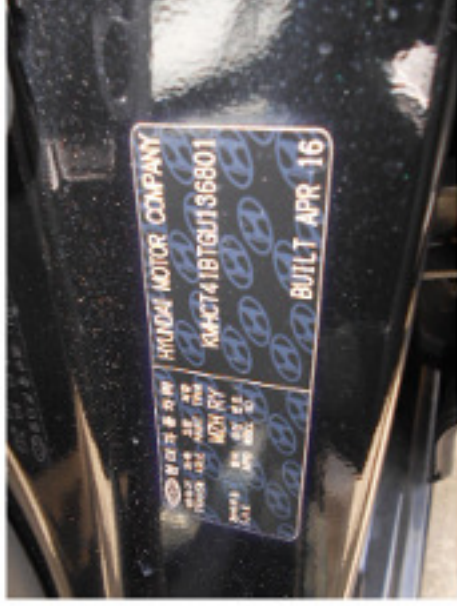
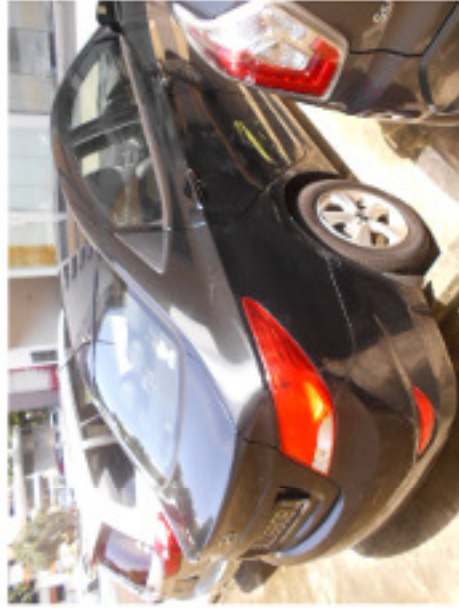
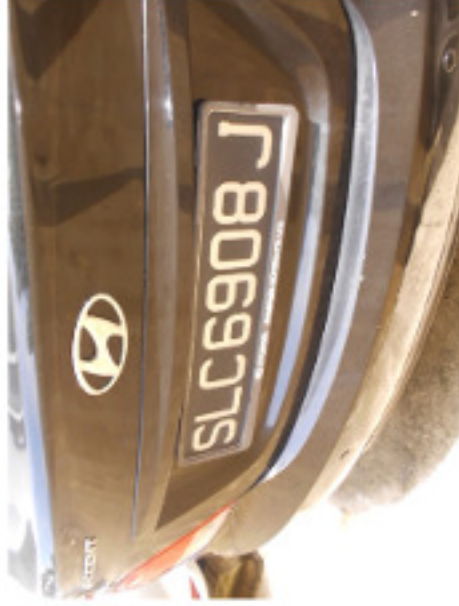
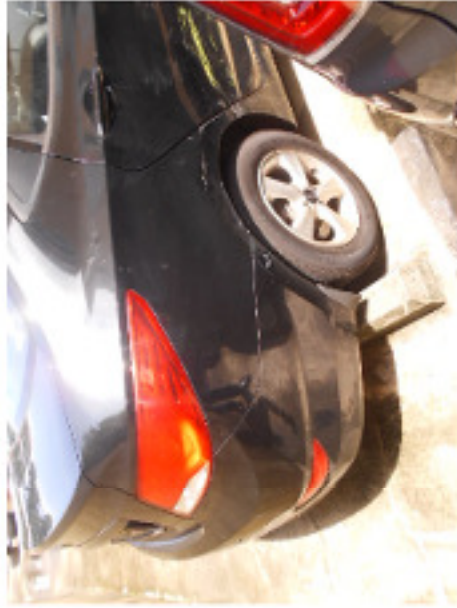
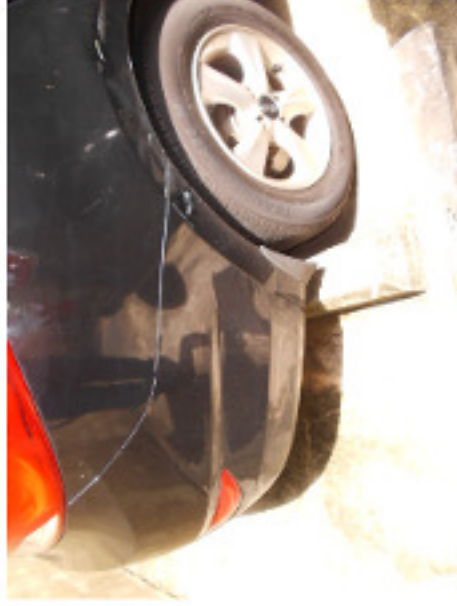
INSPECTION

THE VEHICLE SUSTAINED DAMAGES AT THE O/S REAR PORTION. DAMAGES SEE DETAILS.
--

PHOTOGRAPHS FOR VEHICLE NO. SLC 6908J

Qty	Description of Parts	Condition	Estimate By Workshop (\$))	Our Adjusted (\$)
	<u>REPLACEMENT OF PARTS</u>			
1	REAR FENDER RH	TO REPAIR SEE LABOUR	1,450.00	-
1	REAR FENDER UNDER -DUST COVER RH	NOT NECESSARY	280.00	-
1	REAR DOOR RH	BENT	1,500.00	1,317.00
1	REAR DOOR WINDOW REGULATOR RH	NOT NECESSARY	220.00	-
1	REAR DOOR WINDOW REGULATOR MOTOR RH	NOT NECESSARY	380.00	-
1	REAR BUMPER	TO REPAIR SEE LABOUR	1,150.00	-
	LESS 10% DISCOUNT		-498.00	-
	LESS 20% DISCOUNT		-	-263.40
			4,482.00	1,053.60
	<u>SPECIAL NETT ITEMS</u>			
1	SET REAR FENDER UNDER-DUST COVER CLIPS (SN)	NOT NECESSARY	40.00	-
1	SET REAR BUMPER CLIPS (SN)	NOT NECESSARY	40.00	-

80.00	-
	<u>LABOUR</u>			
	TO REMOVE ACCIDENT DAMAGED PARTS IN ORDER TO REPAIRS INCLUDING PANEL BEAT ,CUT/WELD ,STRAIGHTEN PANEL WHERE STRAIGHTEN.INCLUSIVE OF THE REPAIR OF REAR FENDER RH AND REAR BUMPER .		1,300.00	400.00
	TO PUTTY & SPRAY PAINT ALL AFFECTED AREAS (INNER/OUTER).		1,000.00	600.00
	TO APPLY RUSTPROOFING /TUFFCOATING TREATMENT TO REPLACED PARTS.		180.00	40.00
	TRANSFER DOOR MECHANISM .		180.00	60.00

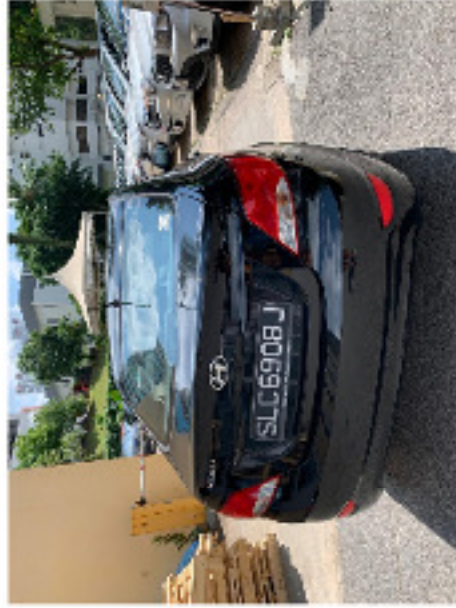
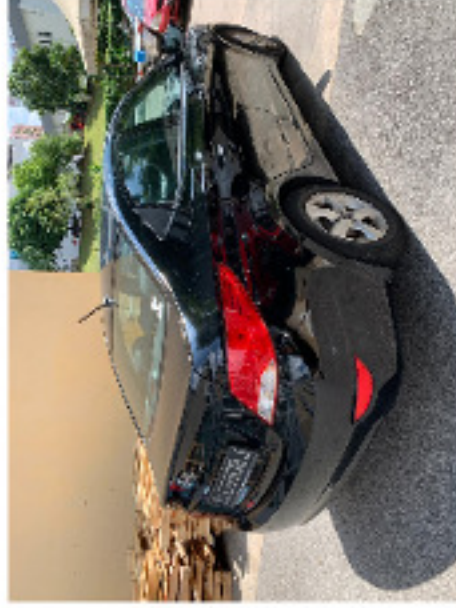
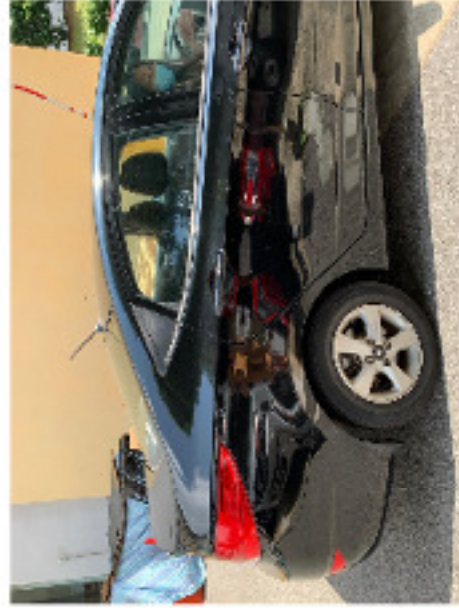
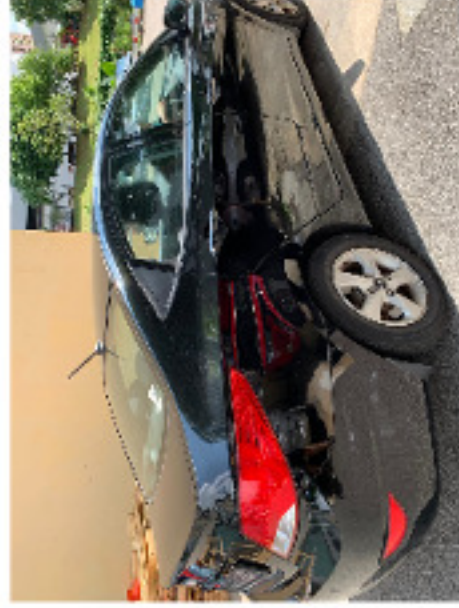
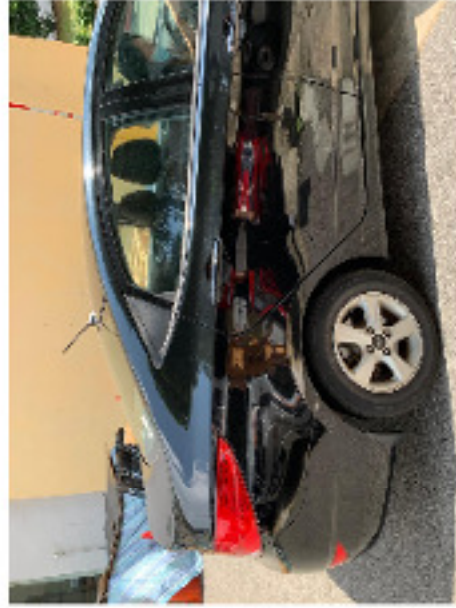
RE-INSPECTION

PHOTOGRAPHS FOR VEHICLE NO. SLC 6908J
