## LKK Auto Consultants Pte Ltd

### 4. Description of Damages

### ADJUSTMENT ON REPAIR COST FOR VEHICLE NO. SKS 1465E

PHOTOGRAPHS FOR VEHICLE NO. SKS 1465E

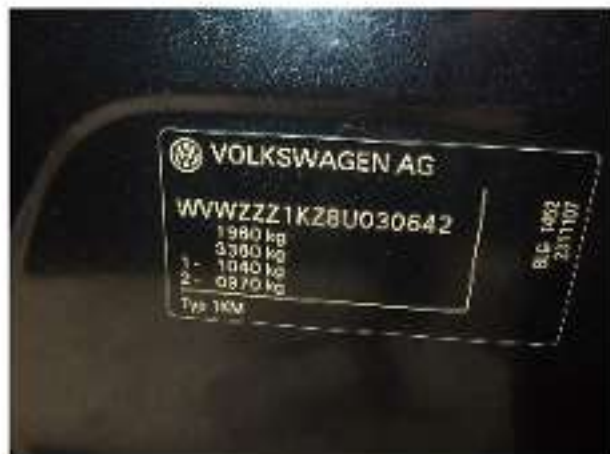
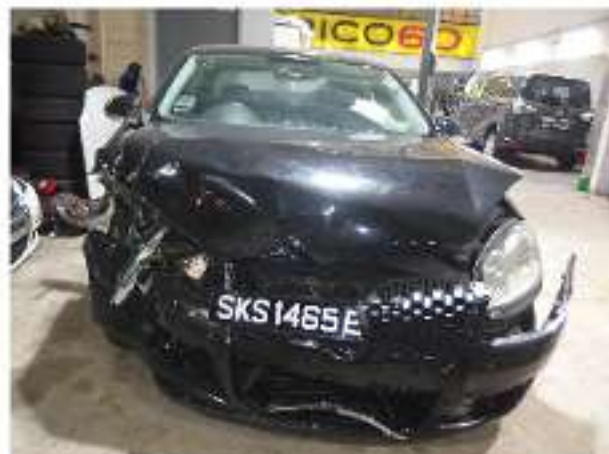
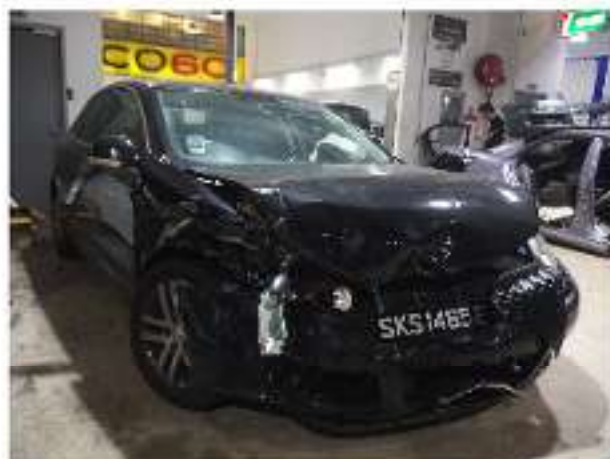
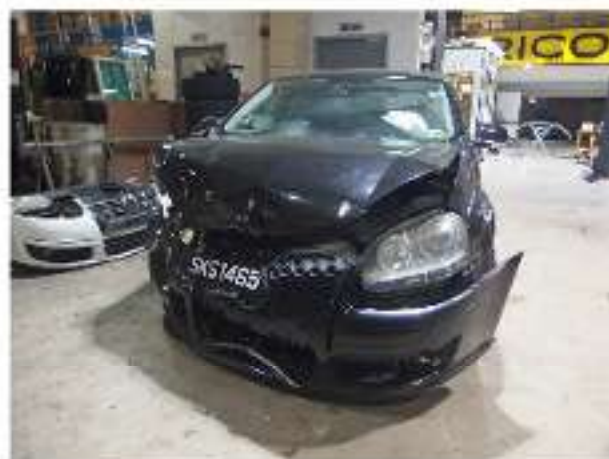
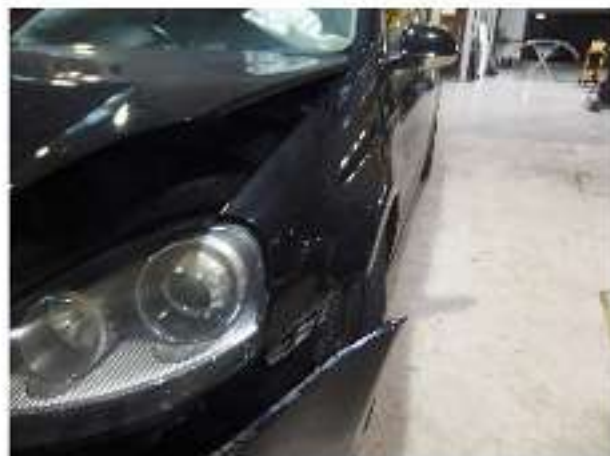
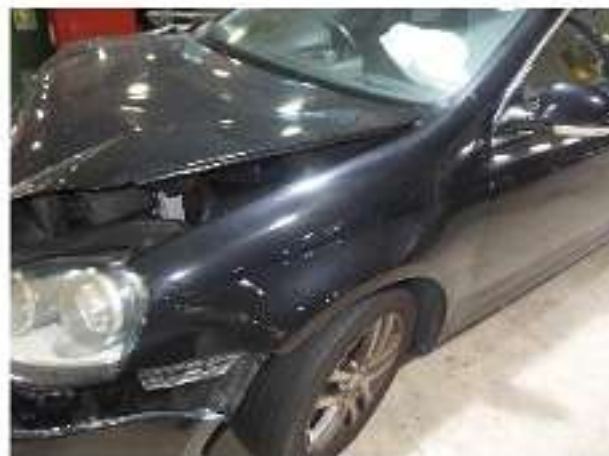
INSPECTION

| THE VEHICLE SUSTAINED DAMAGES AT THE FRONT PORTION. THE UNDERCARRIAGE AND CHASSIS FRAME AFFECTED DUE TO COLLISION.<br><br>DAMAGES SEE DETAILS. |

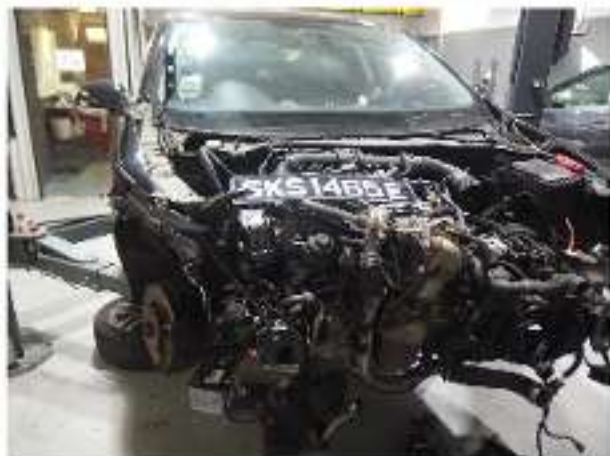
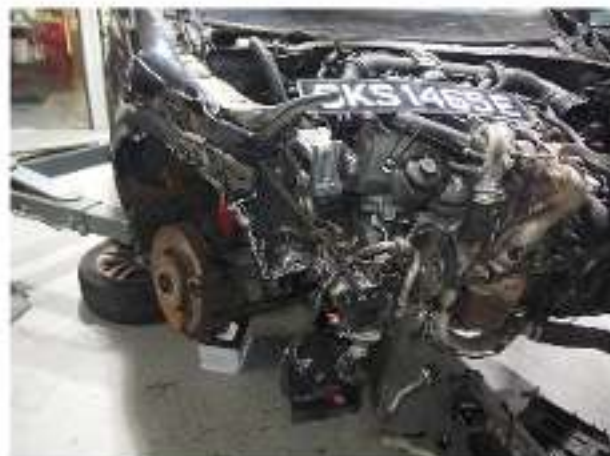
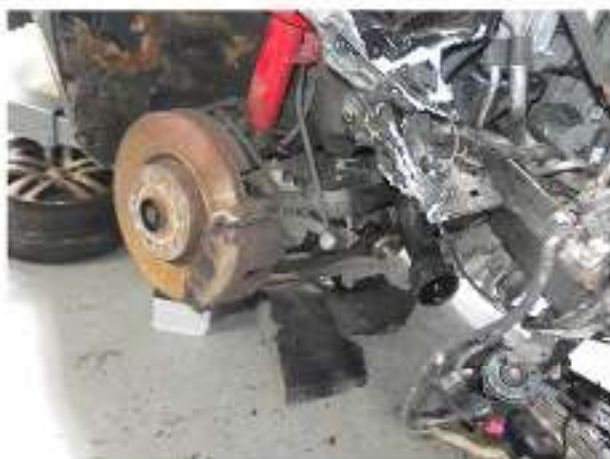
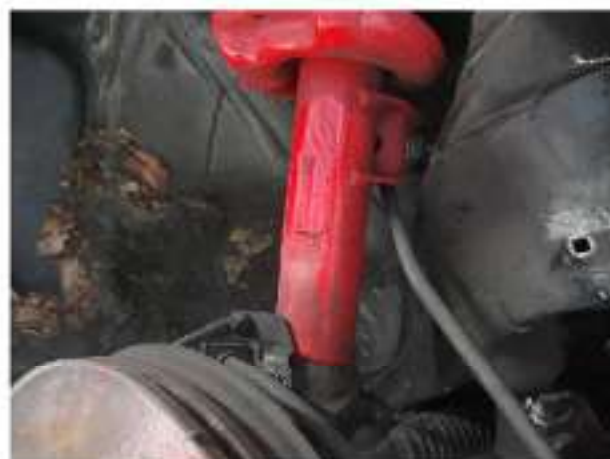
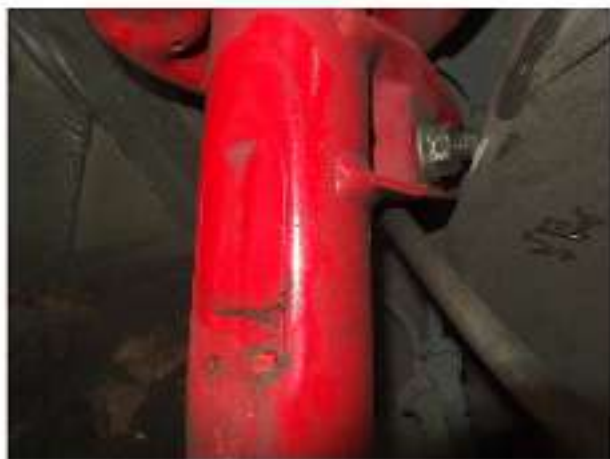
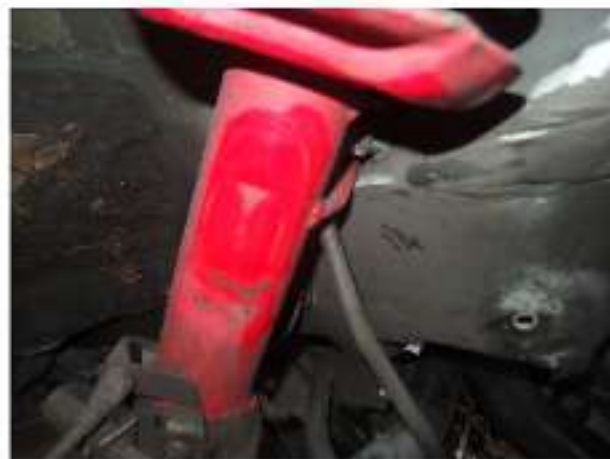
PHOTOGRAPHS FOR VEHICLE NO. SKS 1465E

RE-INSPECTION
