Vehicle No. SKZ 176J  
Insured Veh. SHA 5300B  
Claim No. D20002398MFSH  
Policy No. D-20094922MFSH  
Accident Date 10/06/2020  
Inspection Date 17/06/2020

## ADJUSTMENT ON REPAIR COST FOR VEHICLE NO. SKZ 176J

### PHOTOGRAPHS FOR VEHICLE NO. SKZ 176J

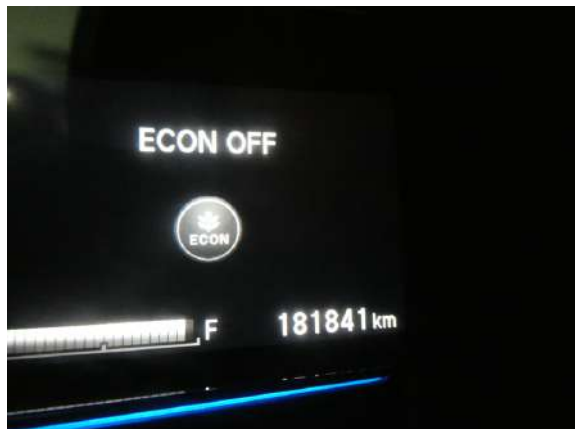
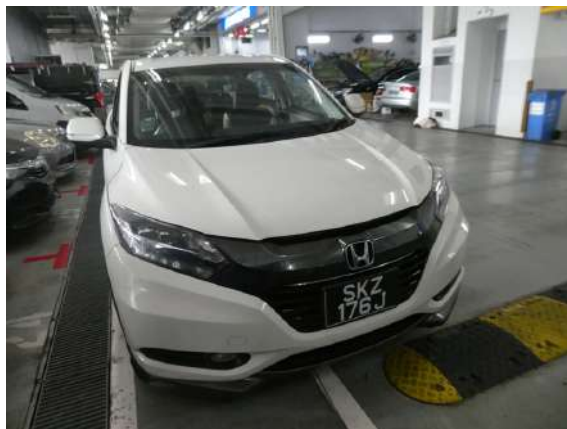
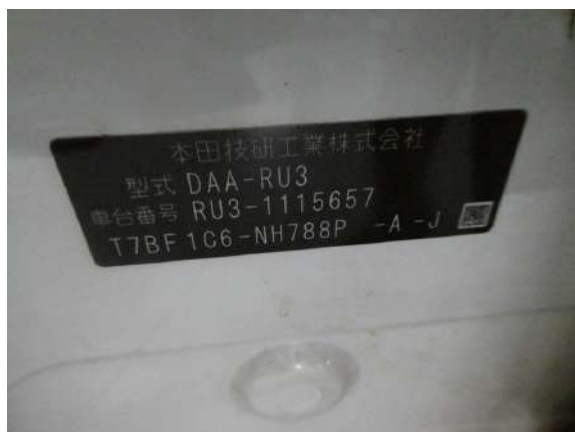
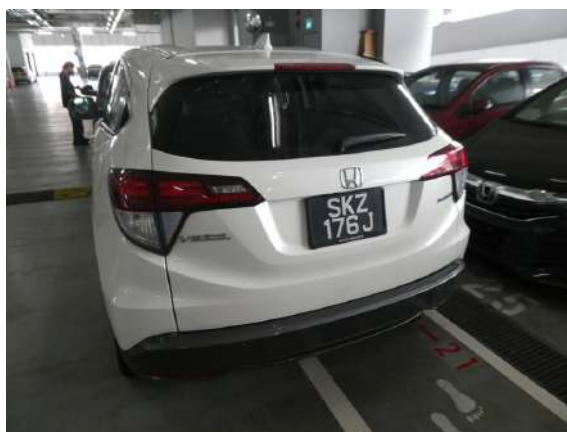
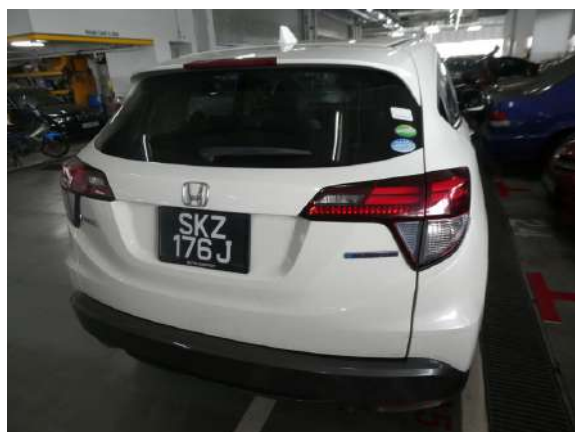
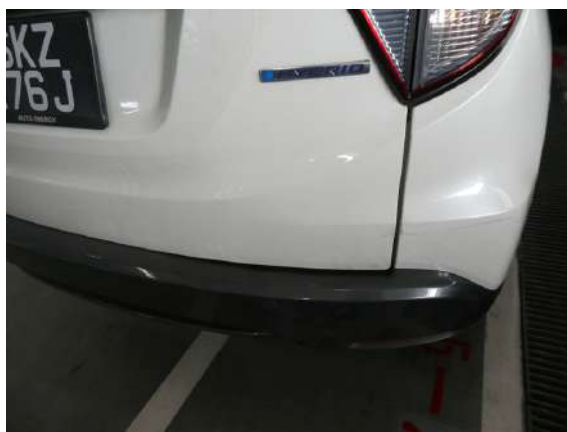
### INSPECTION

| Affiliated to Federation Internationale Des Experts En Automobile | | | | |
|---|---|---|---|--|
| THE VEHICLE SUSTAINED DAMAGES AT THE REAR PORTION.<br><br>DAMAGES SEE DETAILS. | | | | |
