MS FIF	RST CAPITAL IN	SURANCE LTD	D-f - 004/E010000044E			
		FIRST CAPITAL INSURANCE LTD Ref : CC4/FCl20006445/Kda3q2				
	BINSON ROAD I CITY HOUSESI	NGAPORE 068877	Date: 03-09-2020 Code: FCI2

### ADJUSTMENT ON REPAIR COST FOR VEHICLE NO. SJX 2948H

# PHOTOGRAPHS FOR VEHICLE NO. SJX 2948H

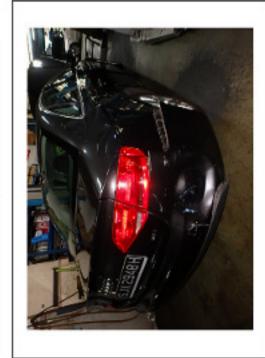
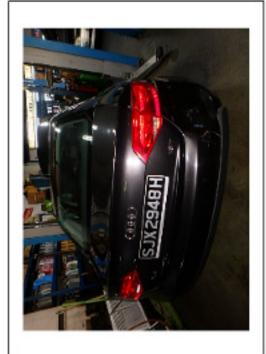
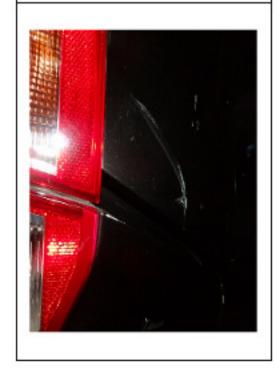
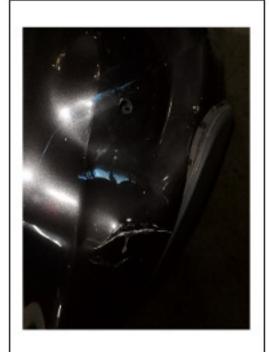
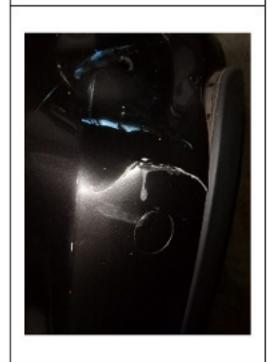
4.		<u> </u>	on of Damages			
	THE VEHICLE SUS	STAINED DAMAGES AT THE REA	AR O/S PORTION.			
	DAMAGES SEE DE	ETAILS.				
5.		General	Information			
/	Accident Date	15/06/2020	Inspection Date	19/06/2020		
	Survey held at	LOH HENG				
		BLK 176 #03-08 SIN MING DRIVE SINGAPORE 575721				
5a.		Re	emarks			
	A)THE INSPECTION WAS CONDUCTED ON A"WITHOUT PREJUDICE" BASIS. B)IN ACCORDANCE TO YOUR INSTRUCTIONS, WE HAVE NOT AUTHORISED REPAIRS.					
5b.	b. Estimate Days of Repair					
E	ESTIMATED NORMAL PERIOD FOR REPAIR: 6 Working Days
