## LKK Auto Consultants Pte Ltd

Affiliated to Federation Internationale Des Experts En Automobile				
MS FIRST CAPITAL INSURANCE LTD		Ref : CC4/FCI20006447/Kka3q2		
36 ROBINSON ROAD #16-01 CITY HOUSESINGAPORE 068877		Date : 23-11-2020

## ADJUSTMENT ON REPAIR COST FOR VEHICLE NO. SJY 3925L

PHOTOGRAPHS FOR VEHICLE NO. SJY 3925L

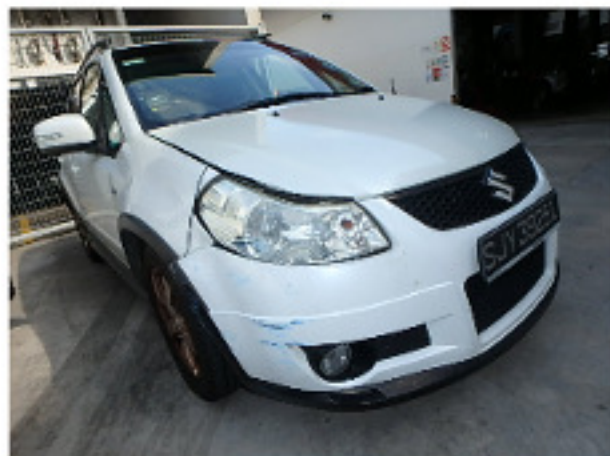
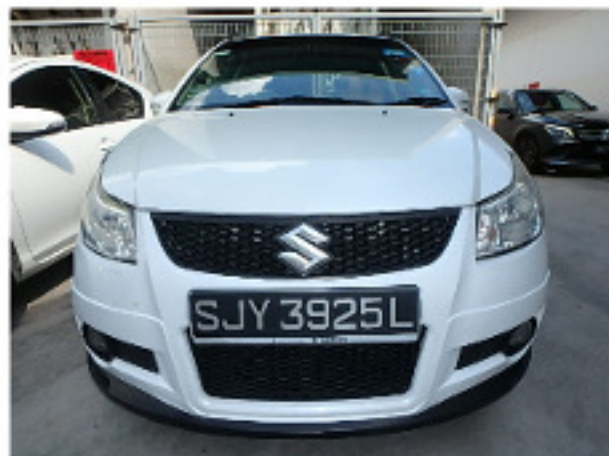
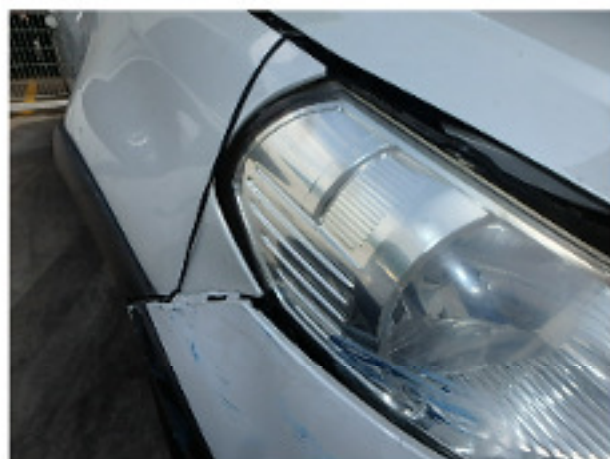
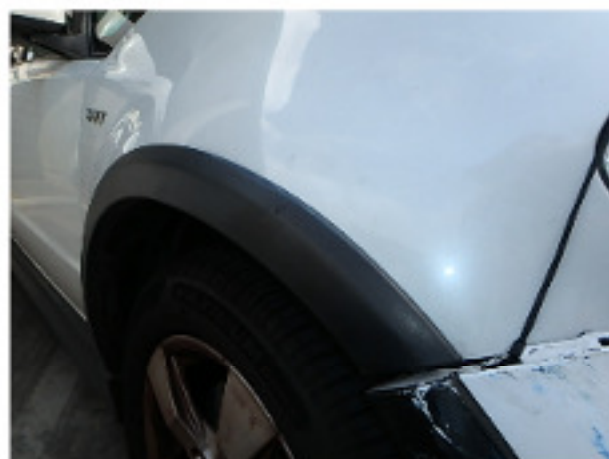
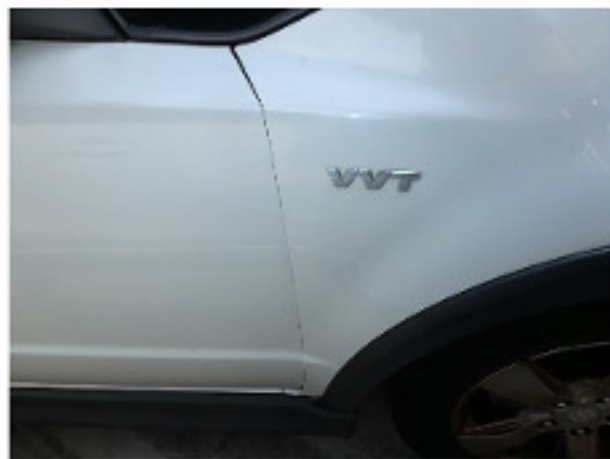
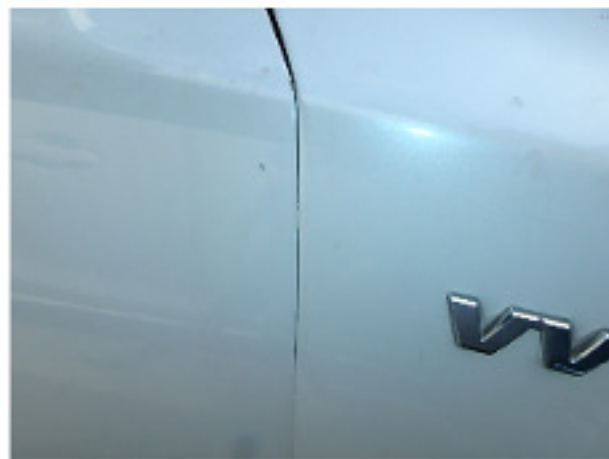
L/H Rear Tyre	205/60 R16	MICHELIN	8 mm	
<b>4. Description of Damages</b>				
THE VEHICLE SUSTAINED DAMAGES AT THE O/S FRONT PORTION. DAMAGES SEE DETAILS.				
<b>5. General Information</b>				
Accident Date	30/05/2020	Inspection Date	08/06/2020	
Survey held at	OPTIMA WERKZ PTE LTD 9A SERANGOON NORTH AVE 5 SINGAPORE 554500			
<b>5a. Remarks</b>				
A)THE INSPECTION WAS CONDUCTED ON A"WITHOUT PREJUDICE" BASIS. B)IN ACCORDANCE TO YOUR INSTRUCTIONS, WE HAVE NOT AUTHORISED REPAIRS.				
<b>5b. Estimate Days of Repair</b>				
ESTIMATED NORMAL PERIOD FOR REPAIR:		<b>4 Working Days</b>

INSPECTION

Qty	Description of Parts	Condition	Estimate By Workshop (\$))	Our Adjusted (\$)
	<b><u>REPLACEMENT OF PARTS</u></b>			
1	FRONT BUMPER	BUCKLED	790.45	790.45
8	FRONT BUMPER CLIPS @\$5.80	NECESSARY	46.40	46.40
1	FRONT BUMPER SIDE BRACKET RH	TO REPAIR SEE LABOUR	17.95	-
1	FRONT FENDER RH	BUCKLED	272.20	272.20
1	FRONT FENDER INNER LINER RH	DISTORTED / CRACKED	58.65	58.65
8	FRONT FENDER INNER LINER CLIPS RH @\$5.80	NECESSARY	46.40	46.40
1	FRONT FENDER "VVT" EMBLEM RH	NECESSARY	52.20	52.20
1	FRONT WHEEL ARCH EXTENSION COVER RH	BUCKLED	195.80	195.80
1	FRONT HEADLAMP RH	CUT	369.05	369.05
1	FRONT DOOR RH (NPA)	TO REPAIR SEE LABOUR	-	-
	LESS 15% DISCOUNT		-277.37	-274.67
			1,571.73	1,556.48
	<b><u>LABOUR</u></b>			
	LABOUR CHARGES TO REMOVE,REFIX,REPLACE,REPAIR & READJUST FRONT ACCIDENT AREAS & ETC.INCLUSIVE OF THE REPAIR OF FRONT BUMPER SIDE BRACKET RH AND FRONT DOOR RH.		600.00	400.00
	LABOUR CHARGES FOR PAINTING & TO SUPPLY PAINT & FURNISHING MATERIALS AT FRONT BUMPER,FRONT FENDER RH,FRONT DOOR RH & ETC.		700.00	600.00
