Affiliated to Federation Internationale Des Experts En Automobile				
LONF	IPAC INSURANCE BHD Ref : CC4/LPC20006866/Kba3n2			6/Kba3n2	
300 BEACH ROAD #17-04/07 THE CONCOURSESINGAPORE 199555		Date: 02-09-2020 Code: LPC2

1.		Policy Particulars	:- THIRD PARTY CLAIM		
	Insured Veh.	SKU 2361D	Veh. Inspected	SKQ 4218T	
	Policy No.	Z19VP05023921	Coverage (\$)	0.00	
	Claim No.	19/20/20/VP05/023435	Excess (\$)	0.00	
	Assign From	GERALD	Assign Date	01/07/2020

2.		Vehicle Partic	culars & Condition		
	Make & Model	KIA FORTE K3 (A)	c.c	1591	
	Engine No.	HIDDEN	Year of Reg.	2014	
	Chassis No.	KNAFX411MF5330532	Colour	METALLIC GREY	
	Odometer	64836	Steering	IN ORDER	
	Brakes	IN ORDER	Modification	STANDARD ALLOY RIM	
	General	GOOD

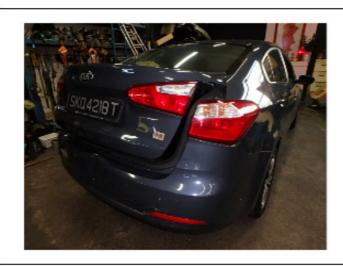
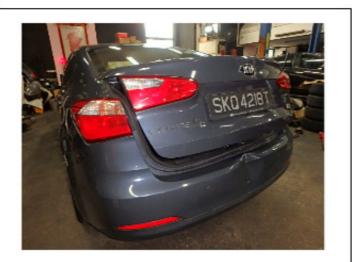
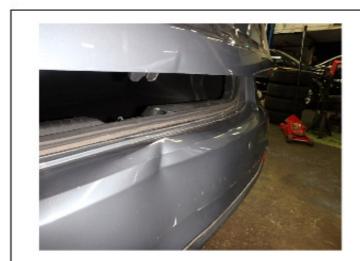
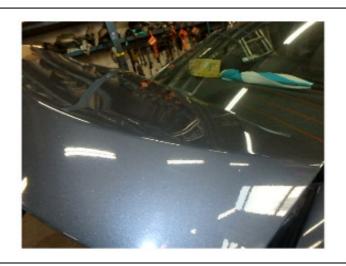
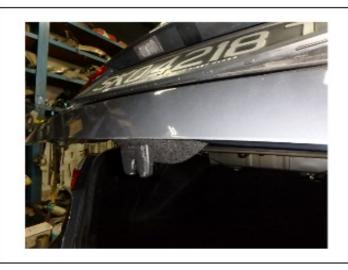
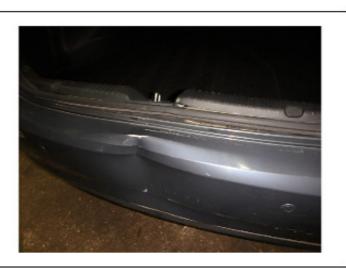
PHOTOGRAPHS FOR VEHICLE NO. SKQ 4218T

4.		•	on of Damages		
	THE VEHICLE SU	STAINED DAMAGES AT THE REA	AR AND FRONT PORTION.		
	DAMAGES SEE D	ETAILS.			
5.		General	I Information		
	Accident Date	30/06/2020	Inspection Date	01/07/2020	
	Survey held at	HUI YANG MOTOR PTE LTD			
		BLOCK 176 SIN MING DRIVE #04-02 SIN MING AUTOCARE SINGAPORE 575721			
5a.		Re	emarks		
	A)THE INSPECTION WAS CONDUCTED ON A"WITHOUT PREJUDICE" BASIS. B)IN ACCORDANCE TO YOUR INSTRUCTIONS, WE HAVE NOT AUTHORISED REPAIRS.				
5b.	b. Estimate Days of Repair				
	ESTIMATED NORI	MAL PERIOD FOR REPAIR:	6 Working Days

INSPECTION
