Precise Appraiser Pte Ltd

VEHICLE DAMAGE ASSESSMENT REPORT

Ref No	: 2020/0082	Date of Report	: 7/4/2020
Claim Type	: Third Party	Date of Request	: 7/4/2020
Third party vehicle	: PA8930T	Date of Accident	: 3/4/2020
Insured Vehicle	:	Date of Inspection	: 7/4/2020
Your Reference No	: -

Registration Plate No	: PA8930T	Engine Modification	: NIL
Model / Make	: Toyota Hiace Commuter	Pre-accident damage	: NIL
Colour	: Silver	General Condition	: Good
Manufacturing Year	: 2008	General Paint Work	: Good
Engine No	: 1KD1836510	Steering	: Serviceable
Engine Capacity	: 3000cc	Handbrake	: Serviceable
Chassis No	: KDH2010027250	Footbrake	: Serviceable
Odometer No	: 215000		
Transmission	:

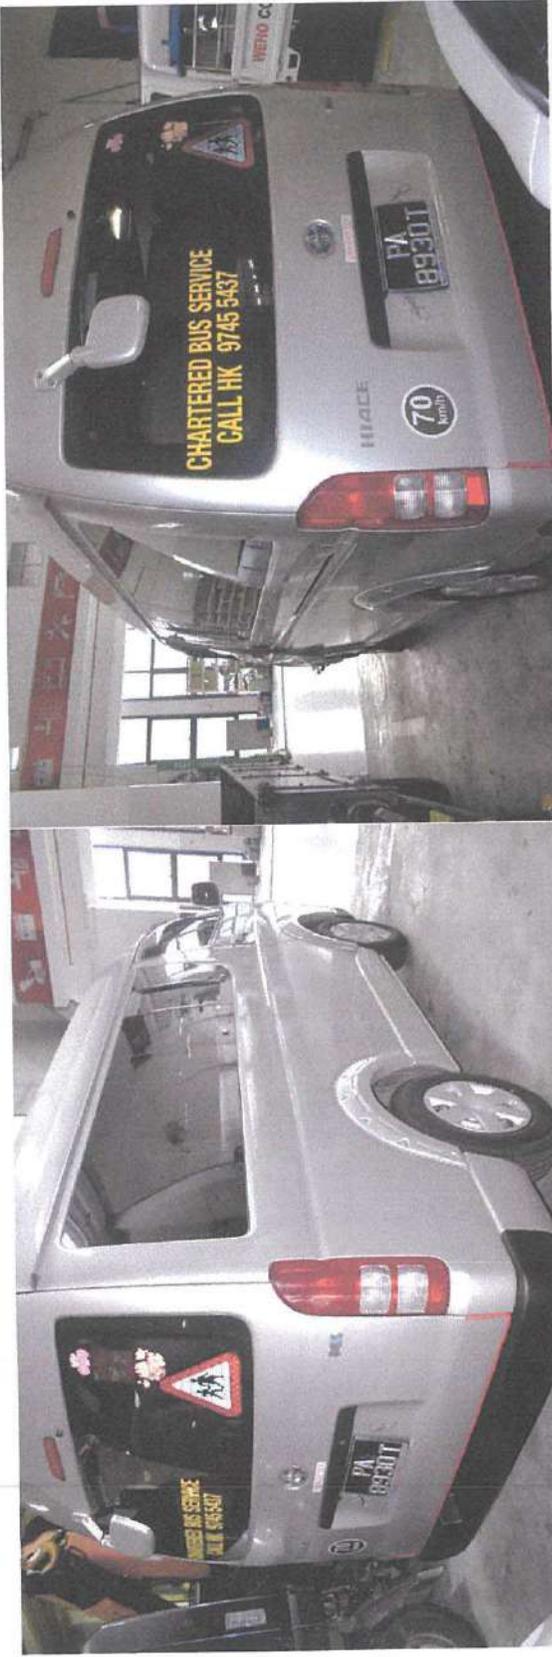
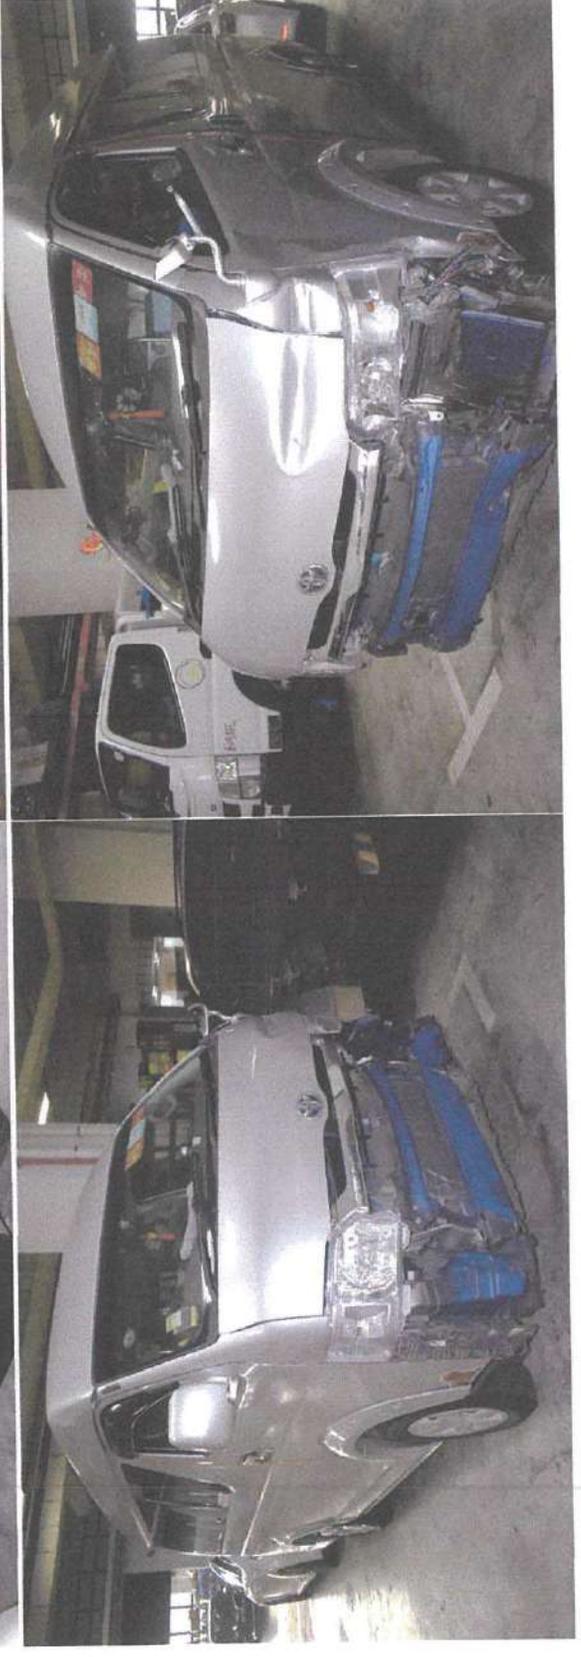
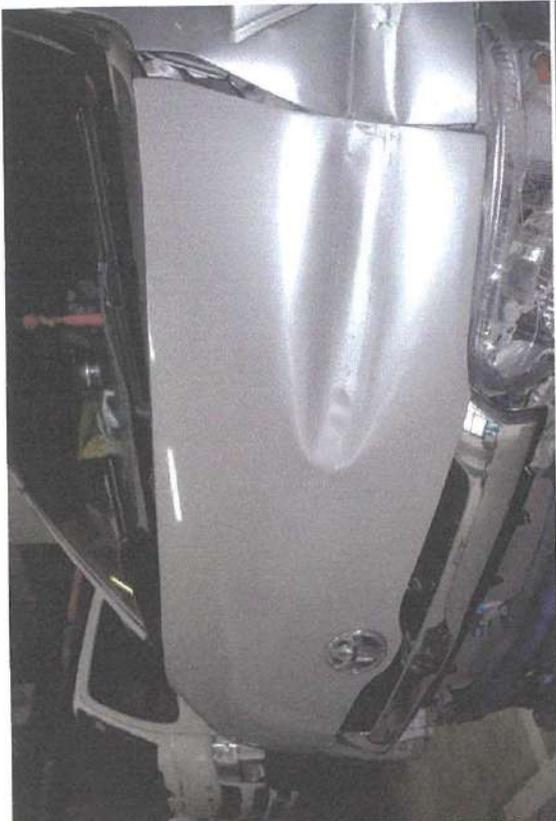
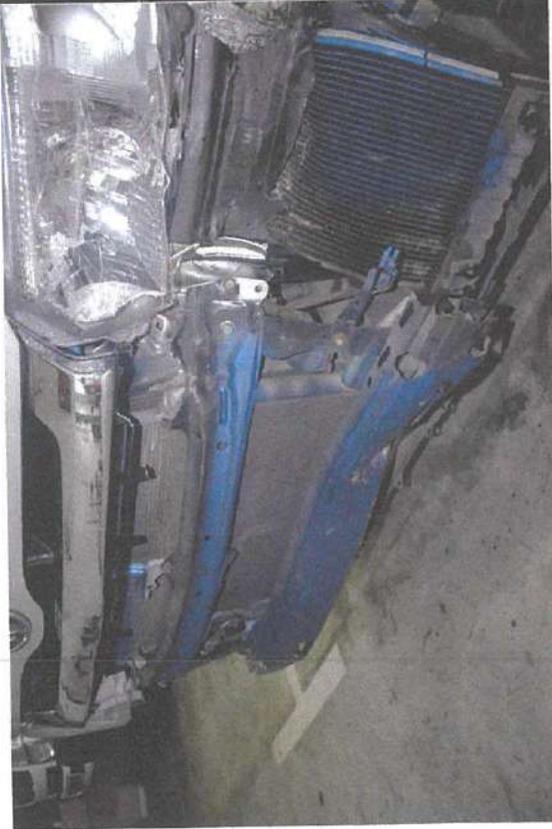
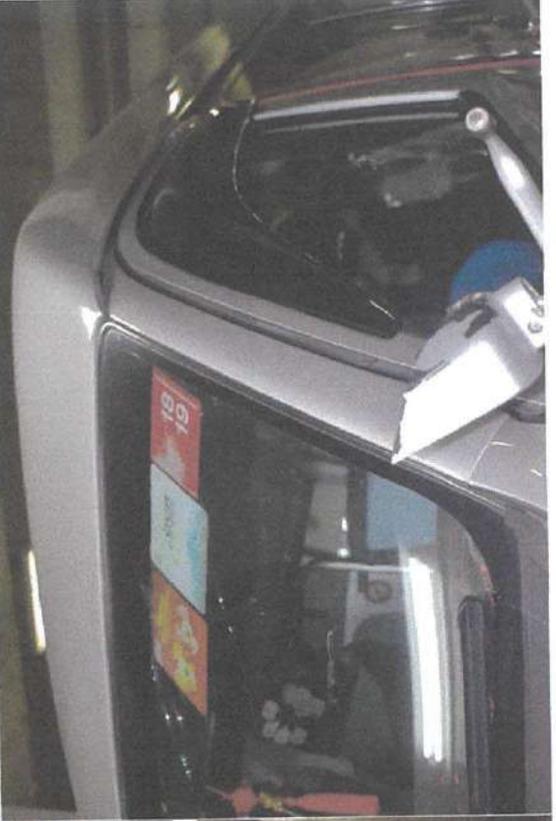
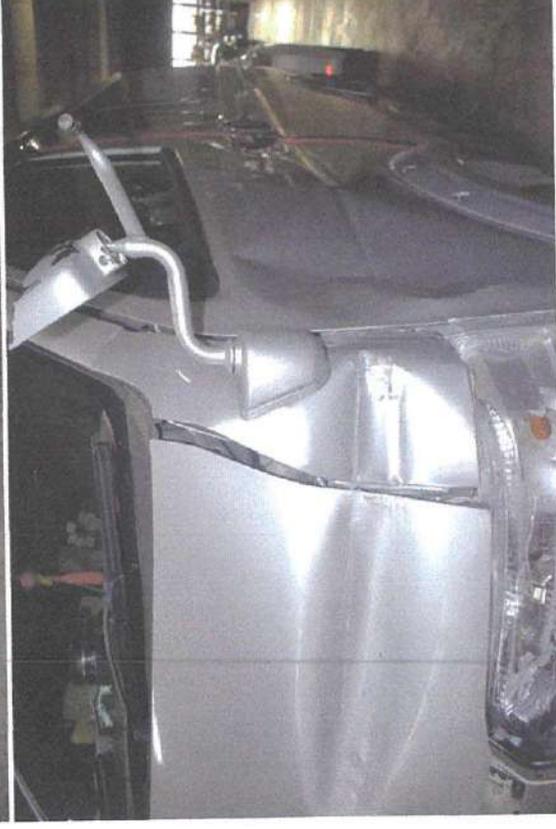
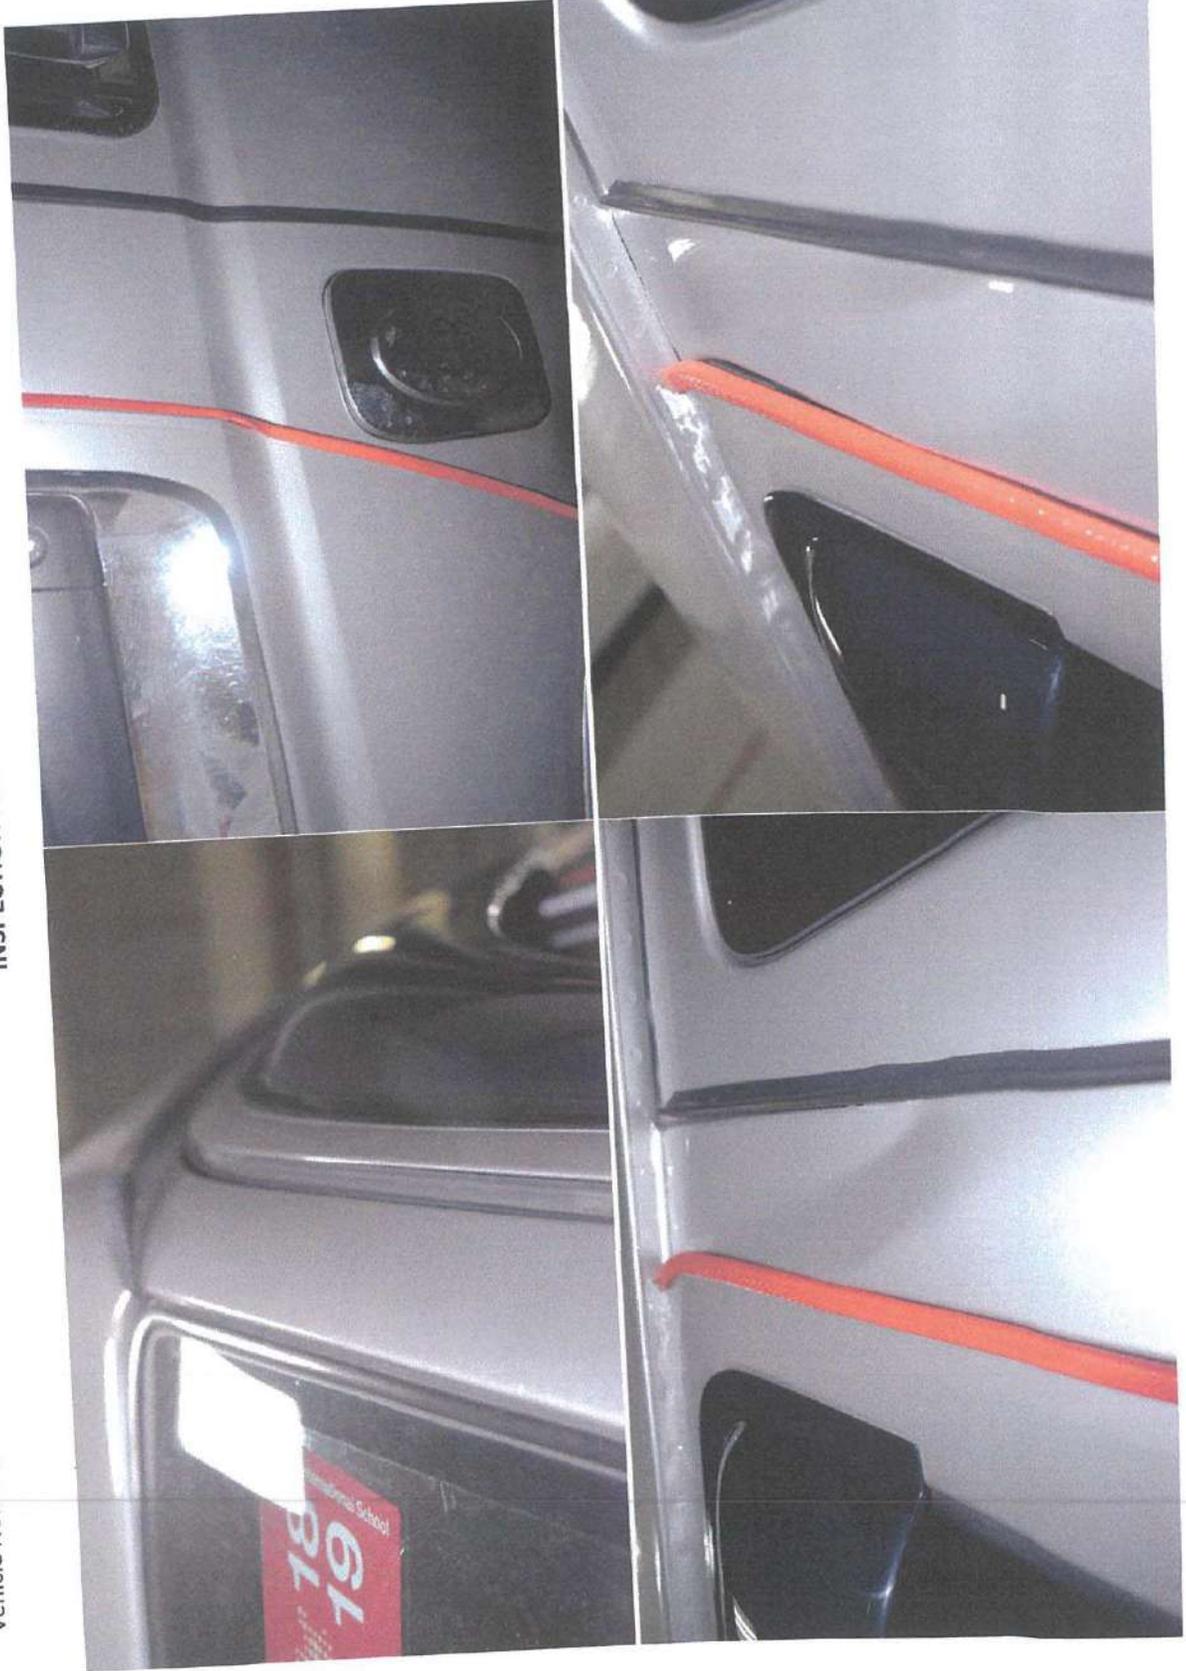
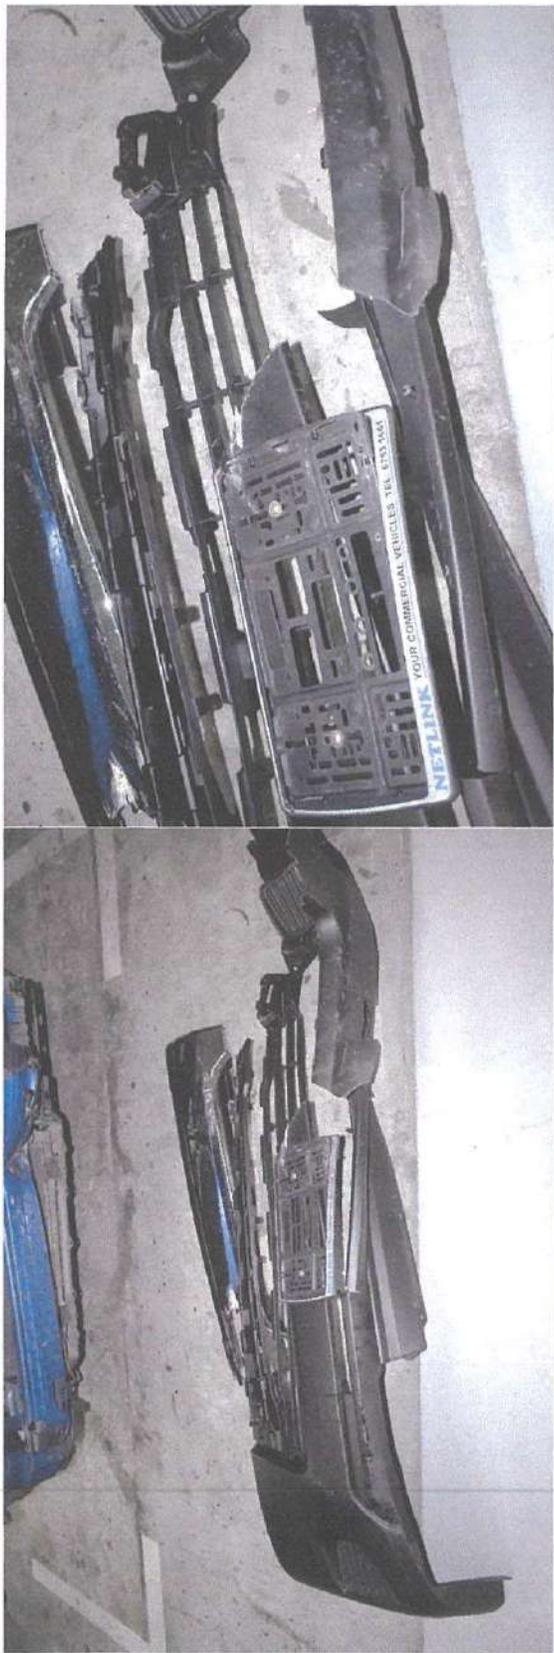
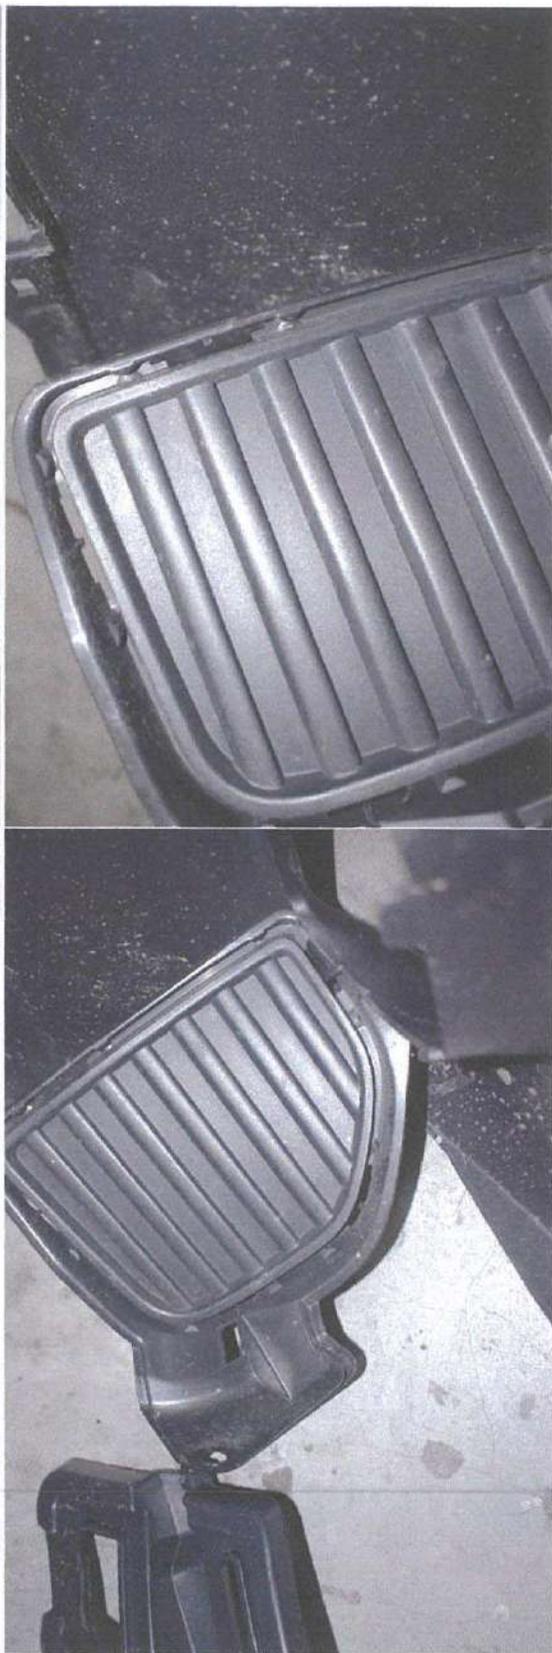
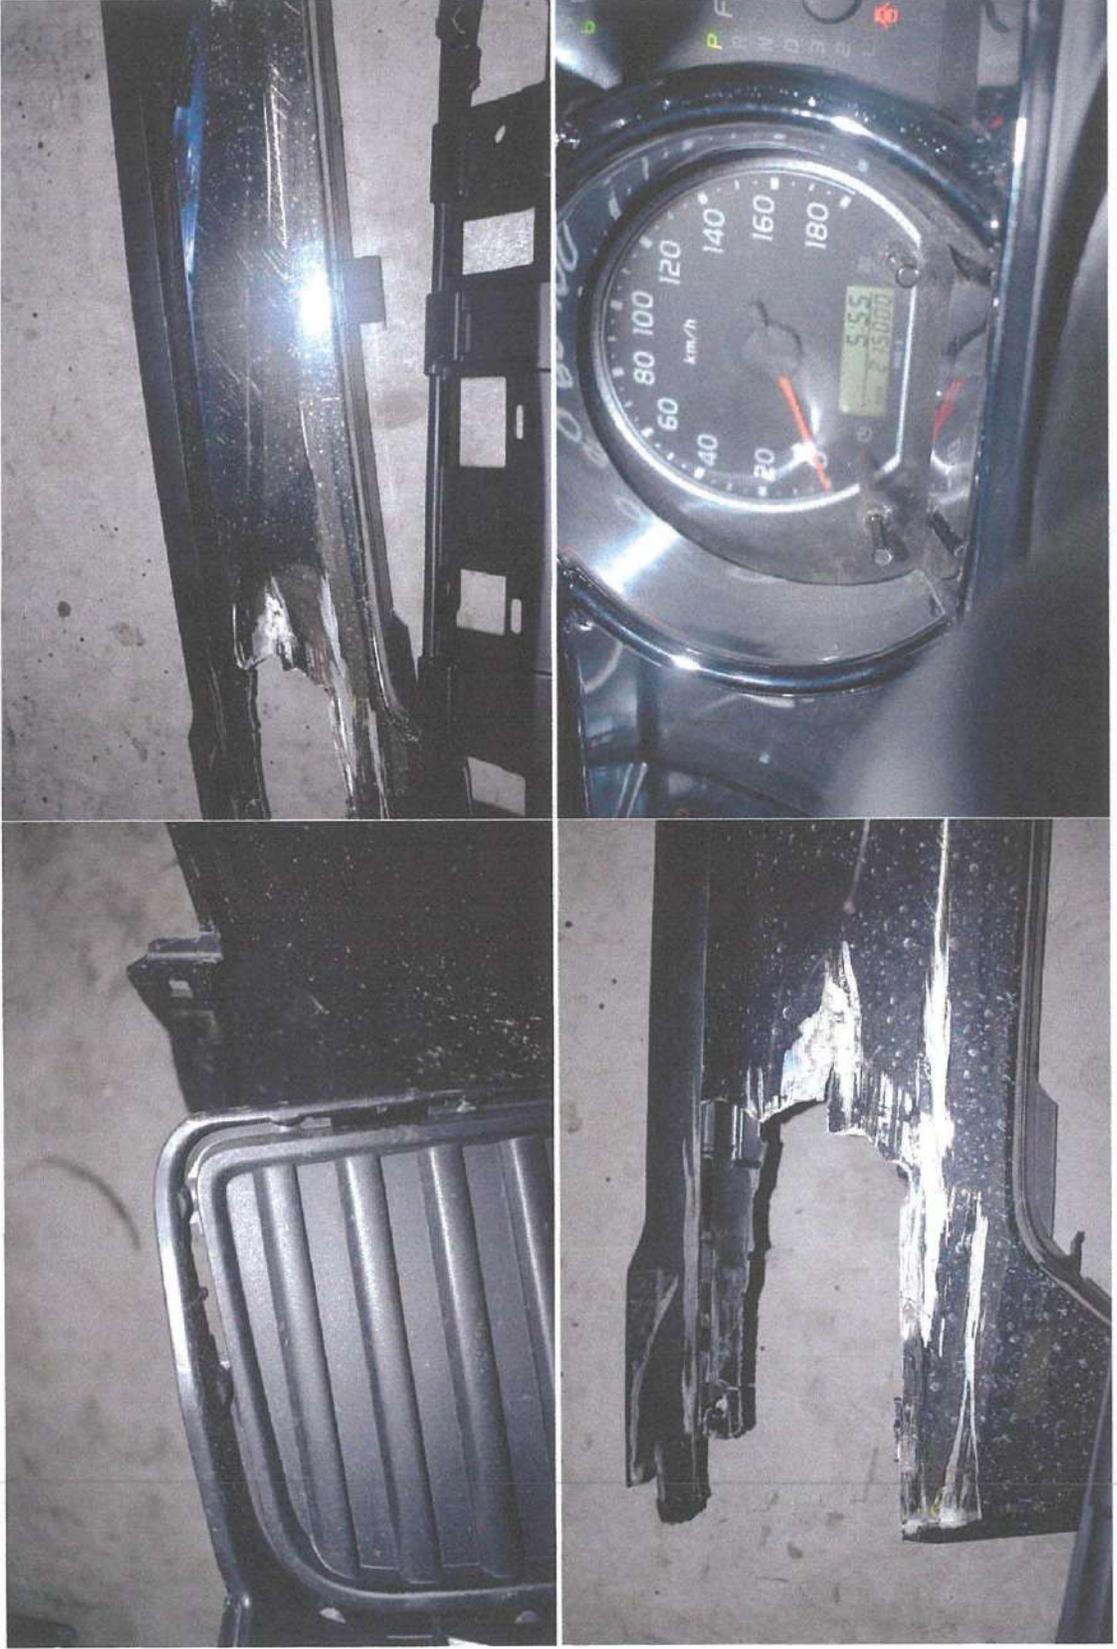
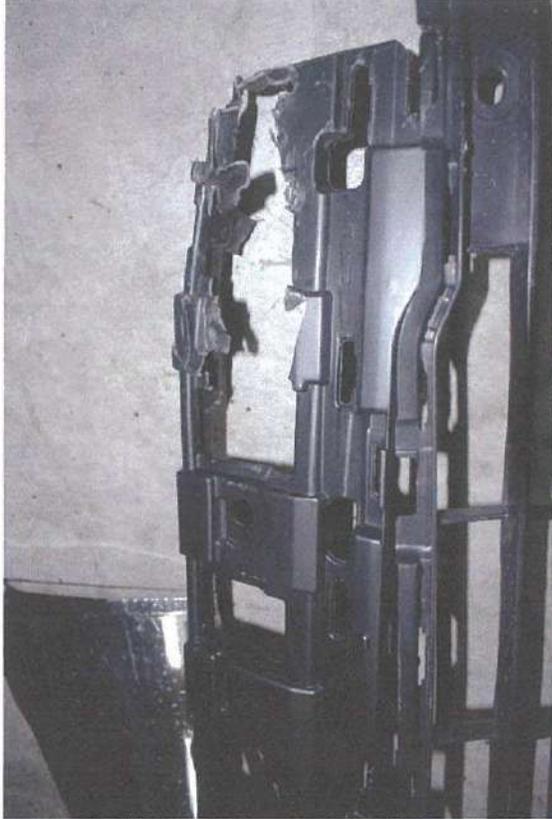
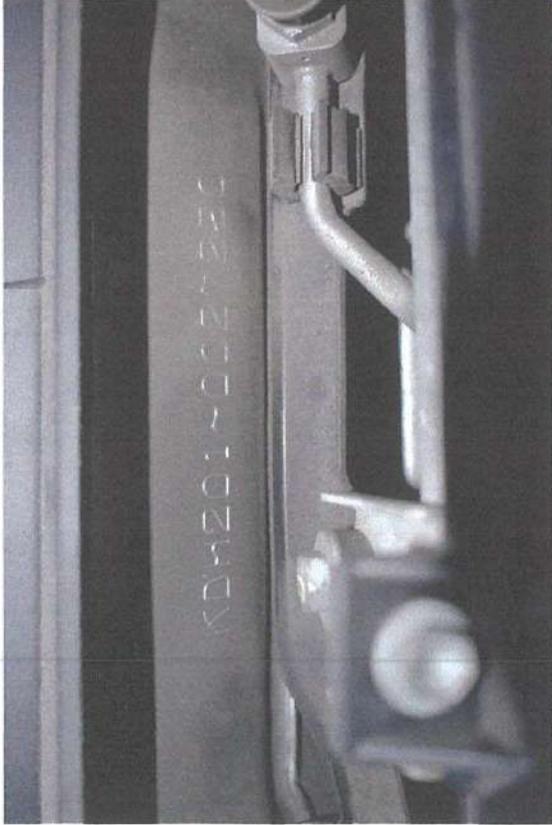
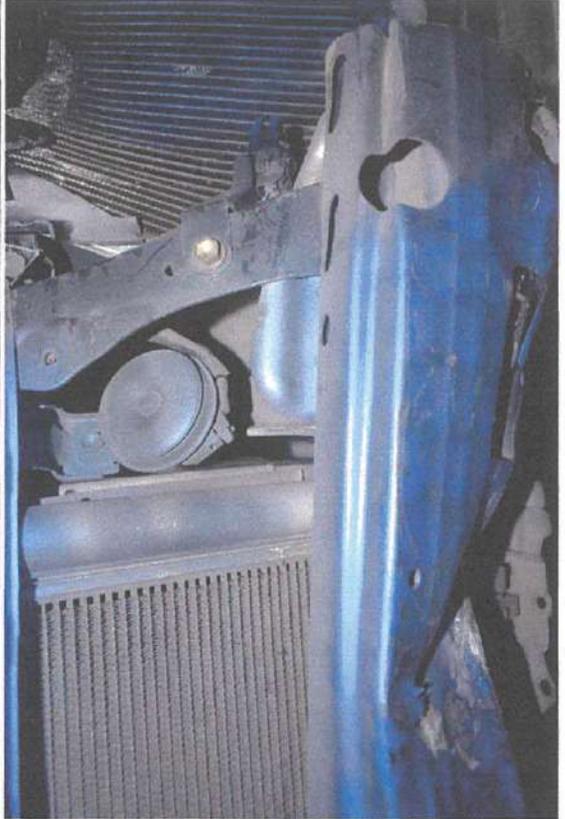
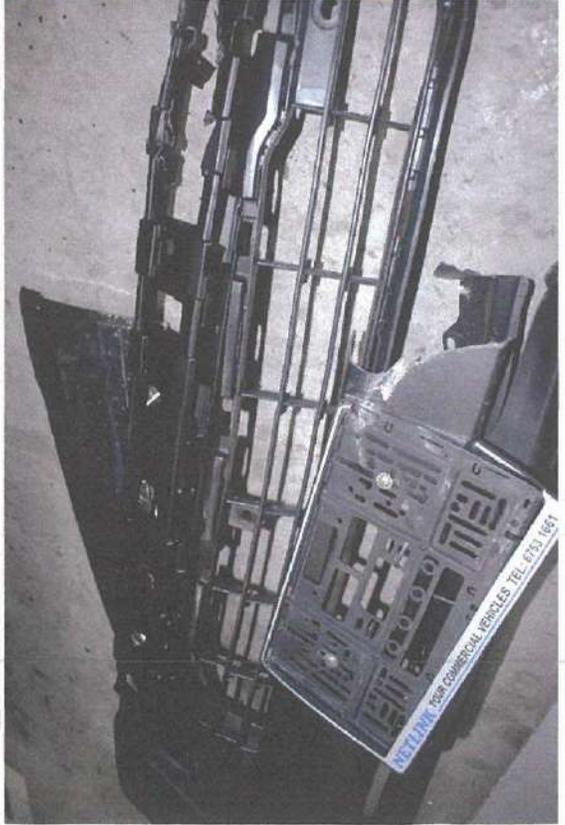
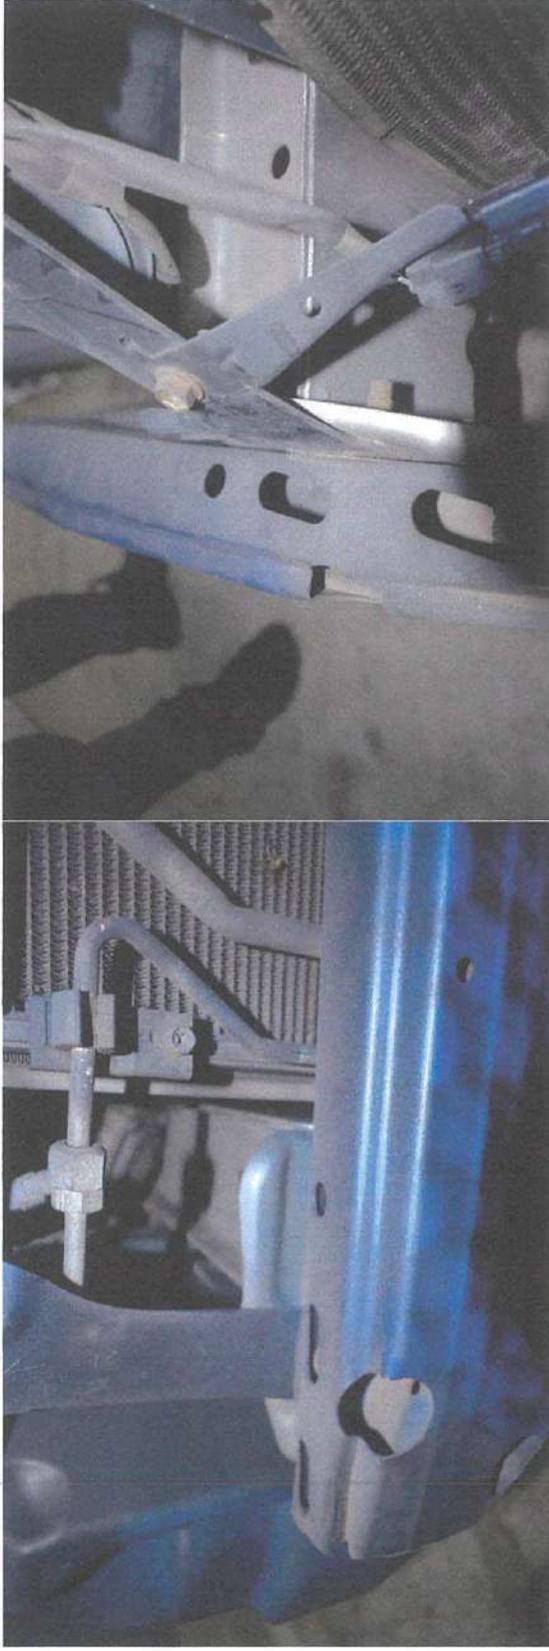
INSPECTION PHOTOS

At the time of inspection, this vehicle sustained damages to the **Front Lh portion**.

Front bumper, bonnet, lh corner panel, fire wall, front lh windscreen pilar, front lh wheel arc panel, floor board dented.
Front windscreen crack, headlamp dislodge/ holder torn, condenser, radiator, intercooler dented. Air con blower , cooling coil broken etc.
