## LKK Auto Consultants Pte Ltd

## ADJUSTMENT ON REPAIR COST FOR VEHICLE NO. SLQ 4759L

PHOTOGRAPHS FOR VEHICLE NO. SLQ 4759L

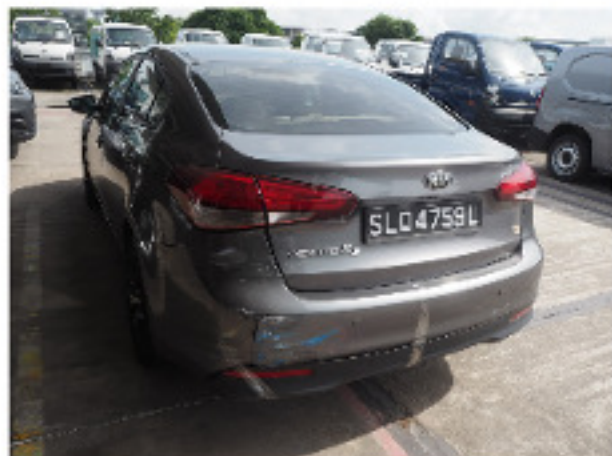
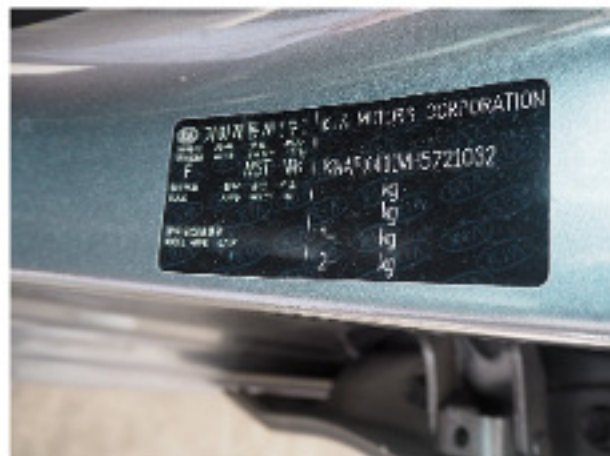
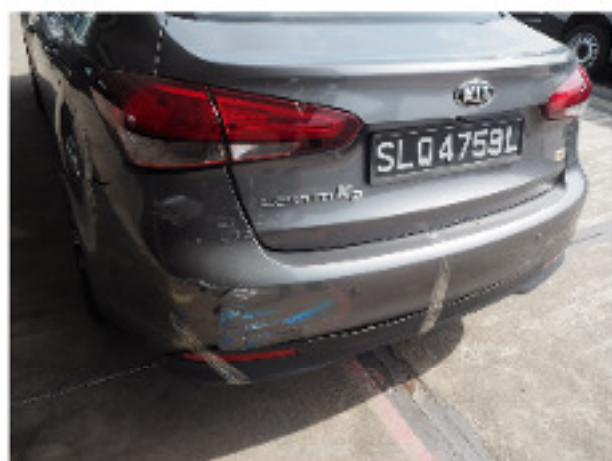
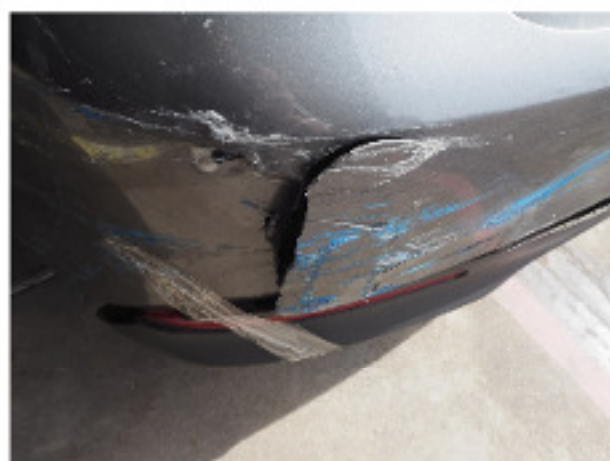
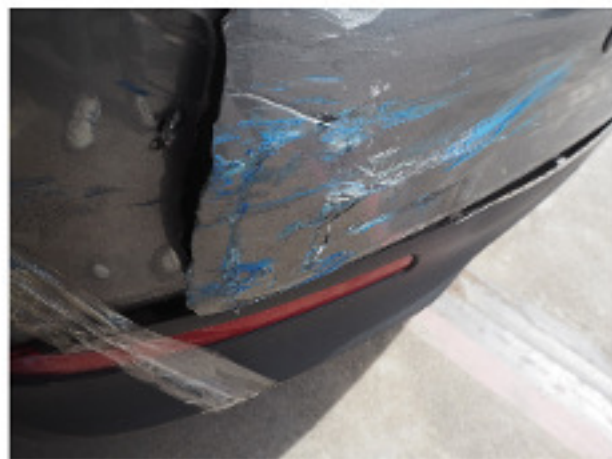
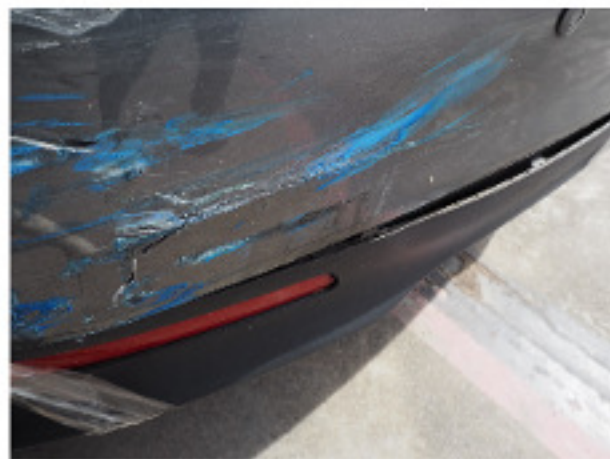
| THE VEHICLE SUSTAINED DAMAGES AT THE REAR PORTION.<br>DAMAGES SEE DETAILS. |

INSPECTION

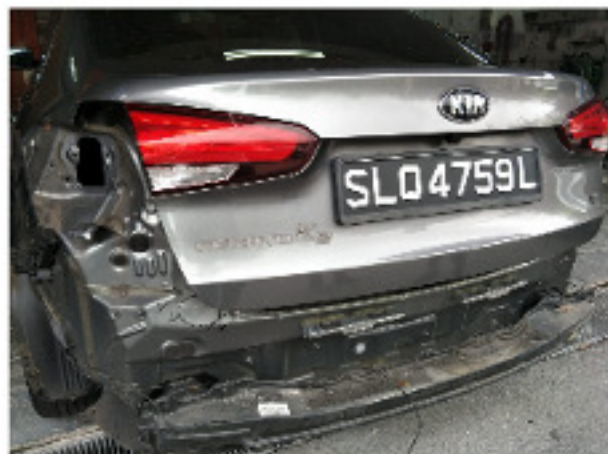
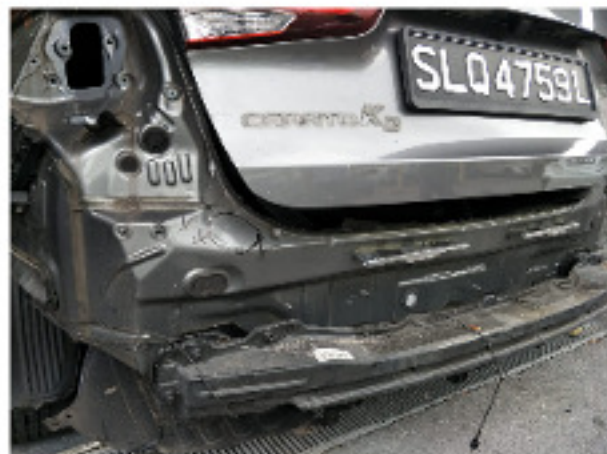
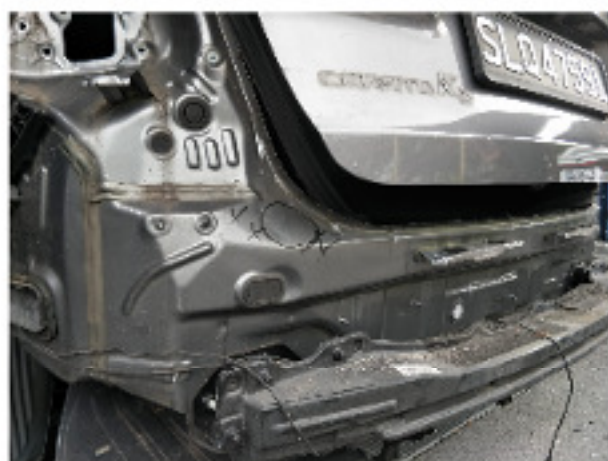
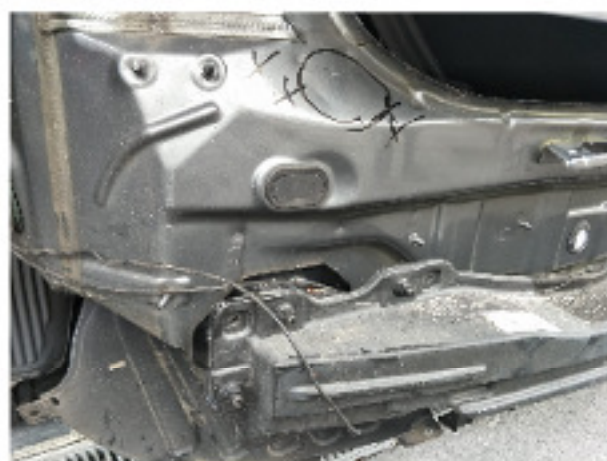
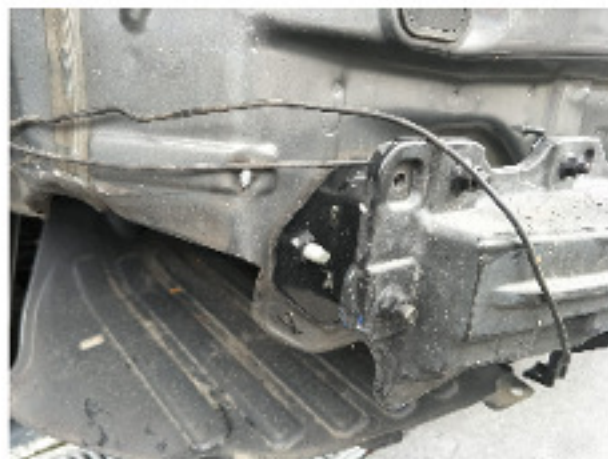
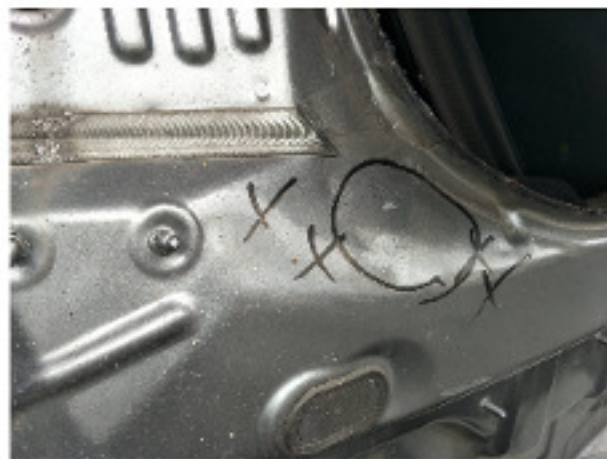
PHOTOGRAPHS FOR VEHICLE NO. SLQ 4759L

RE-INSPECTION
