LKK Auto Consultants Pte Ltd

ADJUSTMENT ON REPAIR COST FOR VEHICLE NO. GBE 6488L

PHOTOGRAPHS FOR VEHICLE NO. GBE 6488L

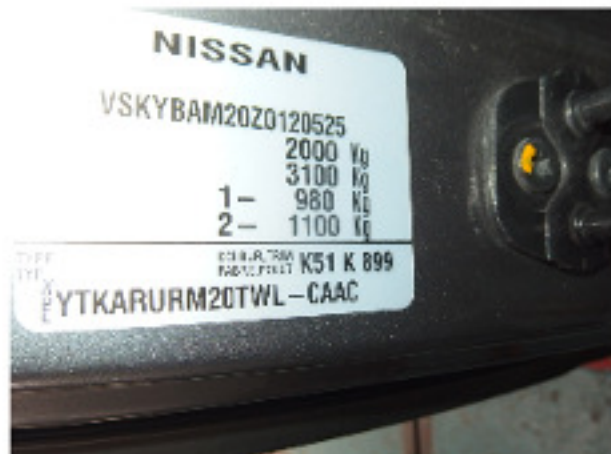
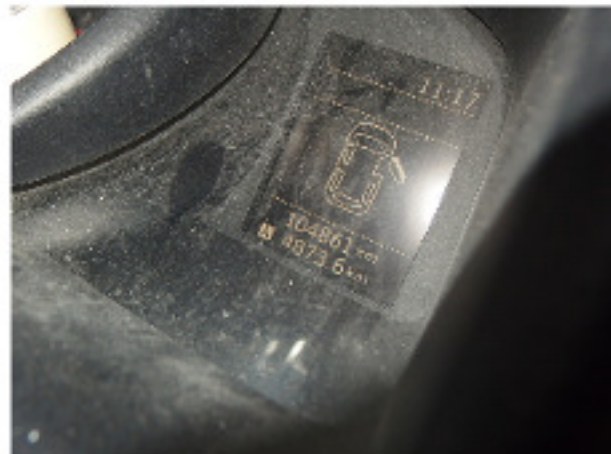
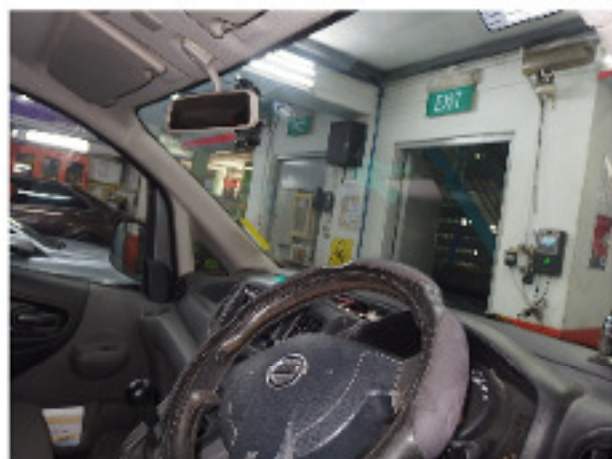
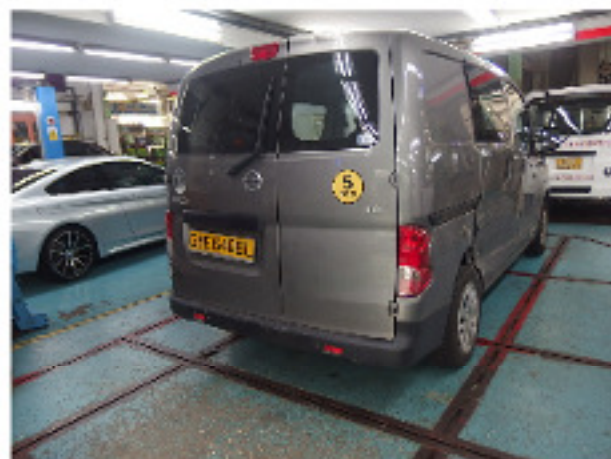
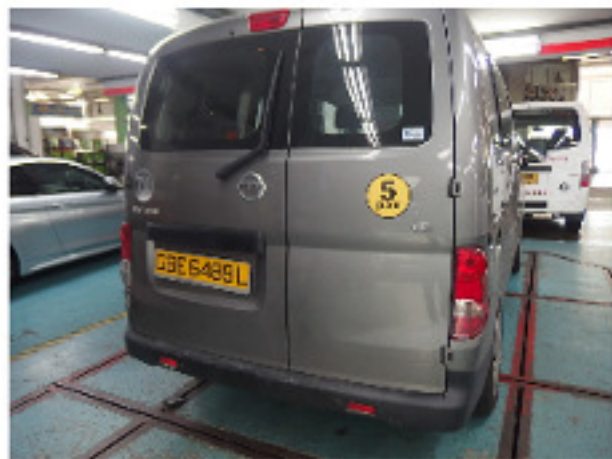
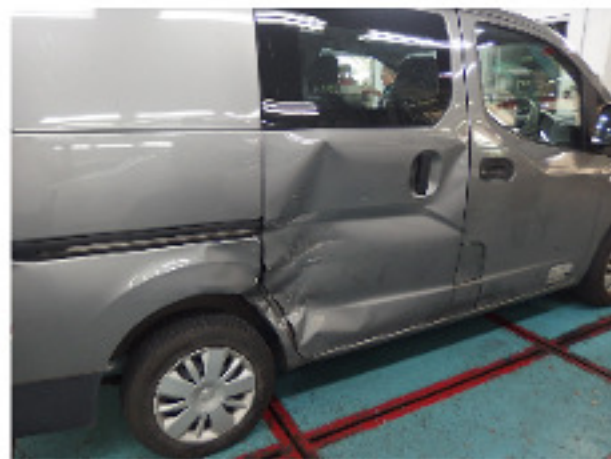
INSPECTION

THE VEHICLE SUSTAINED DAMAGES AT THE O/S BODY. THE UNDERCARRIAGE AFFECTED DUE TO COLLISION. DAMAGES SEE DETAILS.

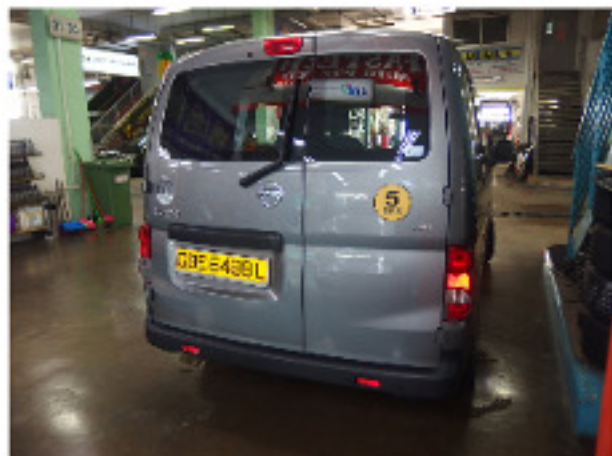
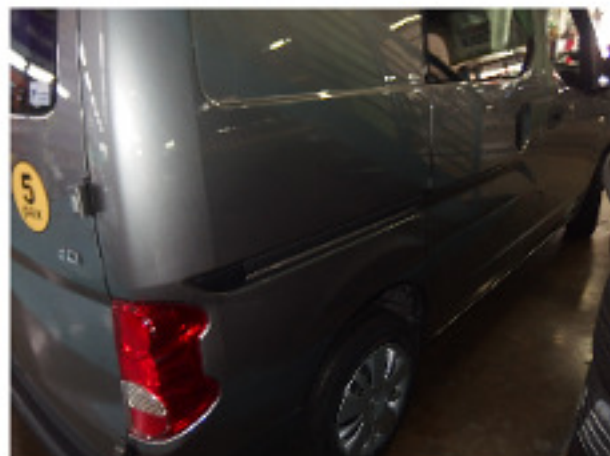
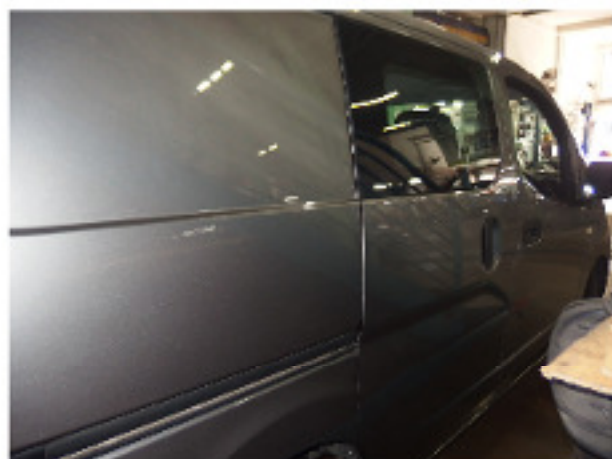
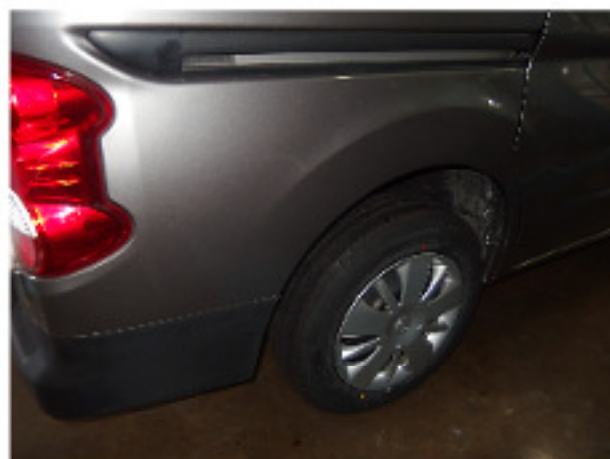
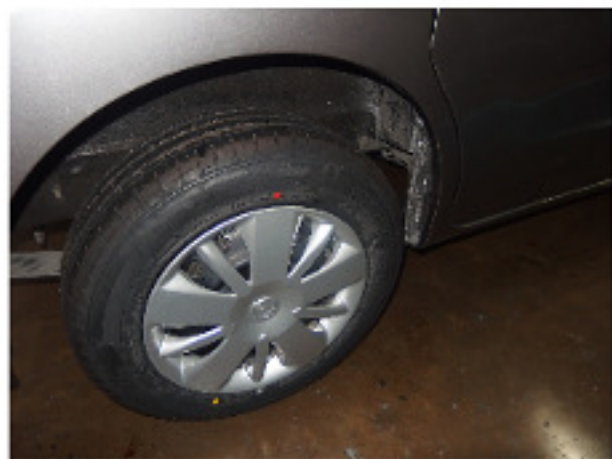
PHOTOGRAPHS FOR VEHICLE NO. GBE 6488L

RE-INSPECTION
