Report No: 0693-16-N51

## ACCIDENT VEHICLE SURVEY REPORT

| Make & Model: | Mitsubishi FK617MSJRDEC | Colour: | White |

Impact on the front LH portion.  
Please see details as described in the Annex for parts and labour.

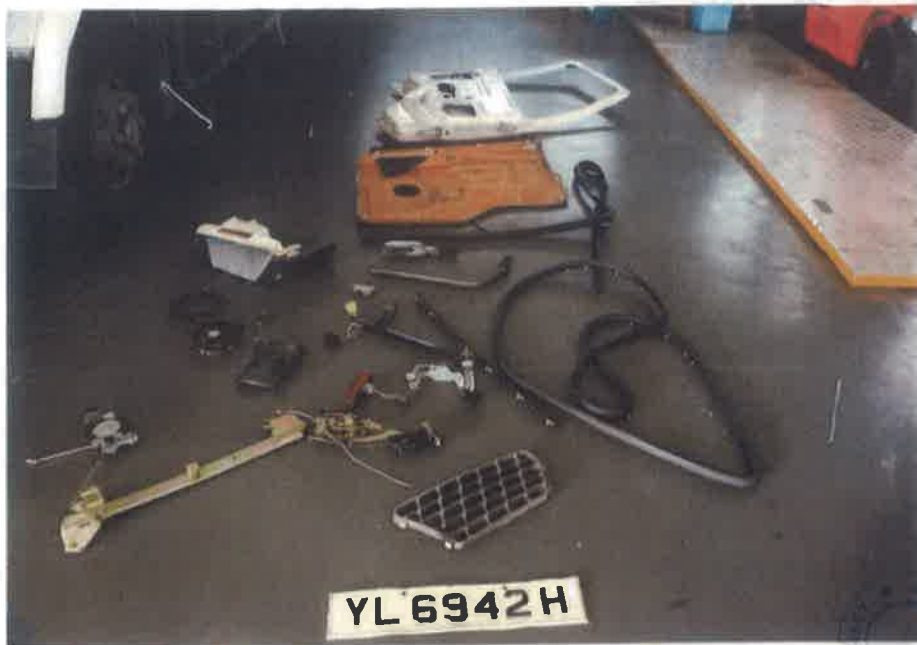
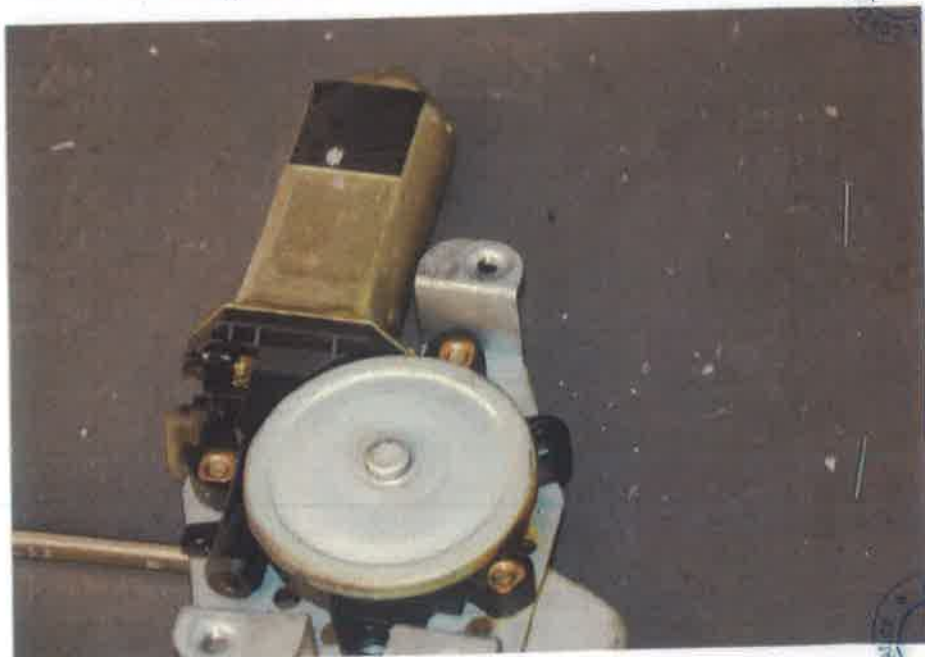
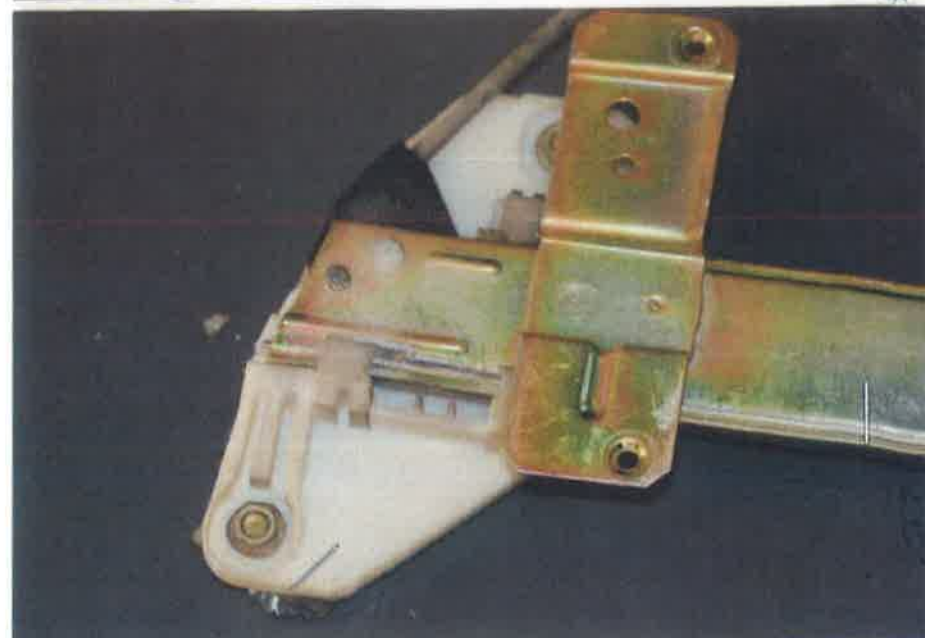
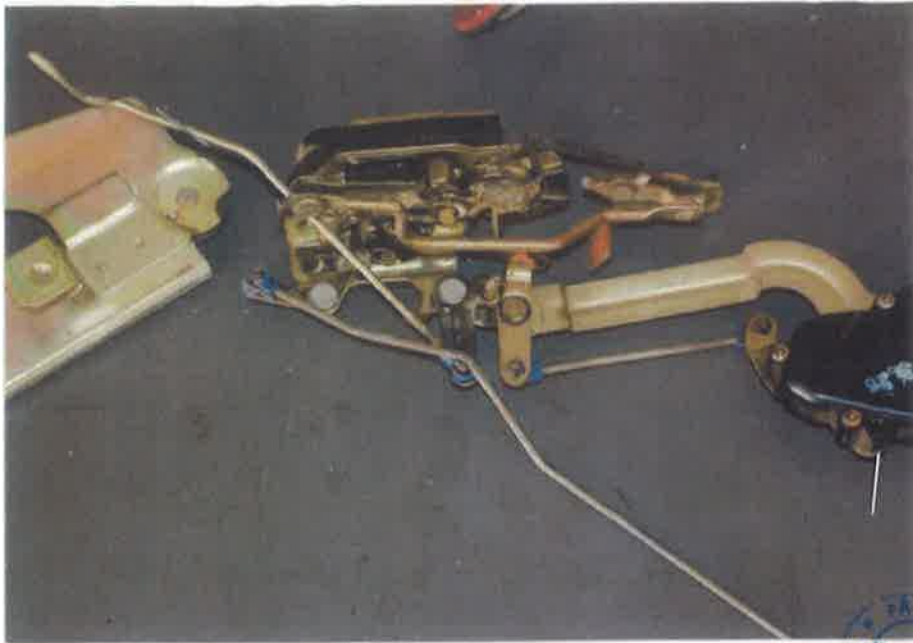
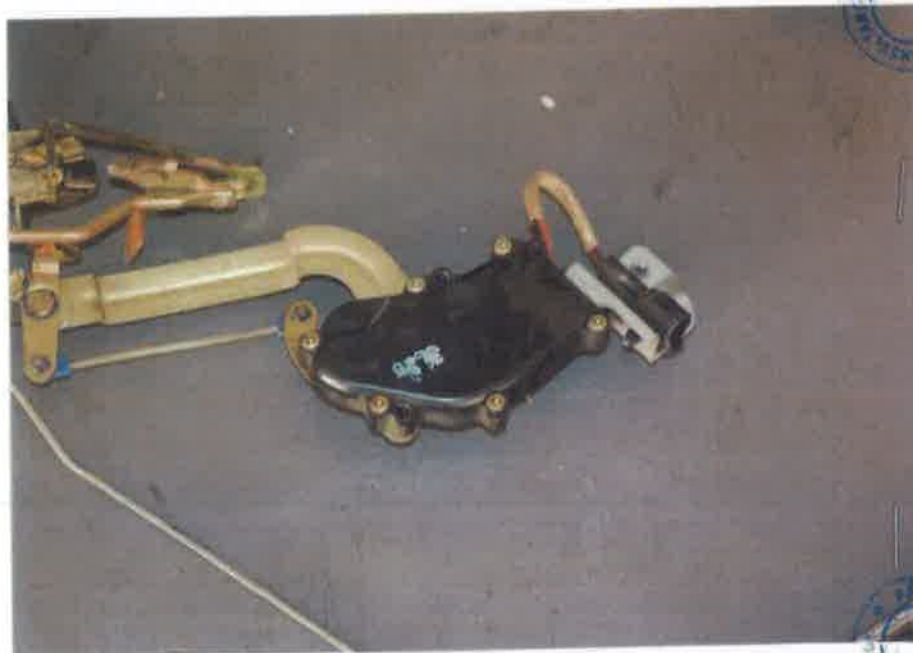
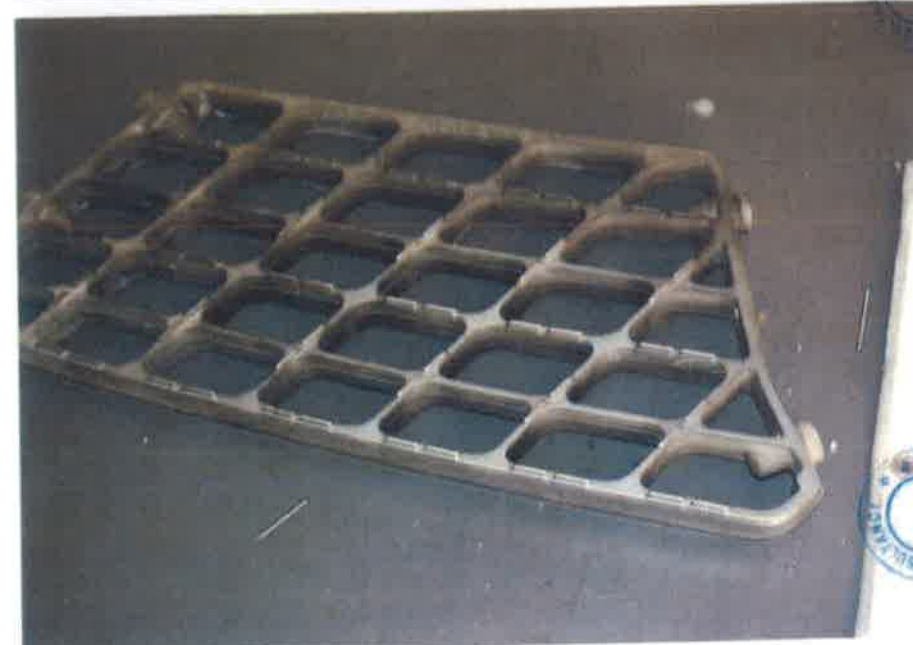
We had carried out re-inspection during works in progress and post repair inspection on the above vehicle. Attached in Annex B are the re-inspection photos, showing the work in progress and our re-inspection to the hidden part that were damaged.
