PRESTIGE APPRAISER SERVICES

Re : **THIRD PARTY CLAIM**

We refer to your instruction to appraise the vehicle **GX 3476 G** on 12th January 2017.

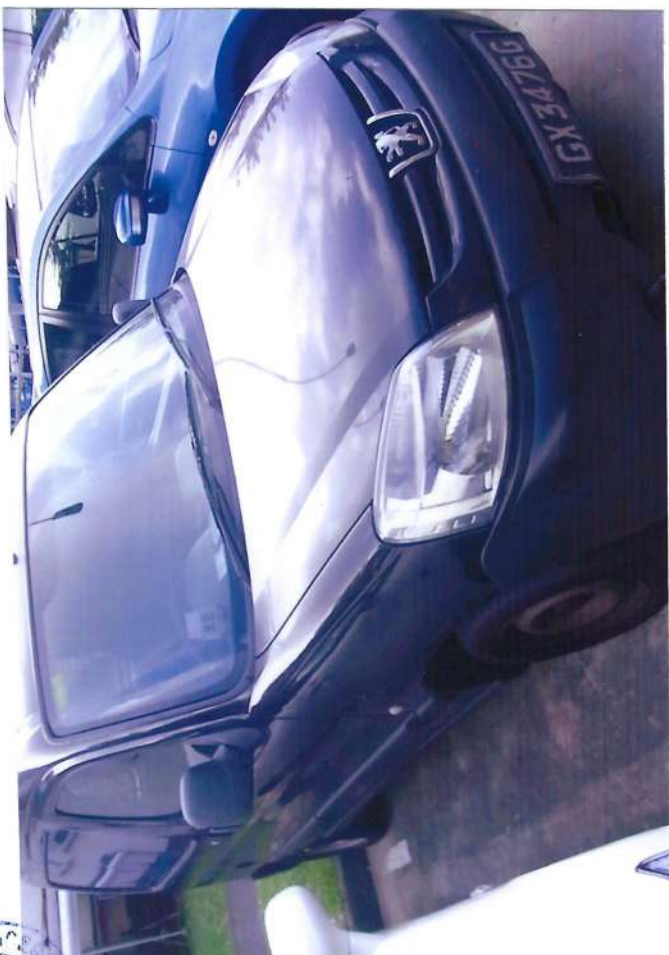
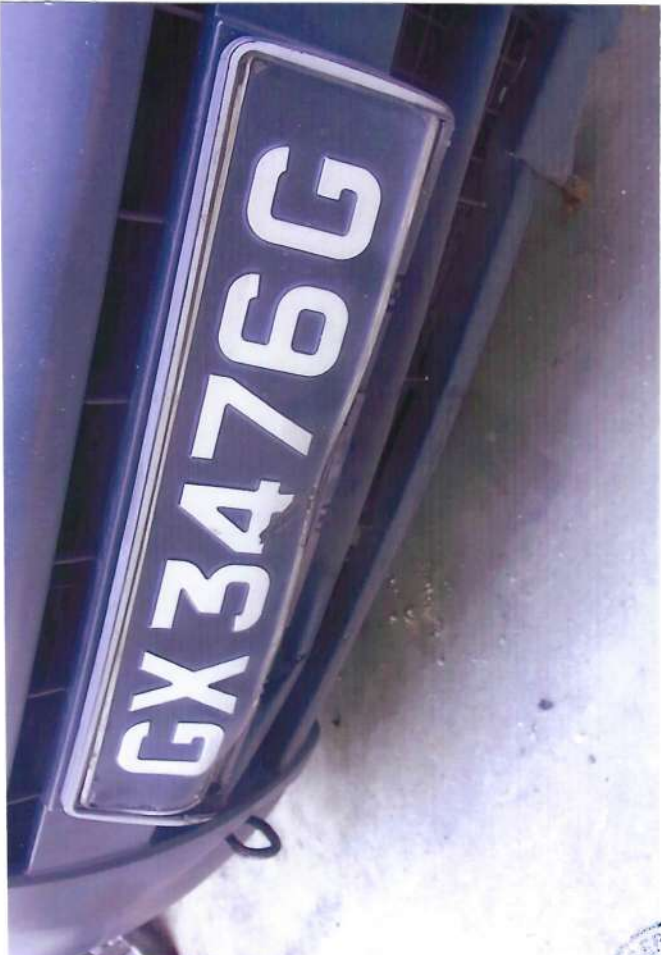
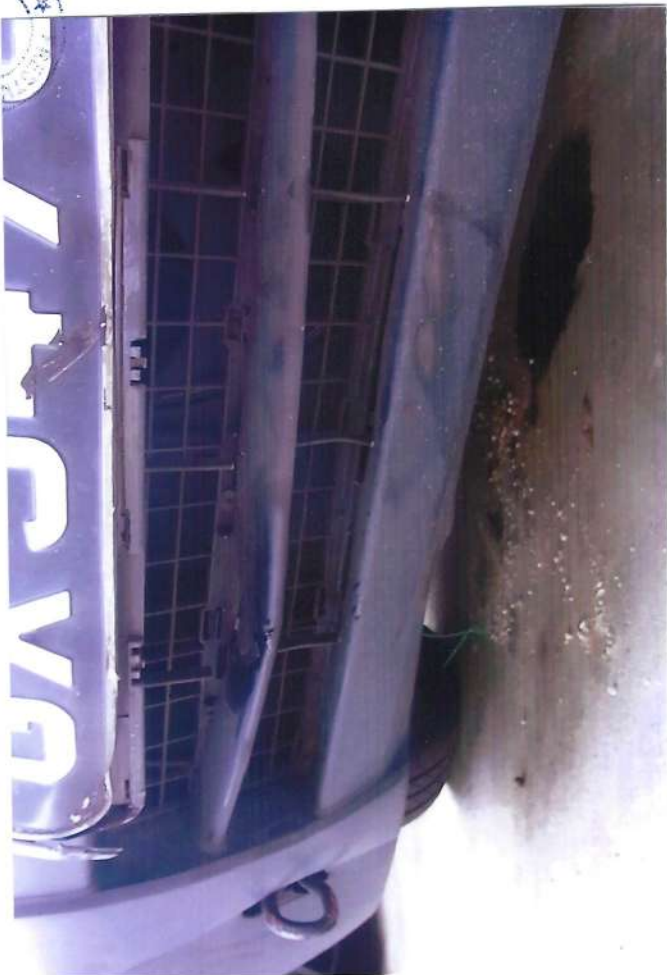
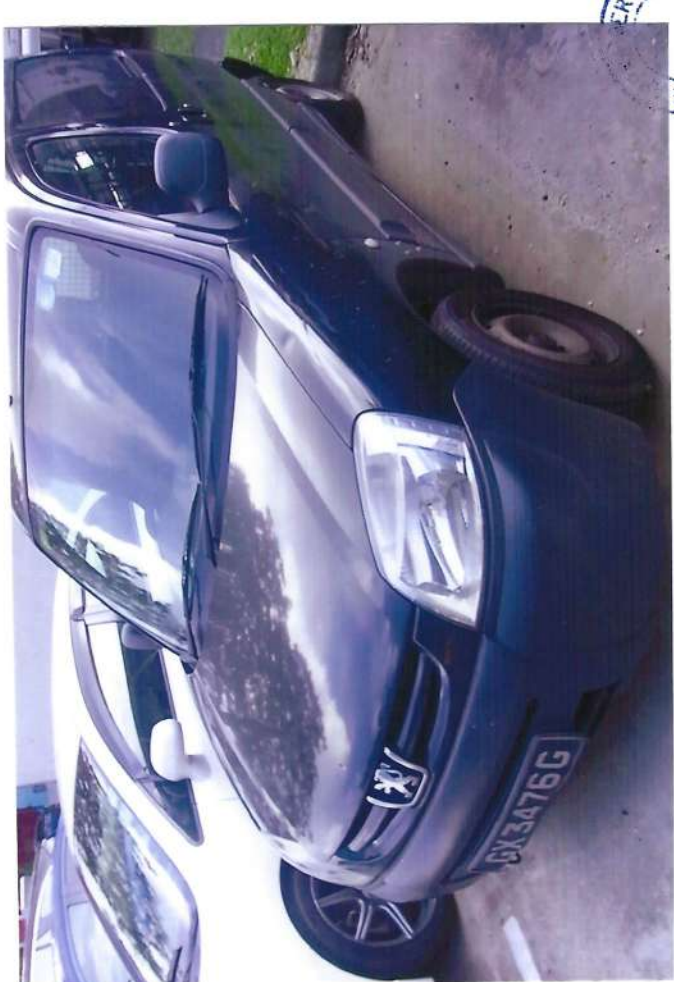
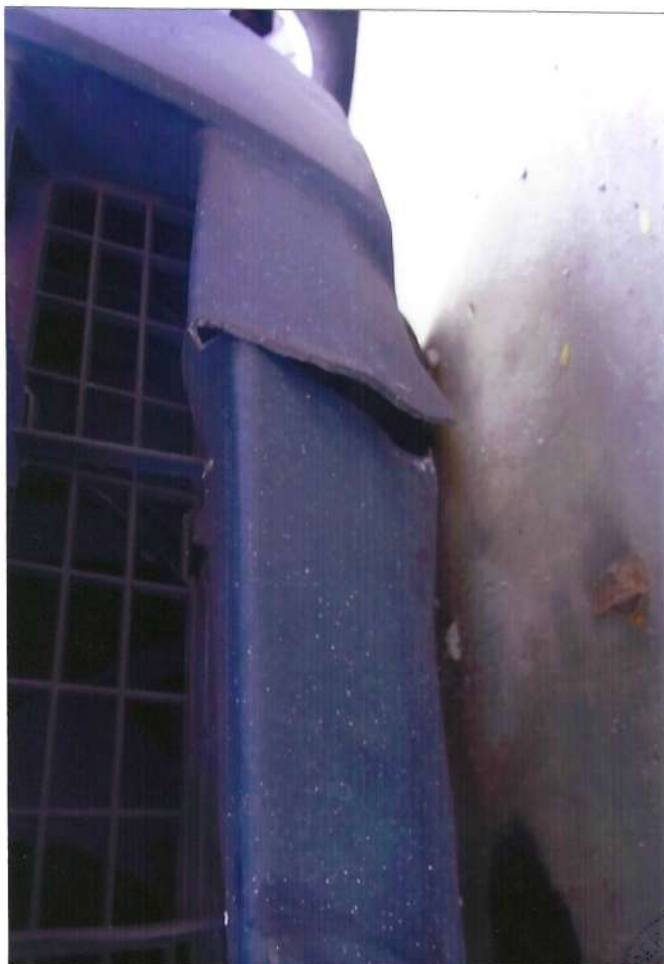
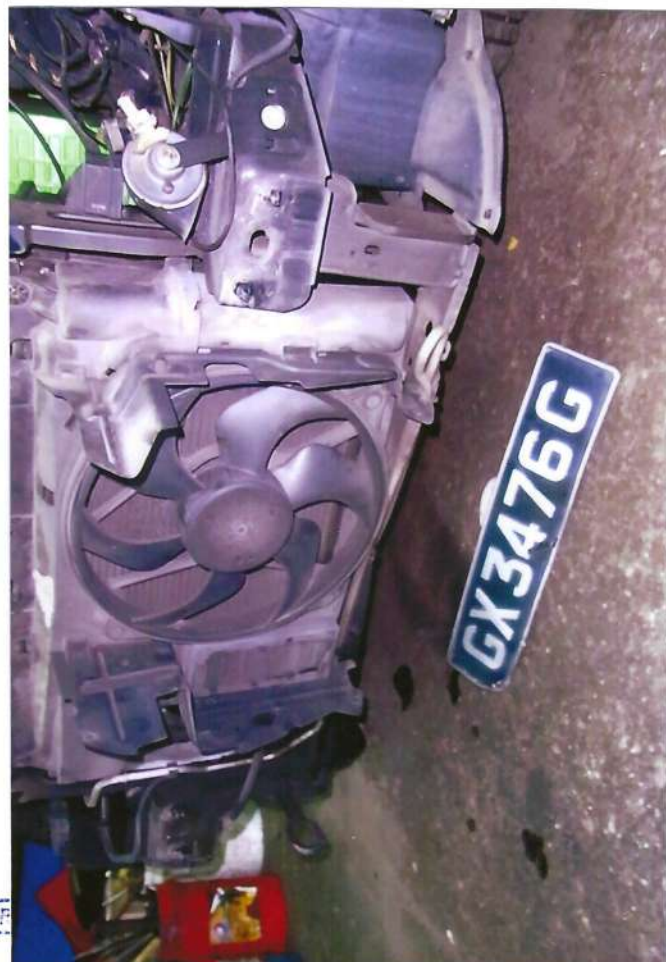
Under normal circumstances, the estimated period of repairs would be **FIVE (5) days**. Photographs of the damaged vehicle taken by us during our inspection are enclosed.
