ADJUSTMENT ON REPAIR COST FOR VEHICLE NO. SGL 3689Y

PHOTOGRAPHS FOR VEHICLE NO. SGL 3689Y

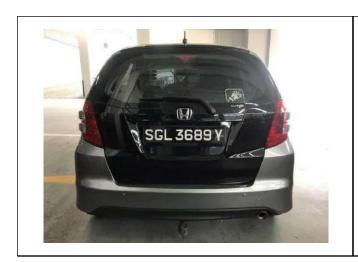
RE-INSPECTION

4.		Description	on of Damages				
	THE VEHICLE SUSTAINED DAMAGES AT THE REAR PORTION.						
	DAMAGES SEE D	ETAILS.					
5.		Genera	I Information				
	Accident Date	07/07/2020	Inspection Date	13/07/2020			
	Survey held at	CITY AUTO PTE LTD					
		BLK 8, SIN MING IND. ESTATE
