PROFESSIONAL SERVICE FEE

ADJUSTMENT ON REPAIR COST FOR VEHICLE NO. SJR 3536M

PHOTOGRAPHS FOR VEHICLE NO. SJR 3536M

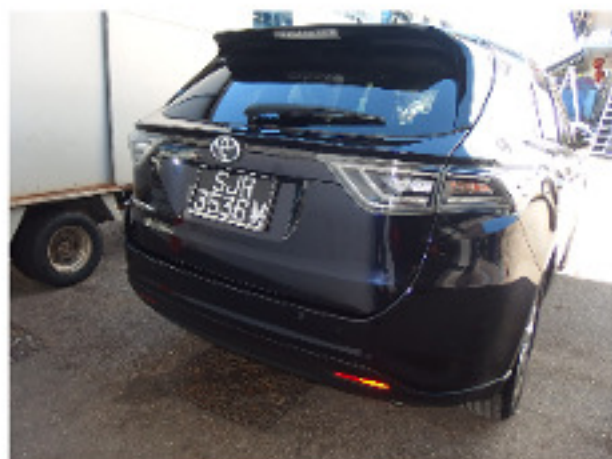
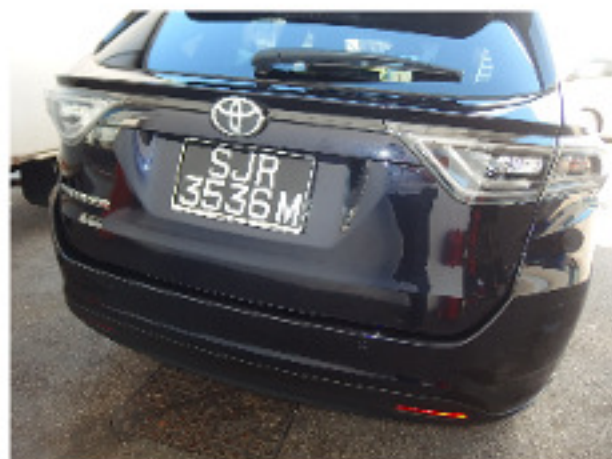
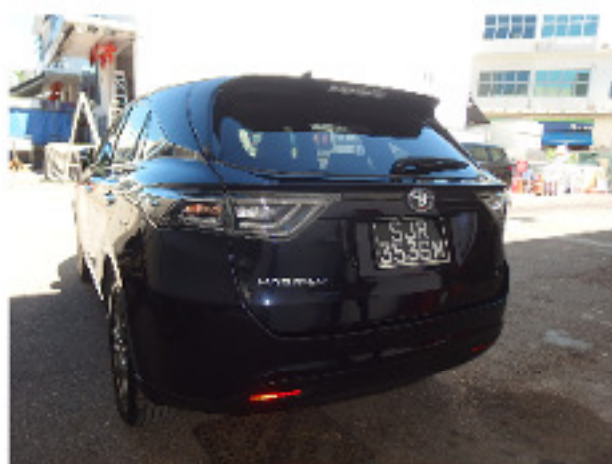
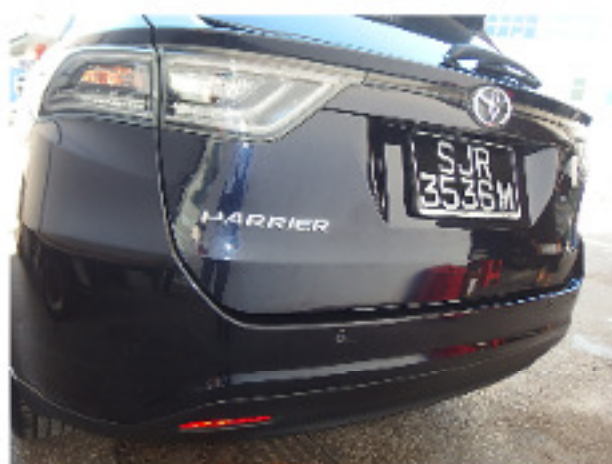
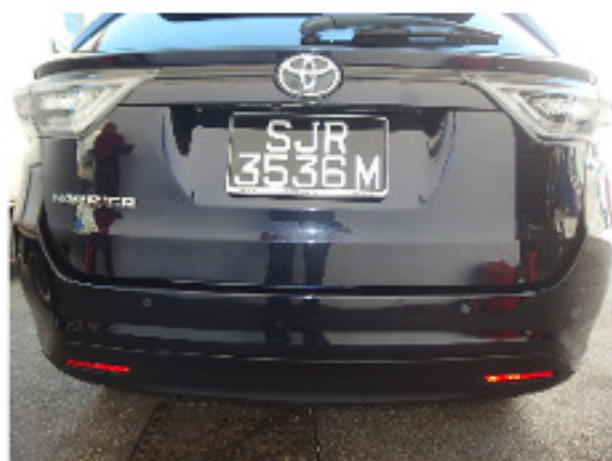
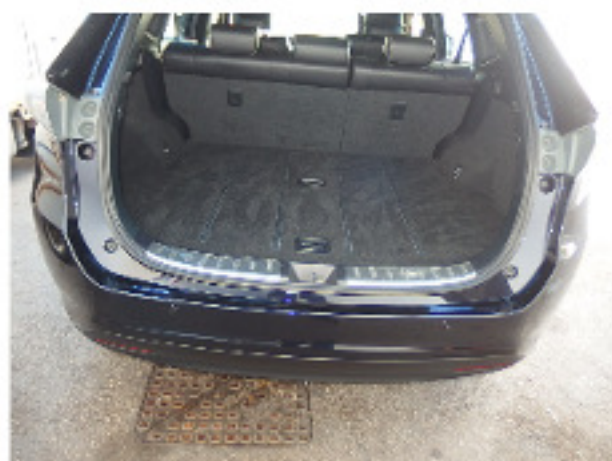
PHOTOGRAPHS FOR VEHICLE NO. SJR 3536M

RE-INSPECTION

4. Description of Damages				
	THE VEHICLE SUSTAINED DAMAGES AT THE REAR PORTION AND ROOFTOP. DAMAGES SEE DETAILS.			
5. General Information				
	Accident Date	09/07/2020	Inspection Date	14/07/2020
	Survey held at	ABWIN SERVICE PTE LTD 17 KAKI BUKIT ROAD 4 #01-60 BARTLEY BIZ CENTRE SINGAPORE 417809		
5a. Remarks				
	A)THE INSPECTION WAS CONDUCTED ON A"WITHOUT PREJUDICE" BASIS. B)IN ACCORDANCE TO YOUR INSTRUCTIONS, WE HAVE NOT AUTHORISED REPAIRS.			
5b. Estimate Days of Repair				
	ESTIMATED NORMAL PERIOD FOR REPAIR:		5 Working Days
