Affiliated to Federation Internationale Des Experts En Automobile					
EQ II	NSURANCE COMPANY LTD Ref : CC3/EQI20007342/Qga3s2			/Qga3s2	
5 MAXWELL ROAD #17-00 TOWER BLOCK MND COMPLEXSINGAPORE 069110		Date: 14-08-2020  Code: EQI

1.		Policy Particulars	- THIRD PARTY CLAIM		
	Insured Veh.	SJN 7337R	Veh. Inspected	SHB 1722M	
	Policy No.		Coverage (\$)	0.00	
	Claim No.	DM20HO01035	Excess (\$)	0.00	
	Assign From		Assign Date	09/07/2020

2.		Vehicle Partic	culars & Condition		
	Make & Model	TOYOTA PRIUS	c.c	1798	
	Engine No.	HIDDEN	Year of Reg.	2015	
	Chassis No.	JTDKN36UX05757173	Colour	MAROON	
	Odometer	755805	Steering	IN ORDER	
	Brakes	IN ORDER	Modification	SPORTS RIM	
	General	FAIR

#### PHOTOGRAPHS FOR VEHICLE NO. SHB 1722M

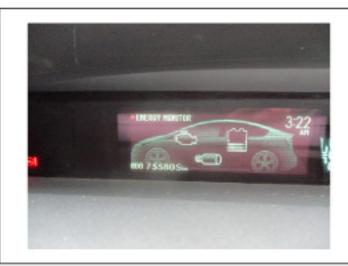
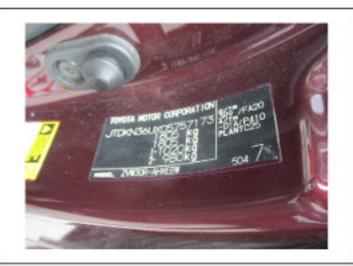
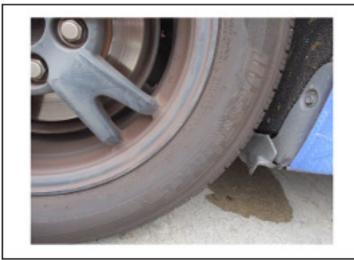
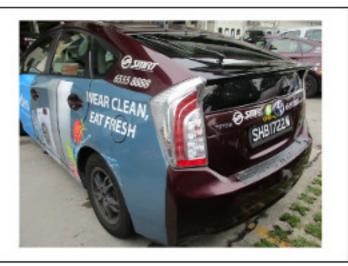
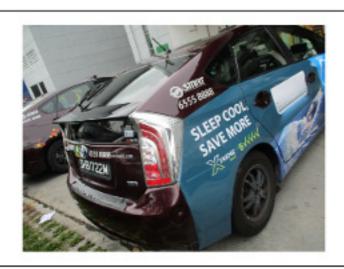
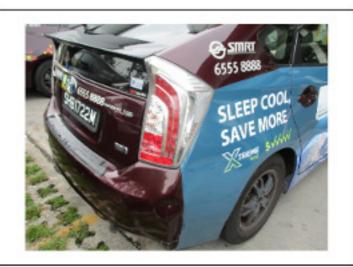
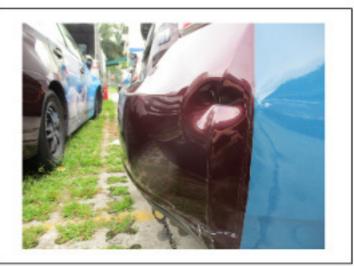
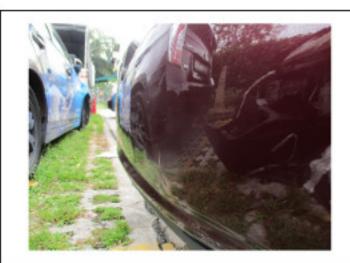
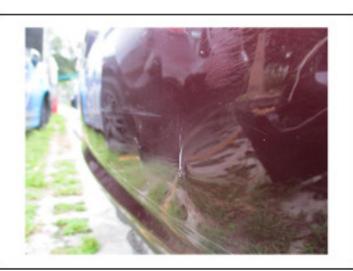
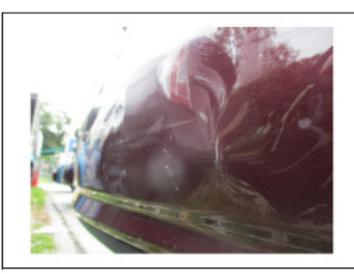
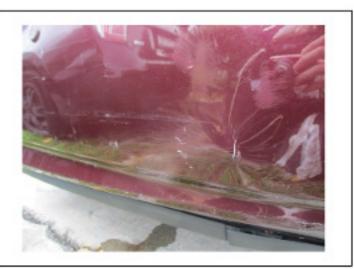
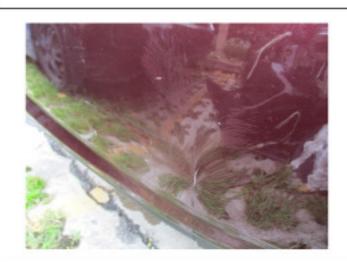
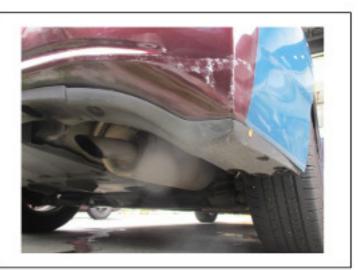
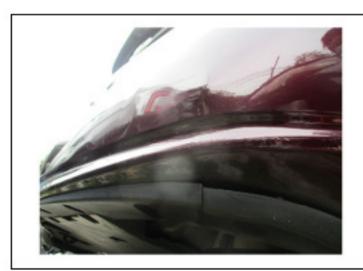
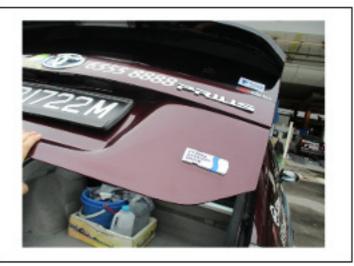
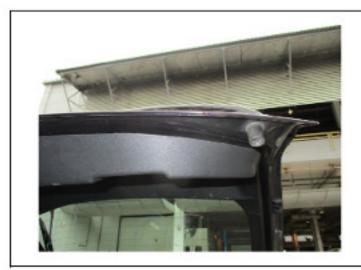
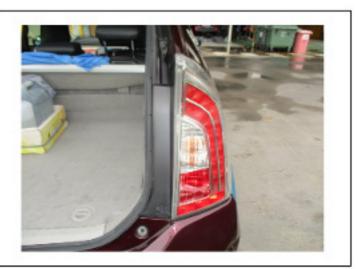
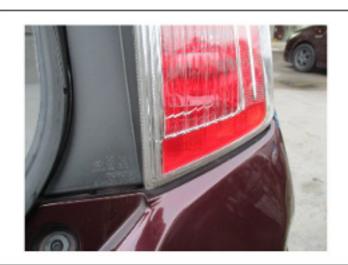
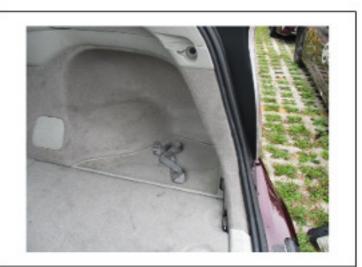
4.		Description	on of Damages		
	THE VEHICLE SU	STAINED DAMAGES AT THE REA	AR PORTION.		
	DAMAGES SEE D	ETAILS.			
5.		General	Information		
	Accident Date	08/07/2020	Inspection Date	09/07/2020	
	Survey held at	SMRT AUTOMOTIVE SERVICES	S PTE LTD		
	60 WOODLANDS INDUSTRIAL PARK E4 SINGAPORE 757705				
5a.		Re	emarks		
	A)THE INSPECTION WAS CONDUCTED ON A"WITHOUT PREJUDICE" BASIS. B)IN ACCORDANCE TO YOUR INSTRUCTIONS, WE HAVE NOT AUTHORISED REPAIRS.				
5b.	Estimate Days of Repair				
	ESTIMATED NORMAL PERIOD FOR REPAIR: 2 Working Days

INSPECTION

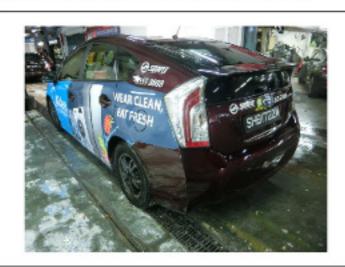
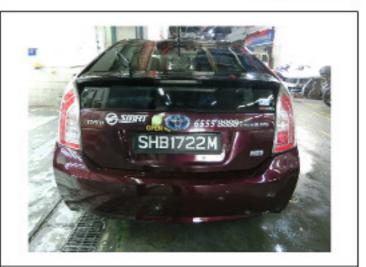
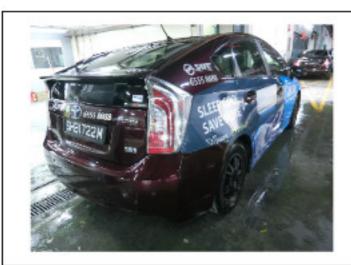
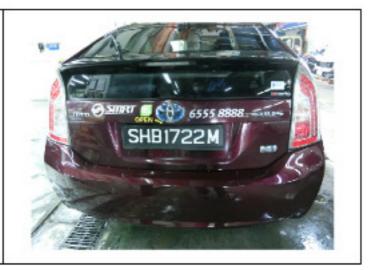
### PHOTOGRAPHS FOR VEHICLE NO. SHB 1722M

#### RE-INSPECTION
