LKK Auto Consultants Pte Ltd

ADJUSTMENT ON REPAIR COST FOR VEHICLE NO. SKX 2495K

PHOTOGRAPHS FOR VEHICLE NO. SKX 2495K

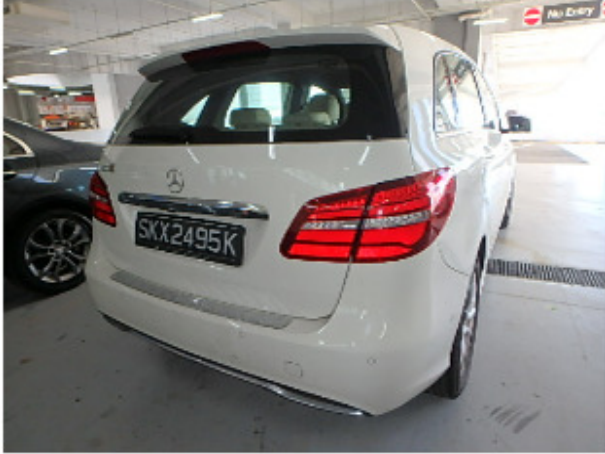
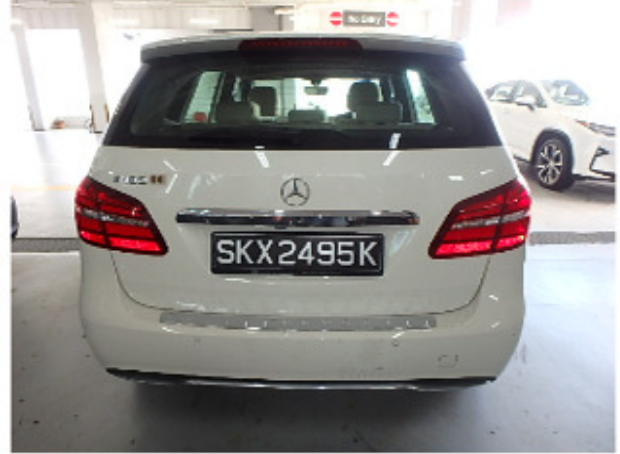
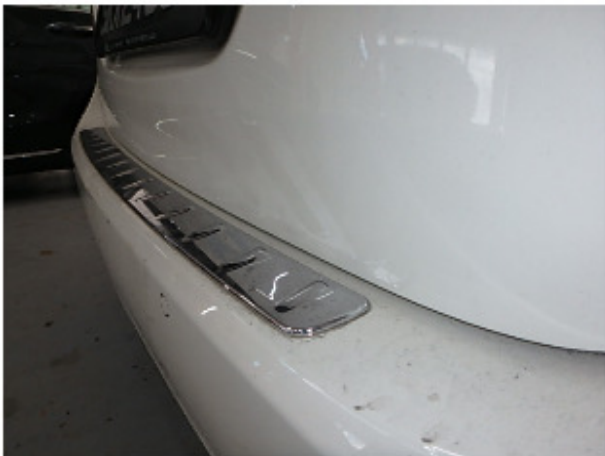
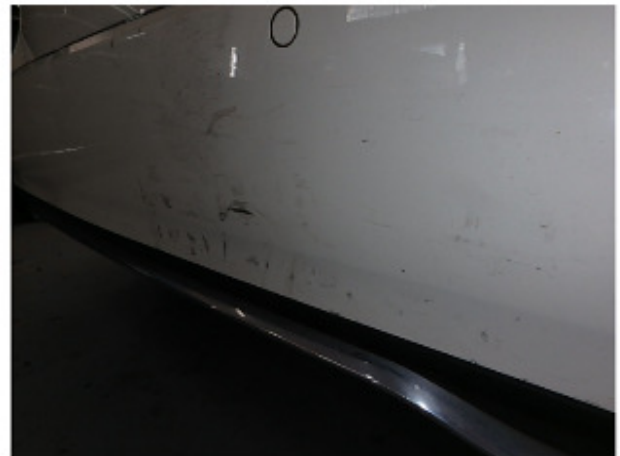
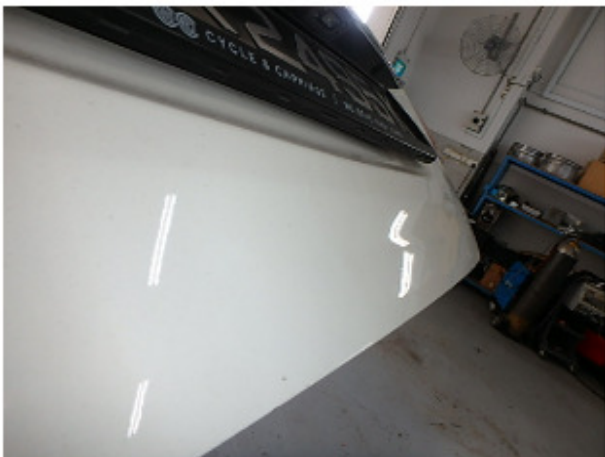
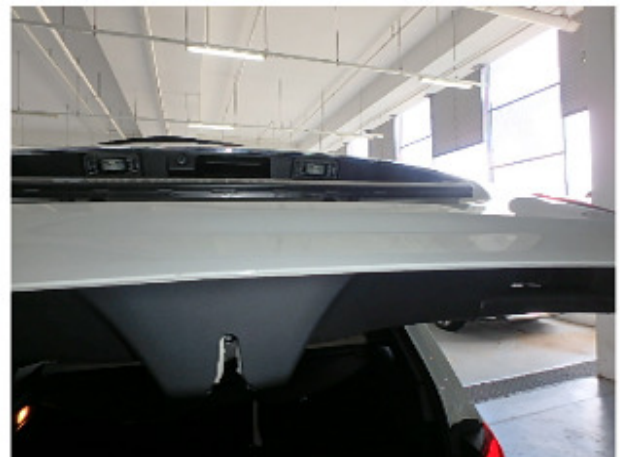
INSPECTION

THE VEHICLE SUSTAINED DAMAGES AT THE REAR PORTION.

Qty	Description of Parts	Condition	Estimate By Workshop (\$)	Our Adjusted (\$)
<u>REPLACEMENT OF PARTS</u>				
1	TAILGATE	BENT	2,122.00	2,122.00
1	TAILGATE WEATHERSTRIP	SERVICEABLE	220.00	-
1	TAILGATE CENTRE LOGO	NECESSARY	53.00	53.00
1	TAILGATE "B180" EMBLEM	NECESSARY	89.00	89.00
10	TAILGATE TRIMBOARD CLIPS @\$10.00	NECESSARY	100.00	100.00
1	REAR END PANEL	TO REPAIR SEE LABOUR	1,083.00	-
1	REAR BUMPER	BUCKLED	1,610.00	1,610.00
1	REAR BUMPER REINFORCEMENT	BENT	524.00	524.00
4	REAR BUMPER SENSOR @\$190.00	SERVICEABLE	760.00	-
6	REAR BUMPER SENSOR SEAL @\$12.00	NECESSARY	72.00	72.00
1	REAR BUMPER STEP CHROME	DENTED	267.00	267.00
15	REAR BUMPER CLIPS @\$9.00	NECESSARY	135.00	135.00
1	REAR BUMPER LOWER SPOILER	DENTED / CUT	170.00	170.00
1	REAR BUMPER LOWER CHROME	SERVICEABLE	225.00	-
	LESS 10% DISCOUNT		-743.00	-514.20
			6,687.00	4,627.80
<u>SPECIAL NETT ITEMS</u>				
1	TAILGATE "C & C" EMBLEM (SN)	NECESSARY	38.00	38.00

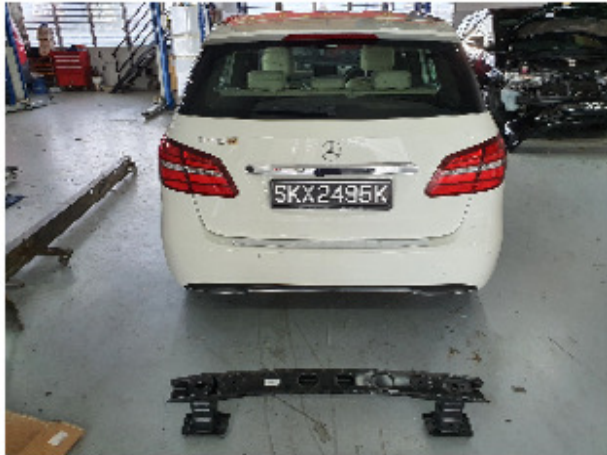
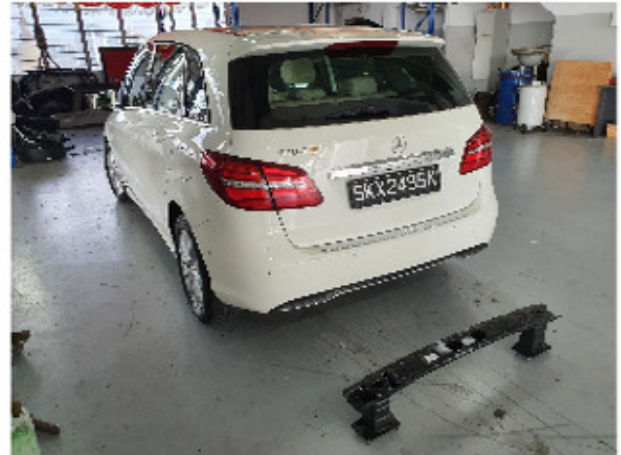
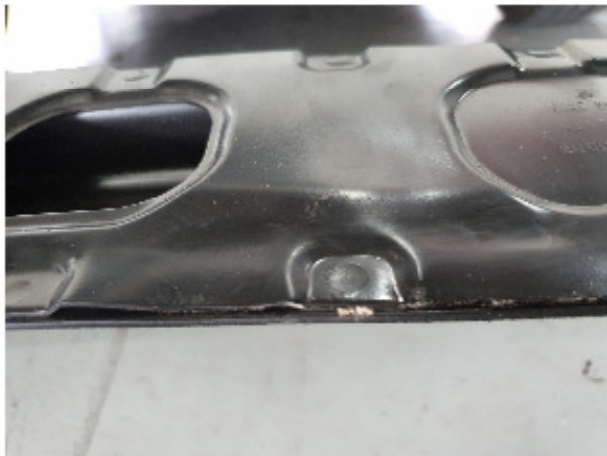
RE-INSPECTION

PHOTOGRAPHS FOR VEHICLE NO. SKX 2495K
