# LKK Auto Consultants Pte Ltd

## ADJUSTMENT ON REPAIR COST FOR VEHICLE NO. SLV 3347Y

PHOTOGRAPHS FOR VEHICLE NO. SLV 3347Y

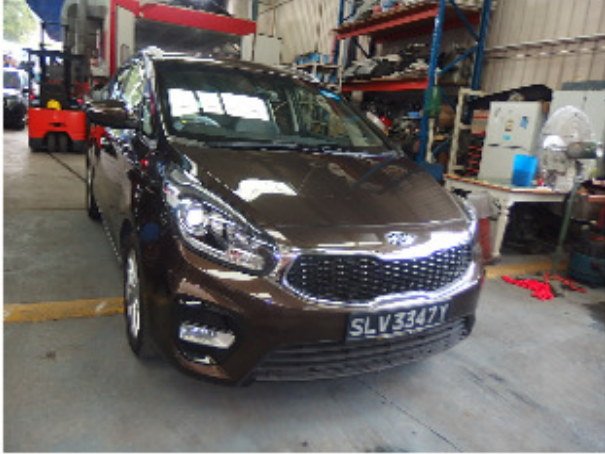
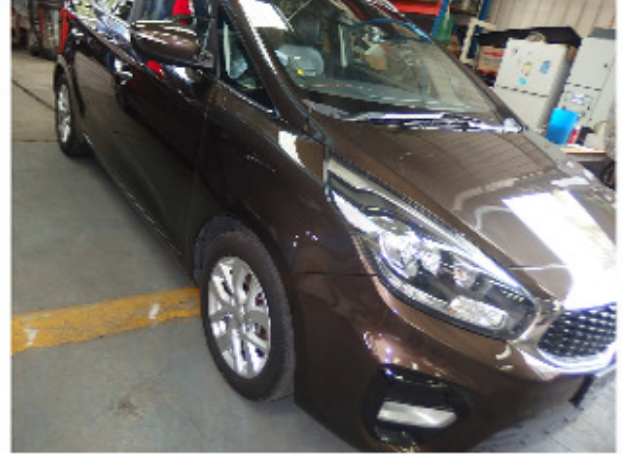
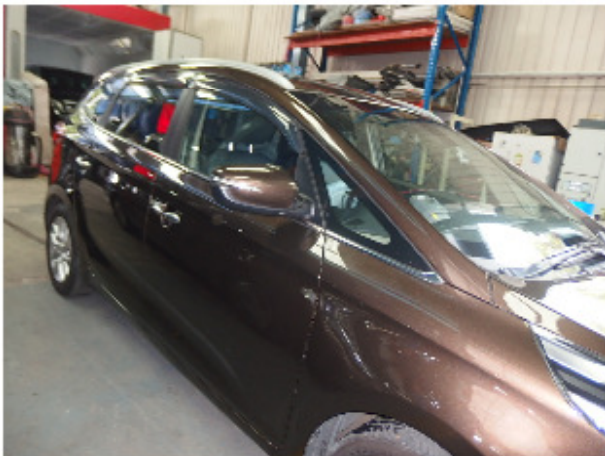
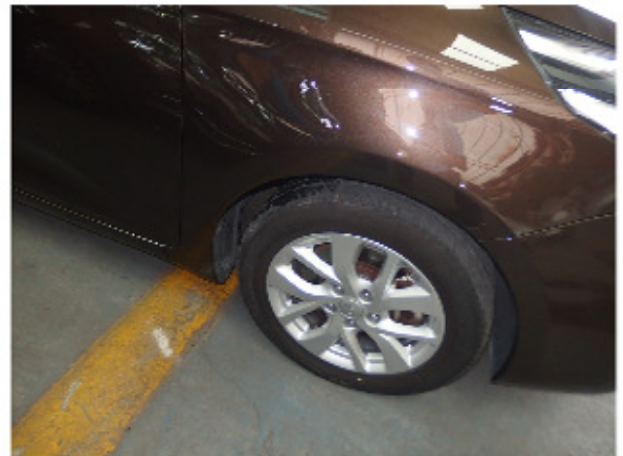
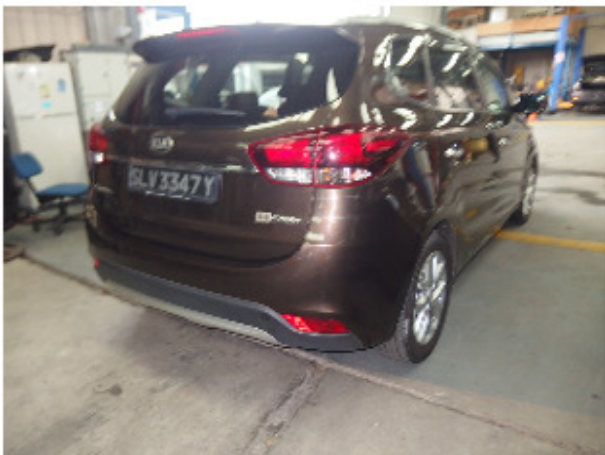
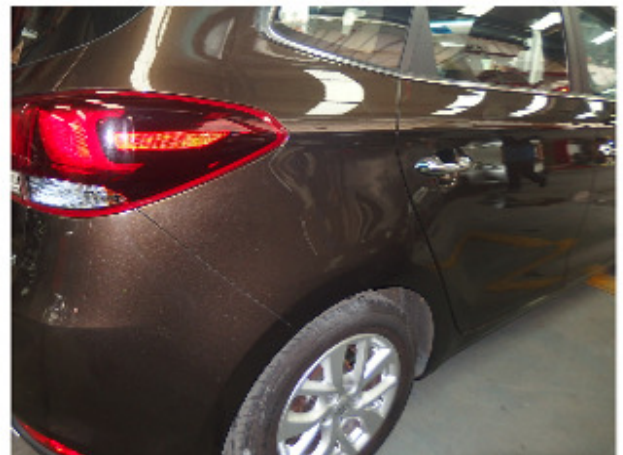
PHOTOGRAPHS FOR VEHICLE NO. SLV 3347Y

RE-INSPECTION

THE VEHICLE SUSTAINED DAMAGES AT THE O/S FRONT PORTION AND O/S BODY.  
DAMAGES SEE DETAILS.
