LKK Auto Consultants Pte Ltd

1. Policy Particulars :- THIRD PARTY CLAIM				
	Insured Veh.	SMG 2397B	Veh. Inspected	SHB 1679E
	Policy No.	DMCTHQ20-000060	Coverage (\$)	0.00
	Claim No.		Excess (\$)	0.00
	Assign From		Assign Date	17/07/2020

2. Vehicle Particulars & Condition				
	Make & Model	TOYOTA PRIUS	c.c	1798
	Engine No.	HIDDEN	Year of Reg.	2014
	Chassis No.	JTDKN36U405748307	Colour	MAROON
	Odometer	489894	Steering	IN ORDER
	Brakes	IN ORDER	Modification	SPORTS RIM
	General	FAIR

ADJUSTMENT ON REPAIR COST FOR VEHICLE NO. SHB 1679E

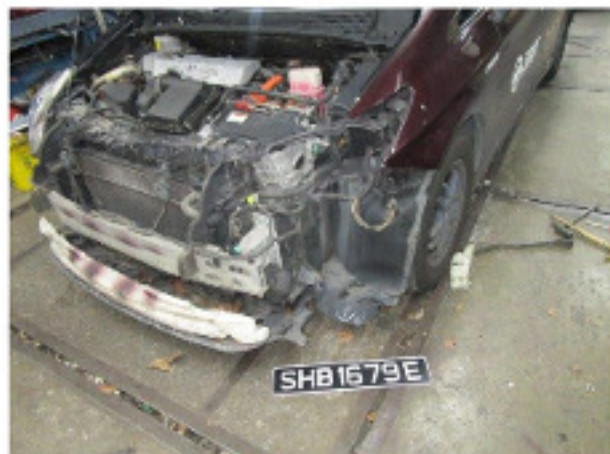
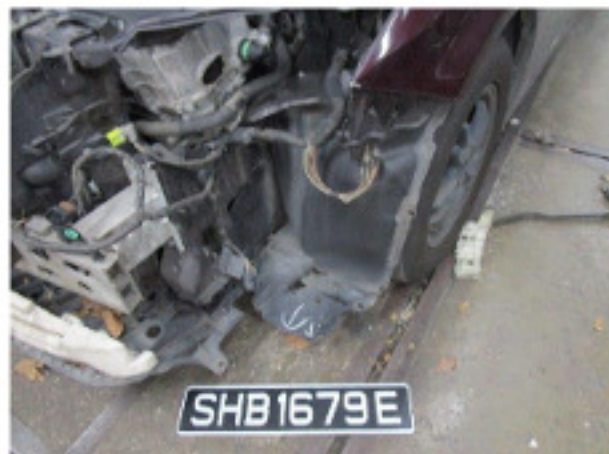
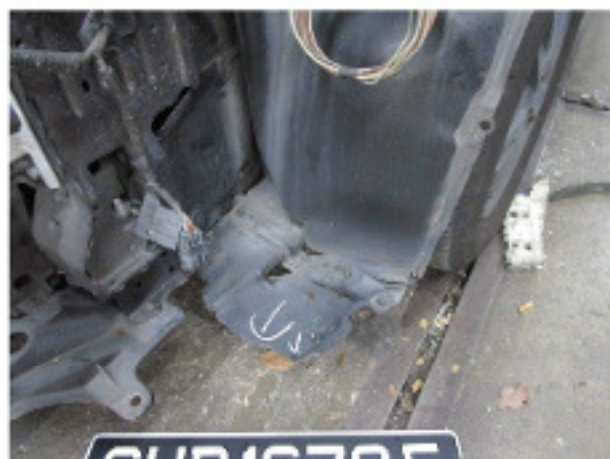
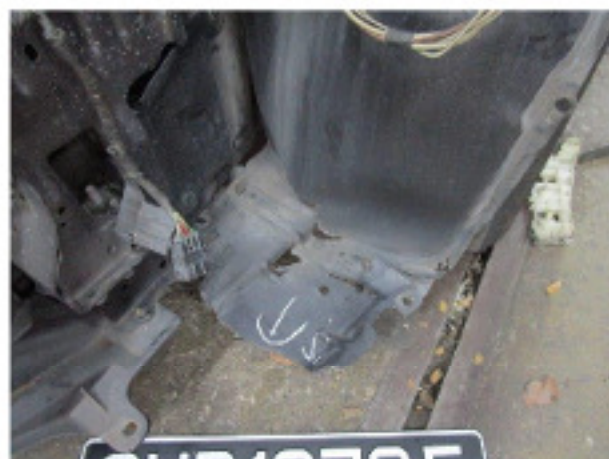
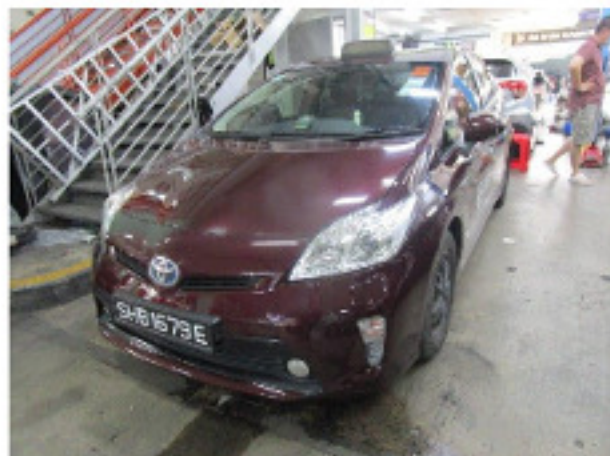
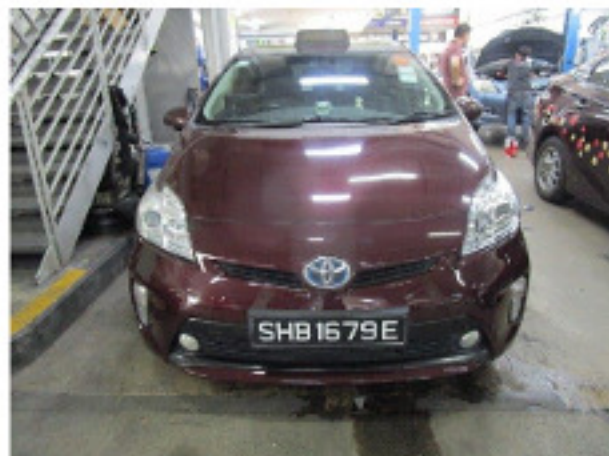
PHOTOGRAPHS FOR VEHICLE NO. SHB 1679E

RE-INSPECTION

4. Description of Damages				
	THE VEHICLE SUSTAINED DAMAGES AT THE N/S BODY. DAMAGES SEE DETAILS.			
5. General Information				
	Accident Date	17/07/2020	Inspection Date	17/07/2020
	Survey held at	SMRT AUTOMOTIVE SERVICES PTE LTD 60 WOODLANDS INDUSTRIAL PARK E4 SINGAPORE 757705		
5a. Remarks				
	A)THE INSPECTION WAS CONDUCTED ON A"WITHOUT PREJUDICE" BASIS. B)IN ACCORDANCE TO YOUR INSTRUCTIONS, WE HAVE NOT AUTHORISED REPAIRS.			
5b. Estimate Days of Repair				
	ESTIMATED NORMAL PERIOD FOR REPAIR:		3 Working Days
