LKK Auto Consultants Pte Ltd

TAX INVOICE

ADJUSTMENT ON REPAIR COST FOR VEHICLE NO. SLB 29R

PHOTOGRAPHS FOR VEHICLE NO. SLB 29R

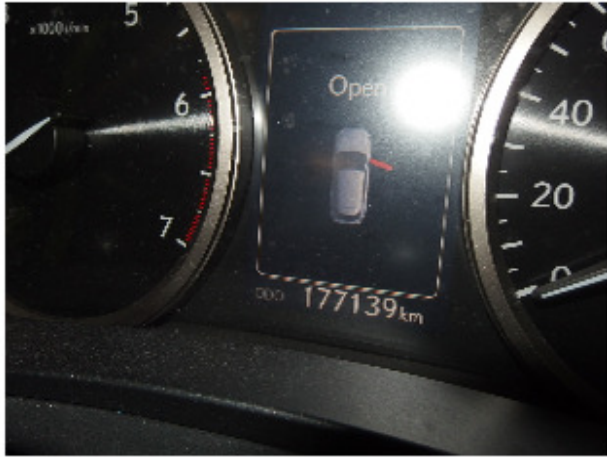
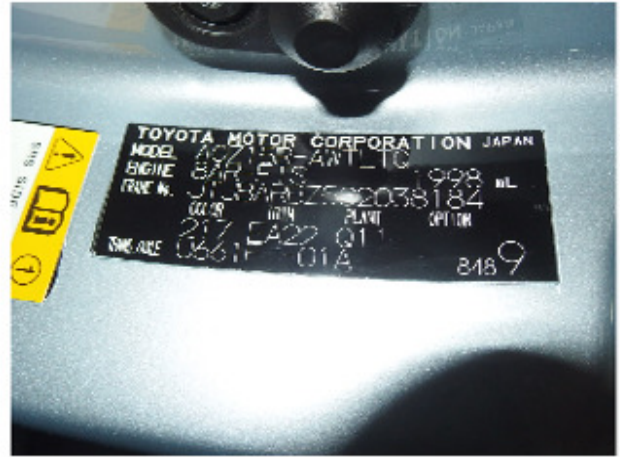
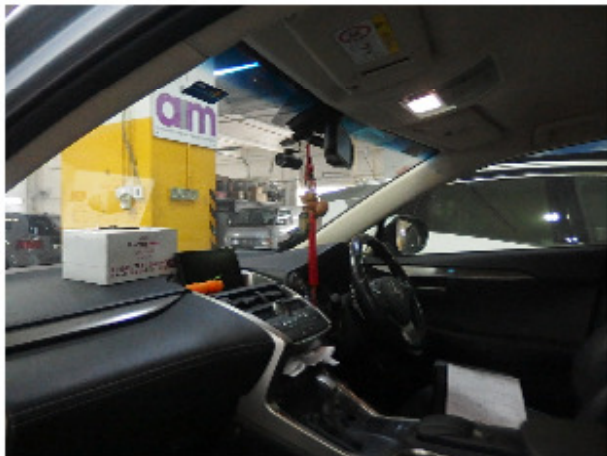
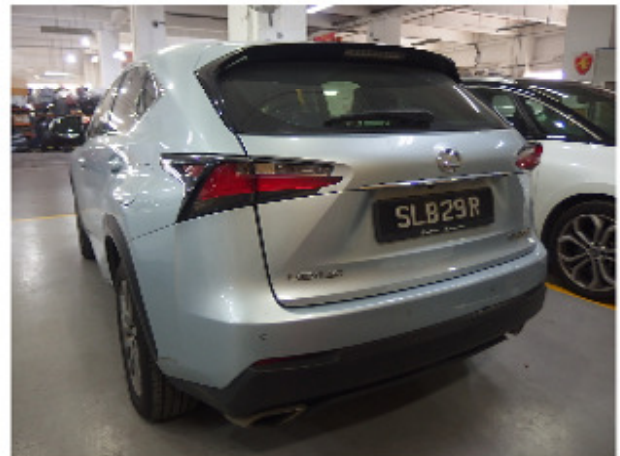
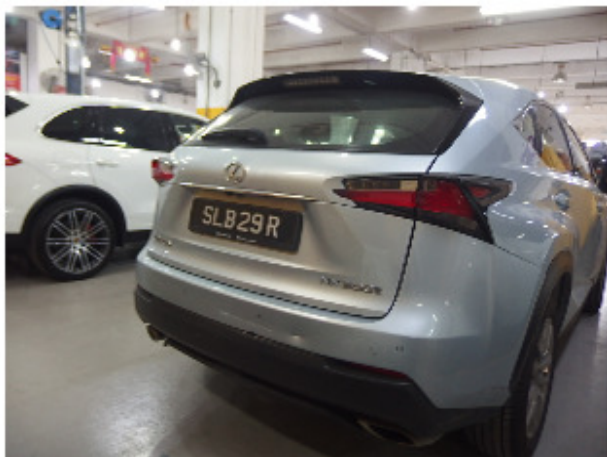
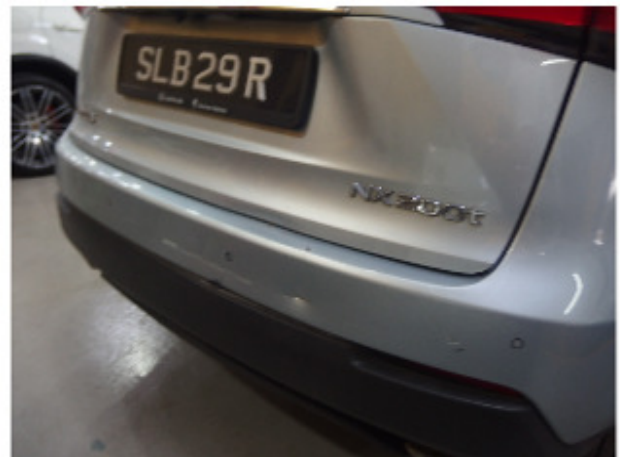
THE VEHICLE SUSTAINED DAMAGES AT THE REAR PORTION. DAMAGES SEE DETAILS.
--

INSPECTION

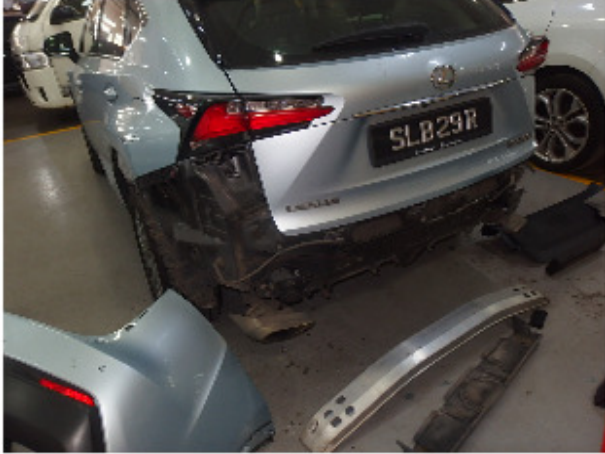
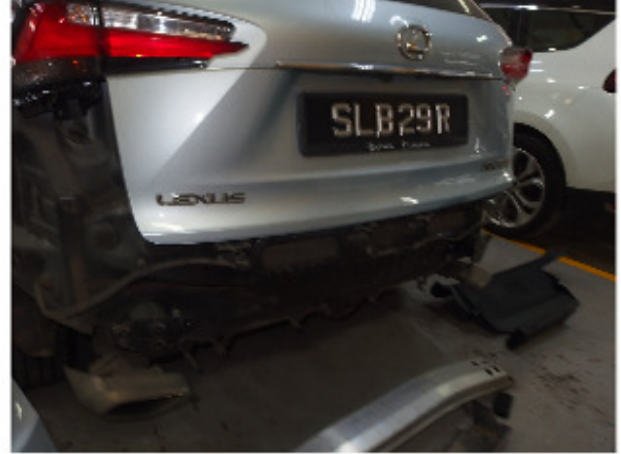
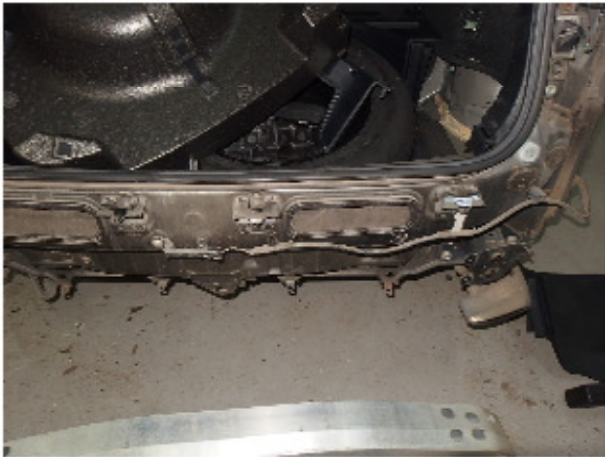
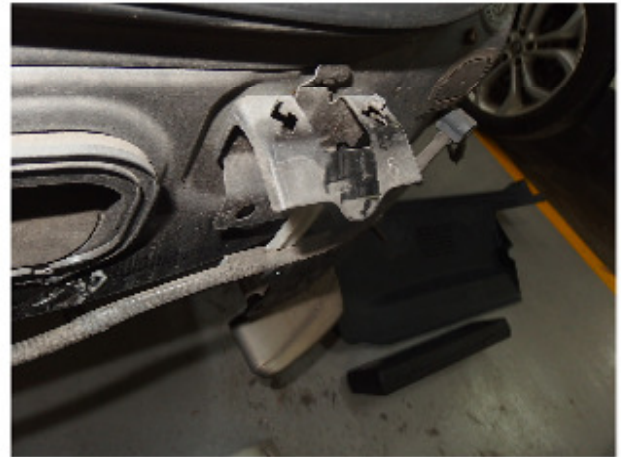
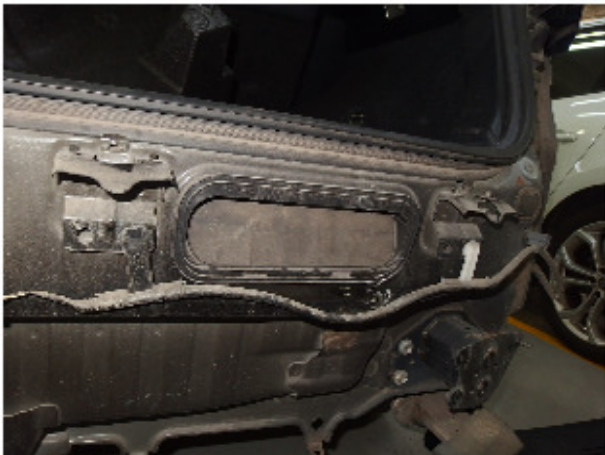
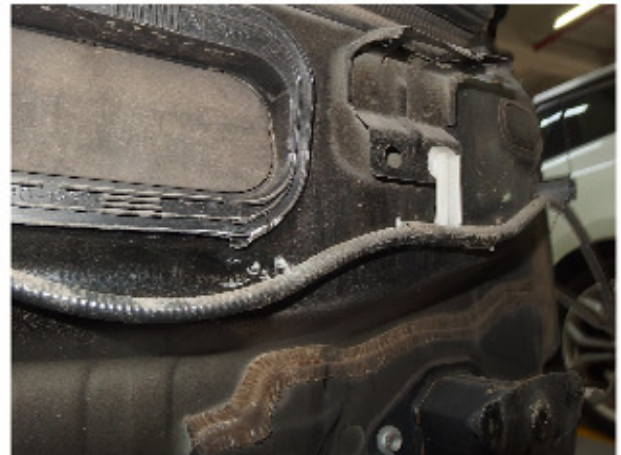
PHOTOGRAPHS FOR VEHICLE NO. SLB 29R

RE-INSPECTION
