LKK Auto Consultants Pte Ltd

ADJUSTMENT ON REPAIR COST FOR VEHICLE NO. SJT 5965J

PHOTOGRAPHS FOR VEHICLE NO. SJT 5965J

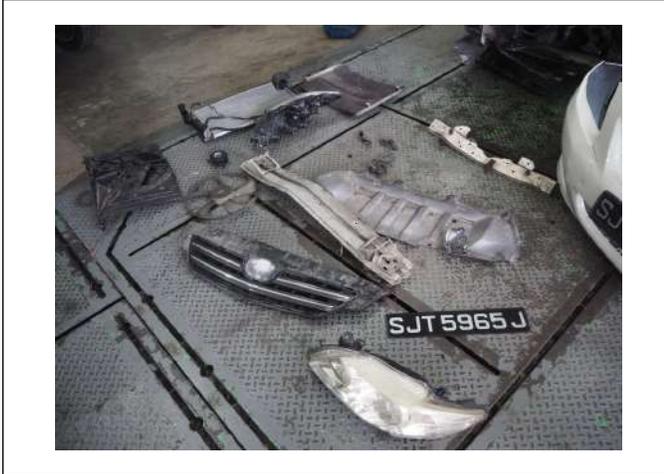
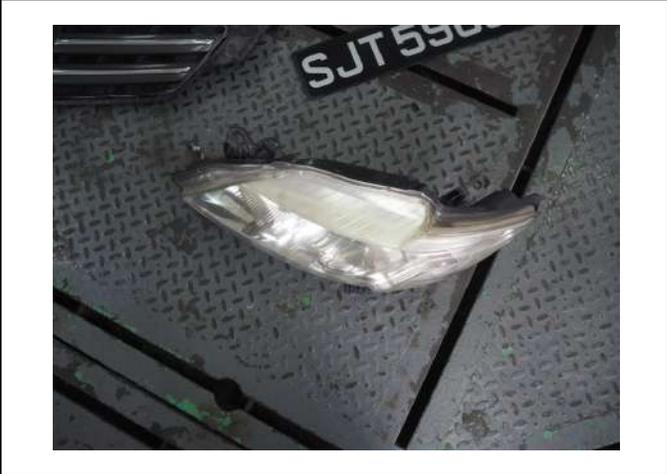
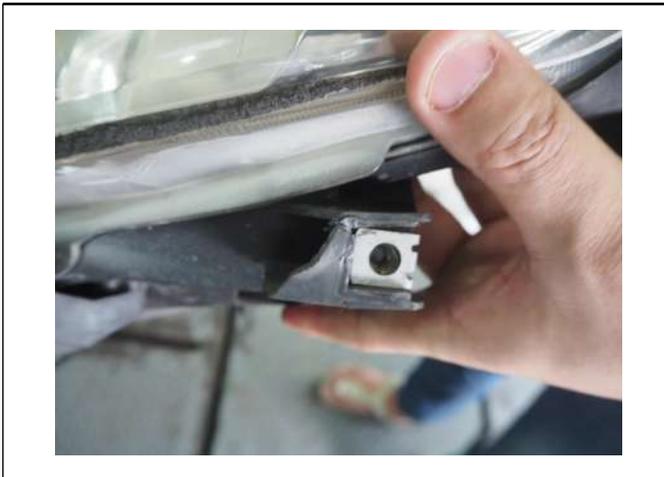
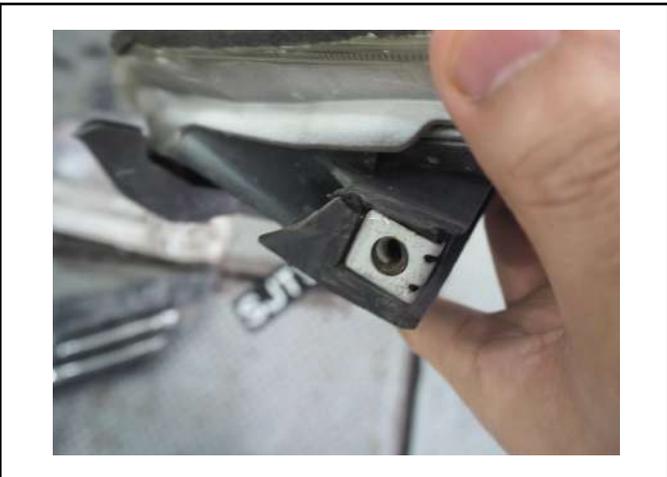
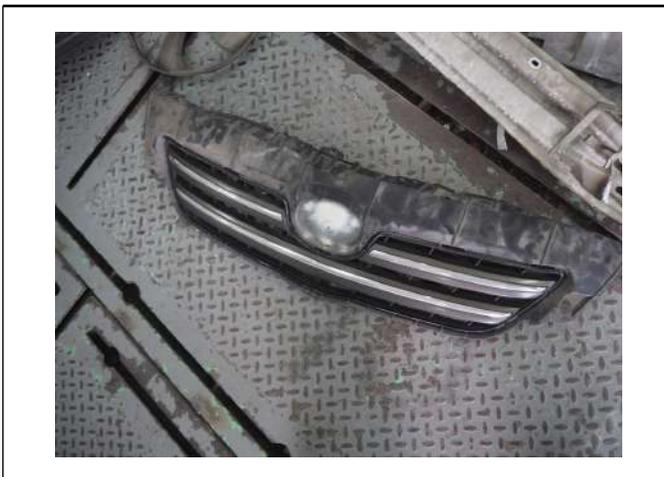
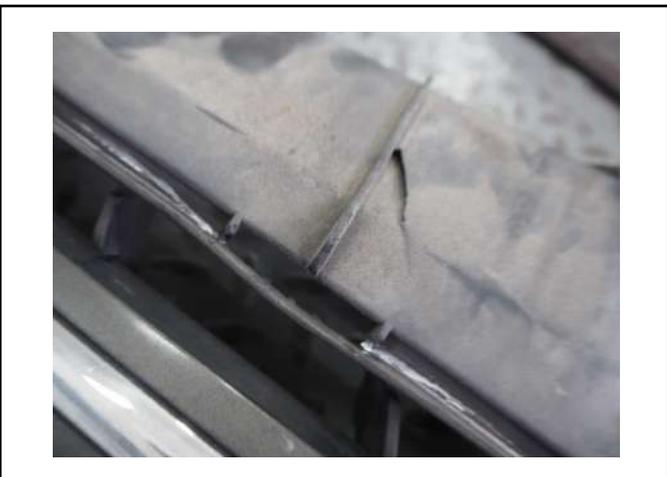
PHOTOGRAPHS FOR VEHICLE NO. SJT 5965J

RE-INSPECTION

4. Description of Damages			
THE VEHICLE SUSTAINED DAMAGES AT THE FRONT PORTION. DAMAGES SEE DETAILS.			
5. General Information			
Accident Date	29/07/2020	Inspection Date	03/08/2020
Survey held at	MG SOLUTION PTE LTD 23 KAKI BUKIT AVE 4 (SOUTH WING) #02-03B VICOM INSPECTION CENTRE, SINGAPORE 415933		
5a. Remarks			
A)THE INSPECTION WAS CONDUCTED ON A"WITHOUT PREJUDICE" BASIS. B)IN ACCORDANCE TO YOUR INSTRUCTIONS, WE HAVE NOT AUTHORISED REPAIRS.			
5b. Estimate Days of Repair			
ESTIMATED NORMAL PERIOD FOR REPAIR:		6 Working Days

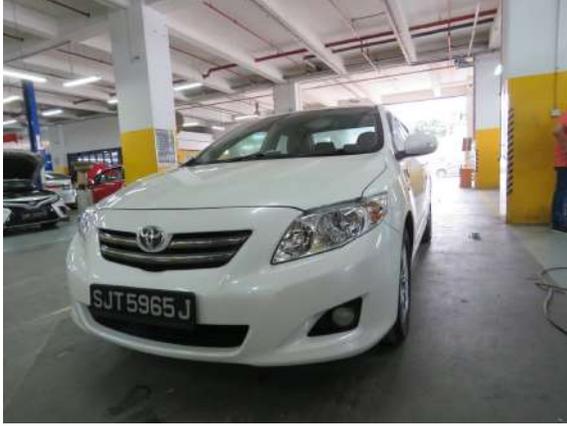
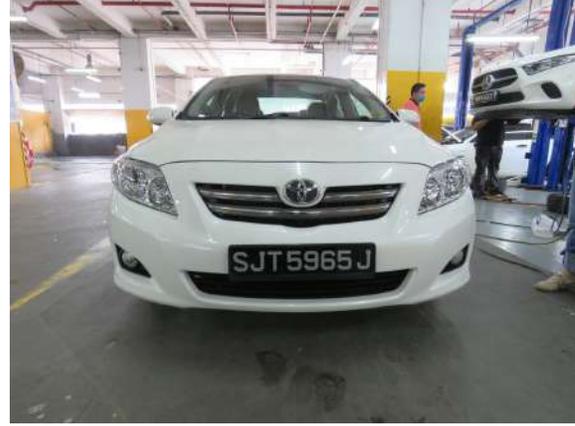
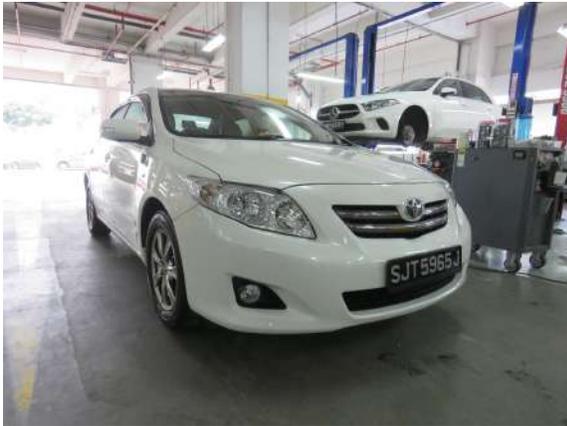
PHOTOGRAPHS FOR VEHICLE NO. SJT 5965J

RE-INSPECTION
