VEHICLE INSPECTION REPORT

Date : 11 June 2020
Our ref : FONE/06/2001/TP

Registration No : SMK 6559 D
Make / Model : Honda Vezel
Chassis No : RU11315396
Engine No : L15B5565408

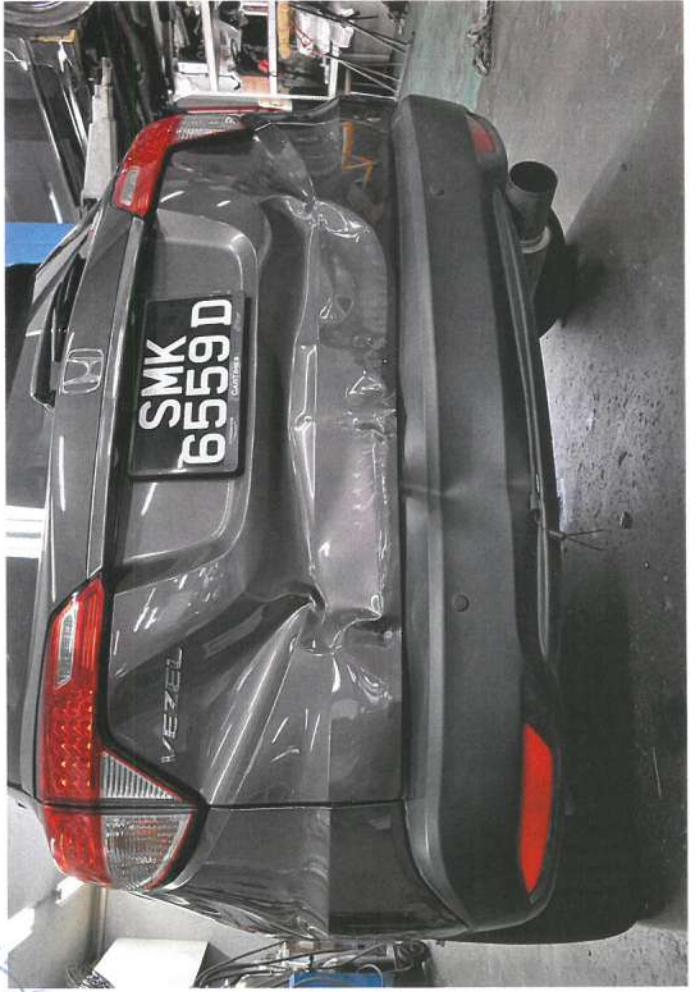
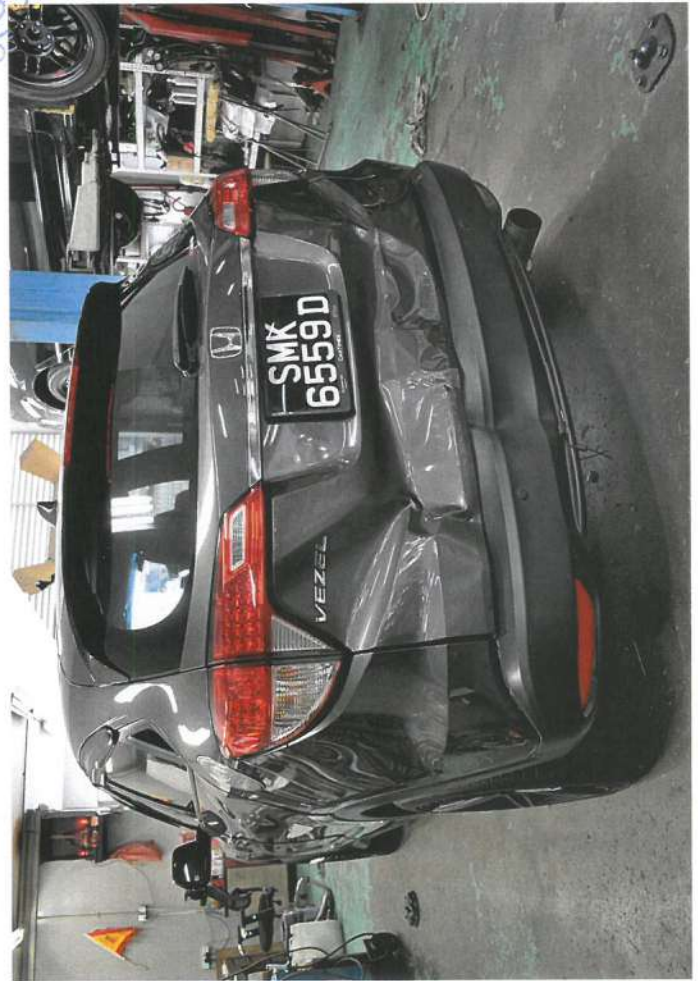
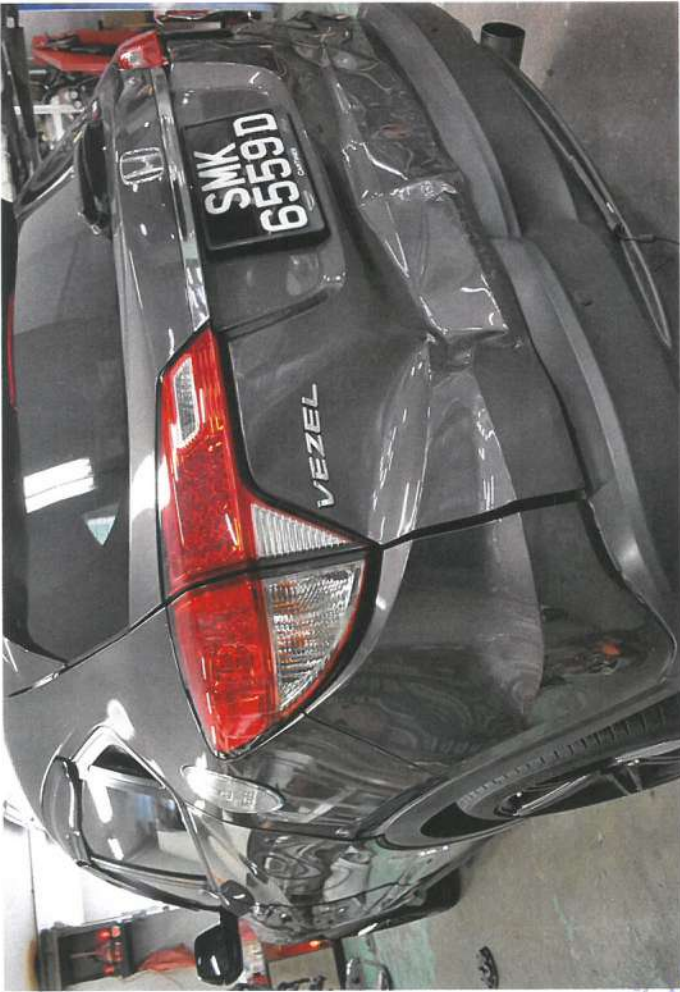
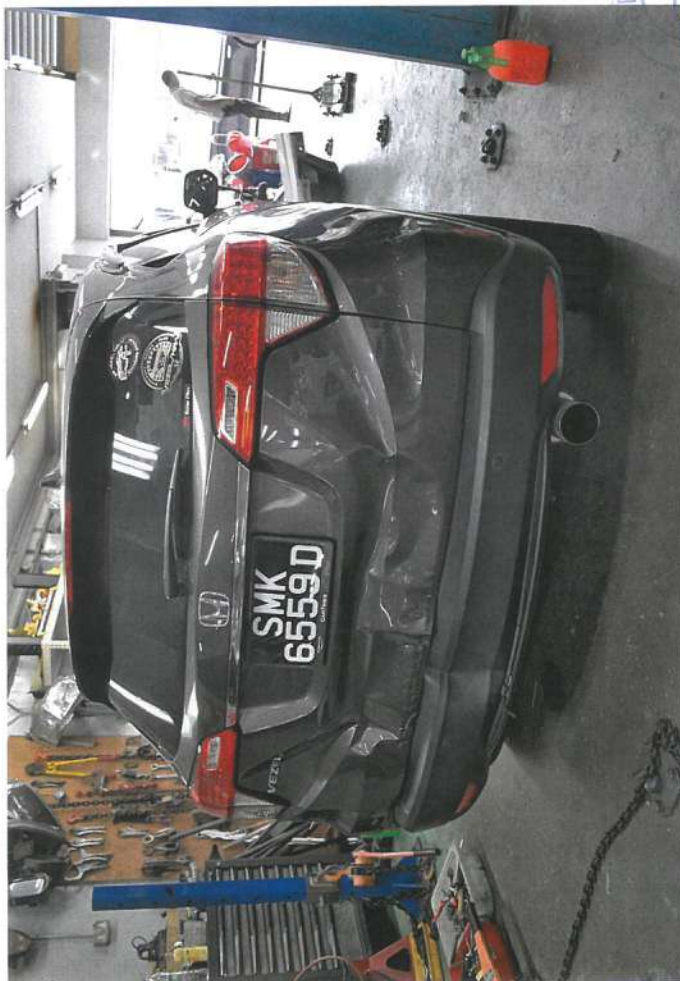
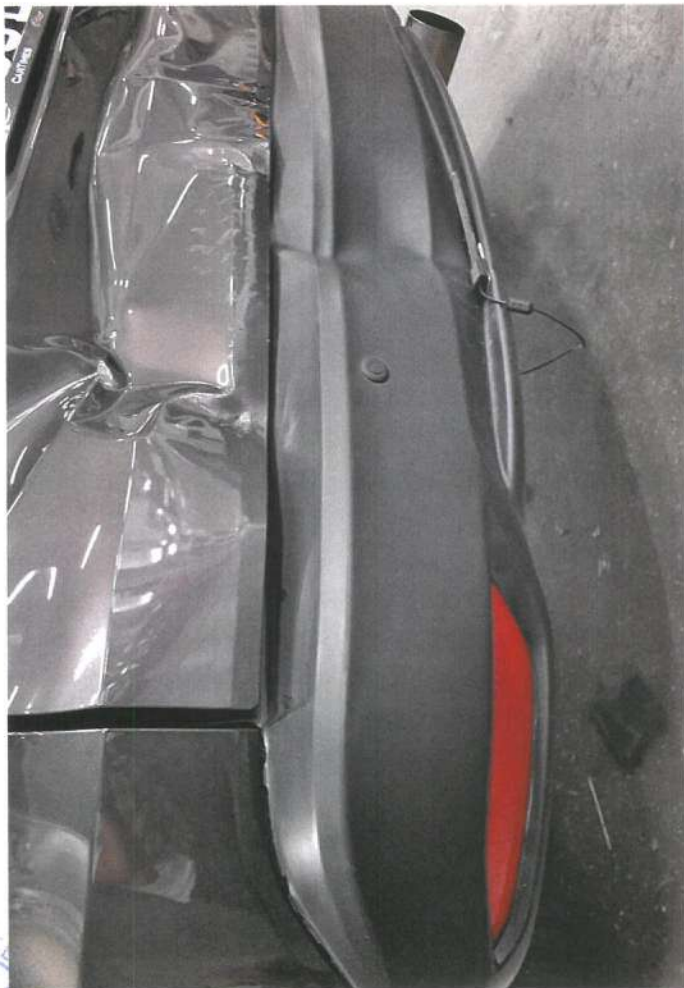
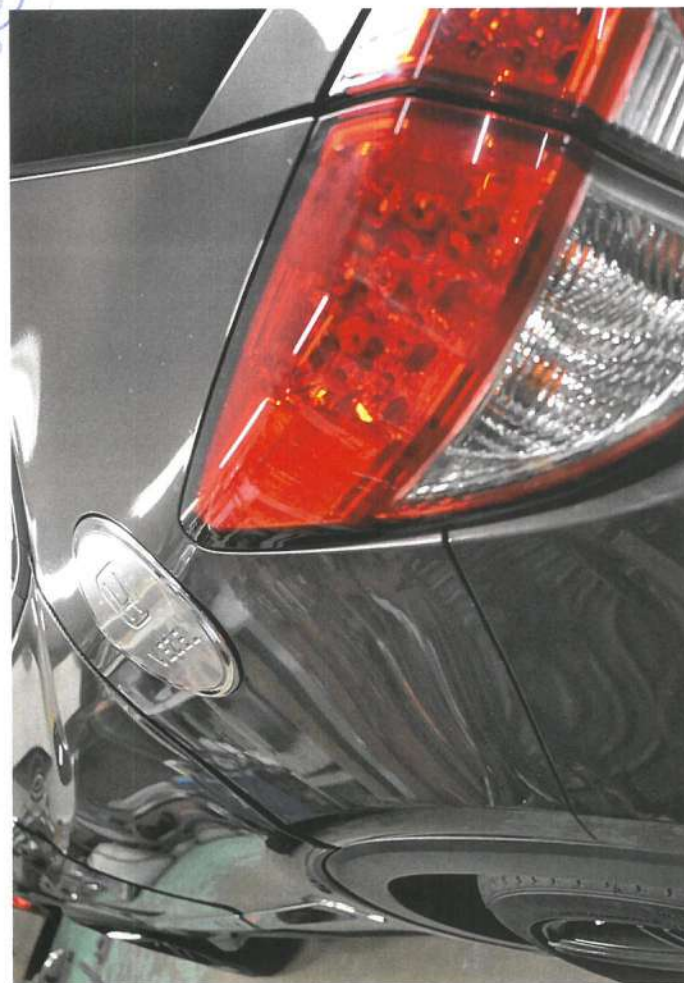
The impact damages sustained on the vehicle at the time of inspection is on the rear portion.
(Details refer to the photographs attached)
