Vehicle No. SHC 333D  
Insured Veh. SML 1688S  
Claim No. SNM20D202671C02  
Policy No. DMPCSNW00053972001  
Accident Date 28/07/2020  
Inspection Date 05/08/2020

## ADJUSTMENT ON REPAIR COST FOR VEHICLE NO. SHC 333D

### PHOTOGRAPHS FOR VEHICLE NO. SHC 333D

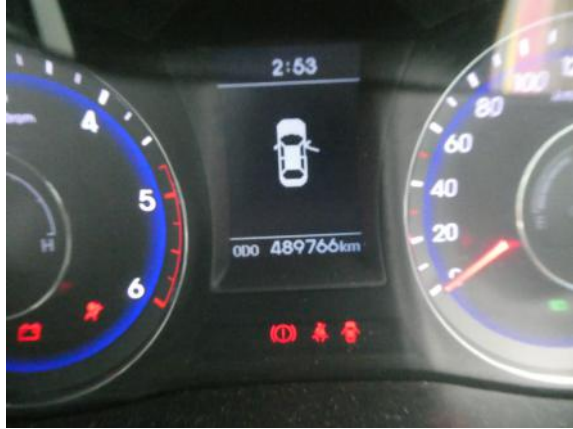
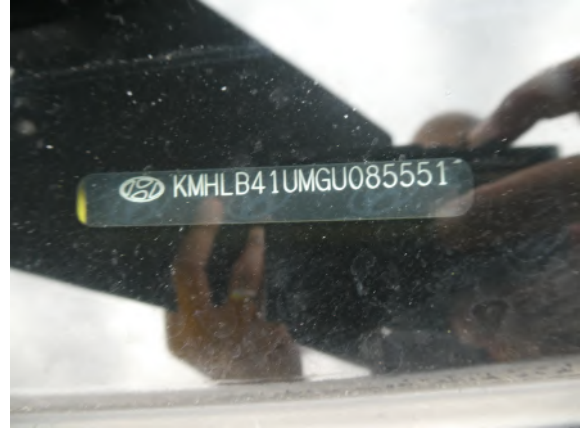
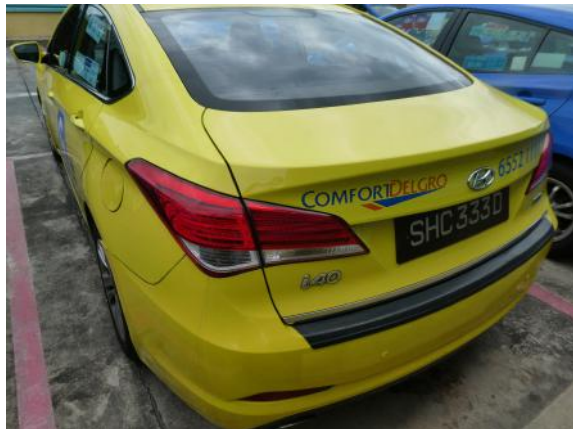
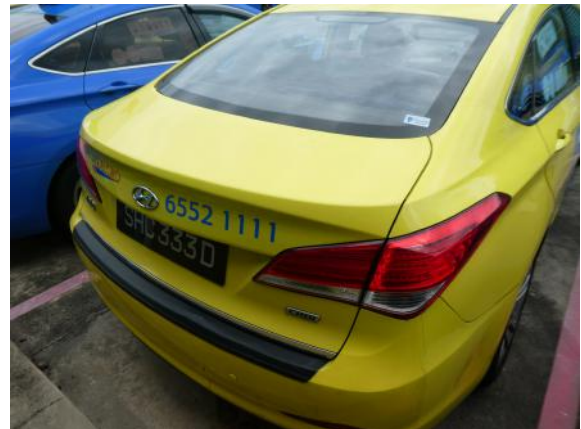
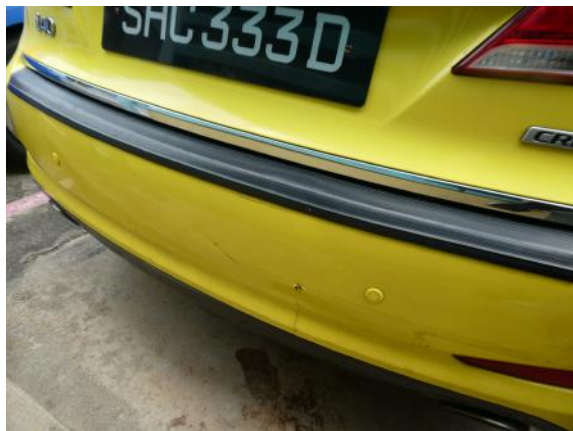
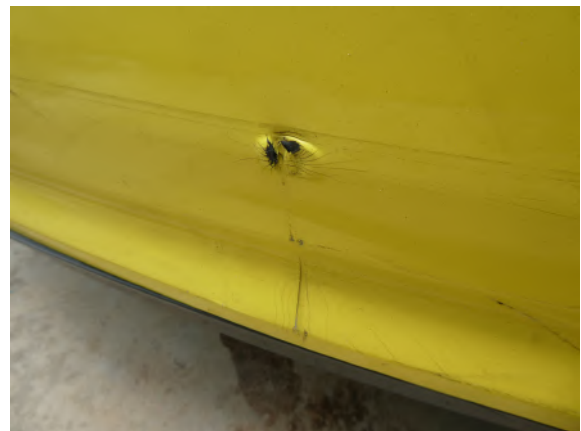
### INSPECTION

| Affiliated to Federation Internationale Des Experts En Automobile | | | | |
|---|---|---|---|--|
| THE VEHICLE SUSTAINED DAMAGES AT THE FRONT AND REAR PORTION.<br>DAMAGES SEE DETAILS. | | | | |

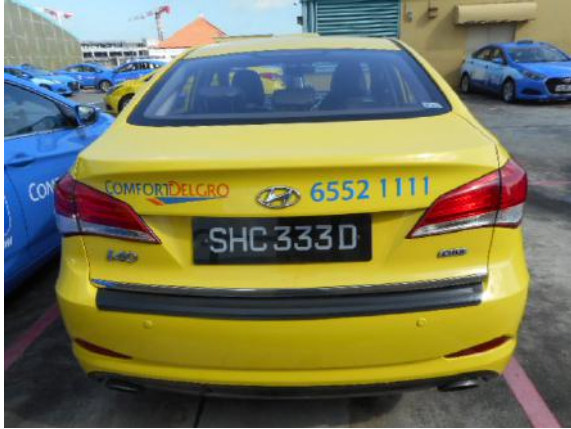
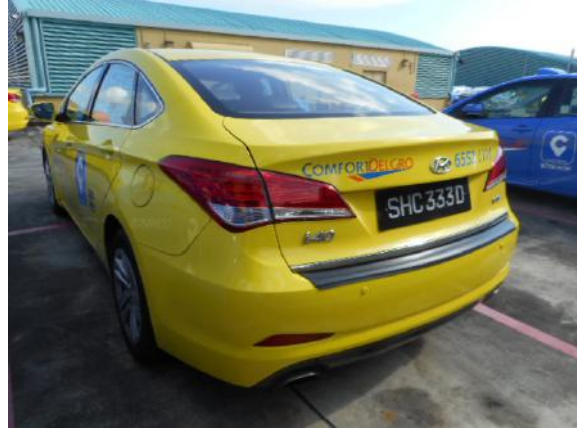
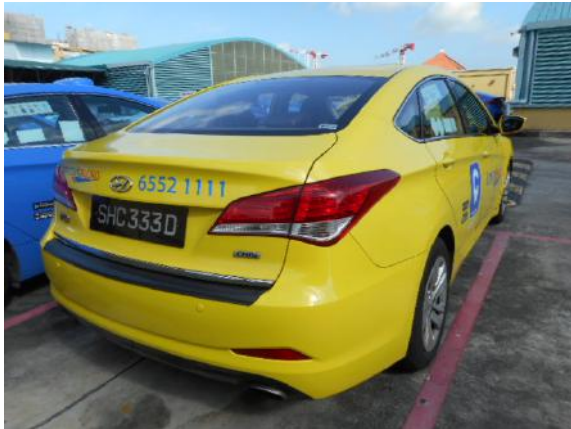
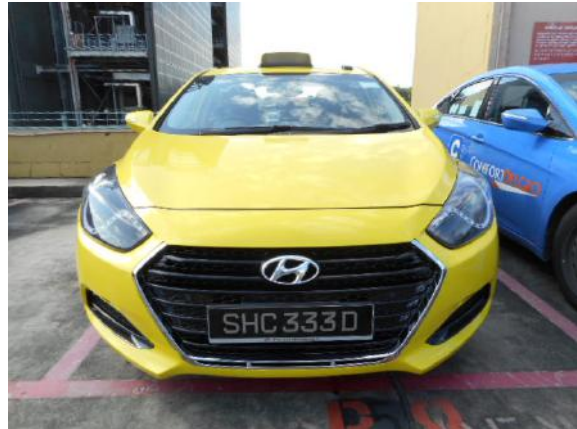
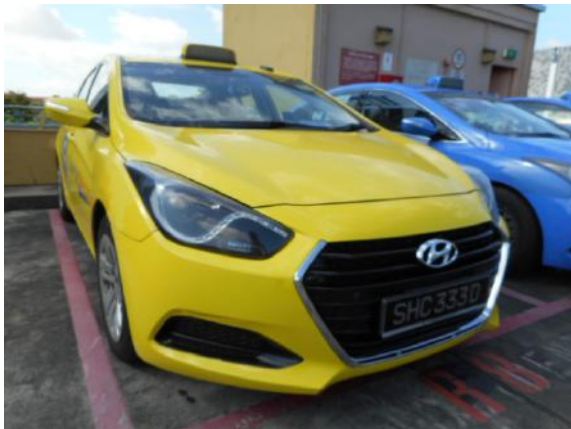
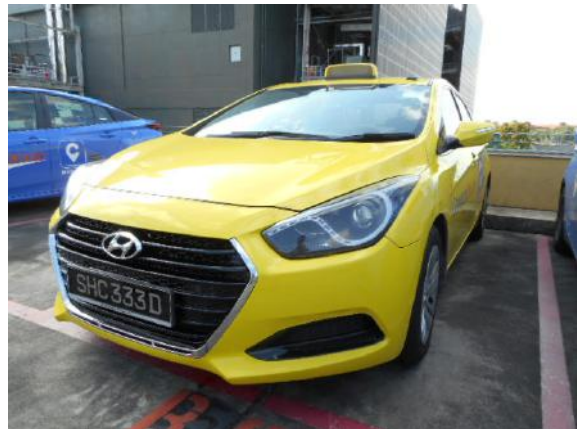
PHOTOGRAPHS FOR VEHICLE NO. SHC 333D

RE-INSPECTION
