Vehicle No. SLU 5698B
Insured Veh. SH 7067U
Claim No. D20003034MFSH
Policy No. D-20094922MFSH
Accident Date 30/07/2020
Inspection Date 05/08/2020

ADJUSTMENT ON REPAIR COST FOR VEHICLE NO. SLU 5698B

PHOTOGRAPHS FOR VEHICLE NO. SLU 5698B

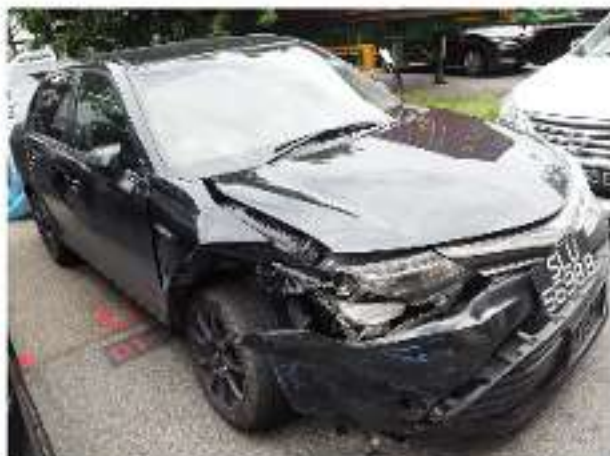
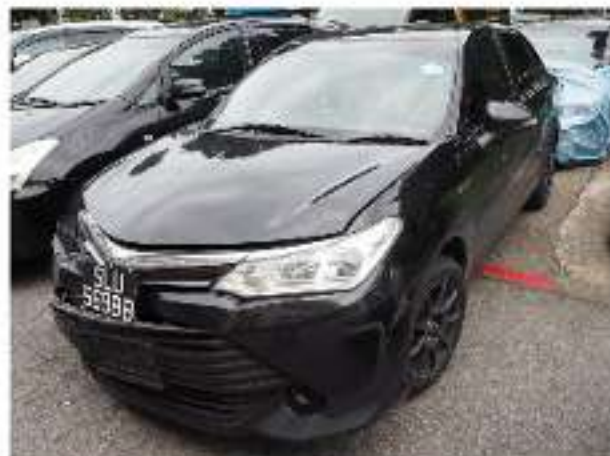
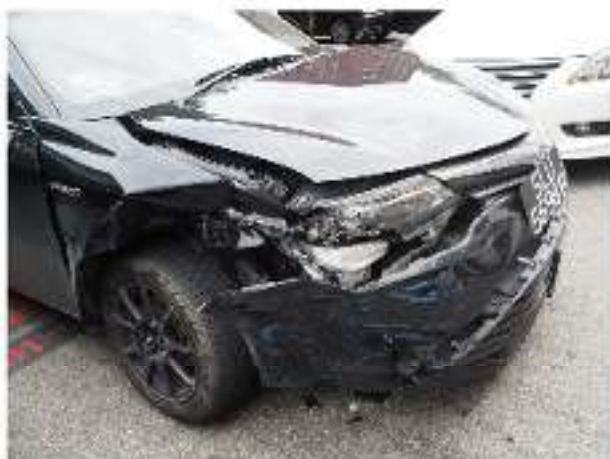
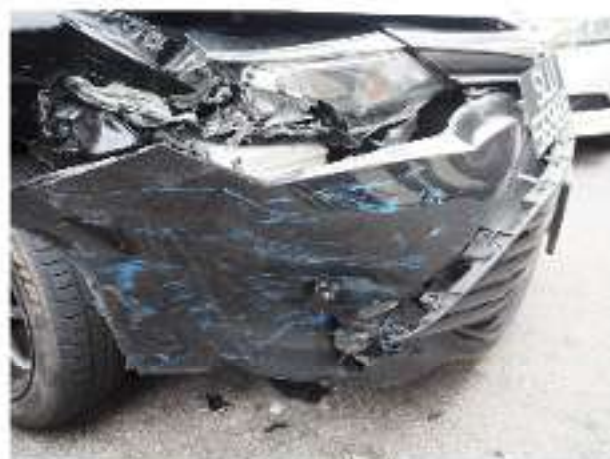
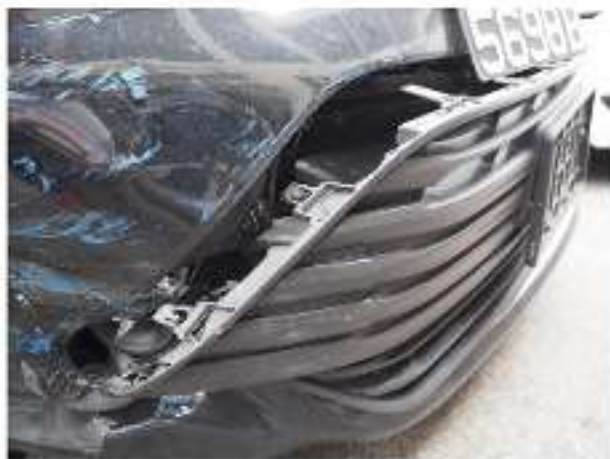
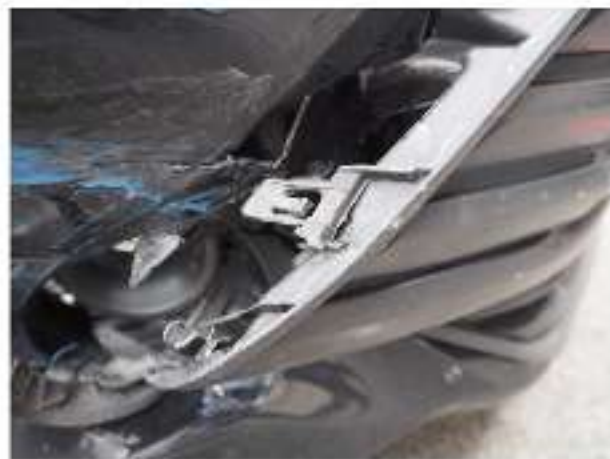
THE VEHICLE SUSTAINED DAMAGES AT THE FRONT O/S PORTION. DAMAGES SEE DETAILS.

INSPECTION
