**ACCIDENT DAMAGED VEHICLE INSPECTION REPORT**

Date : 21 July 2020
Our Ref : TP/WYU/SKL1486G/8397

Registration No : SKL 1486 G
Make : B.M.W
Model : 528I A
Year : 2011

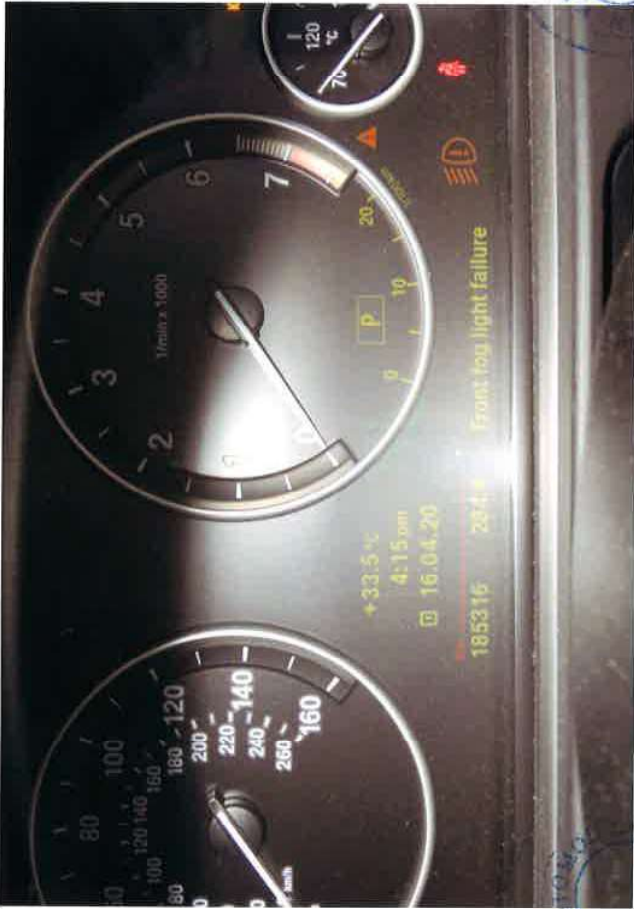
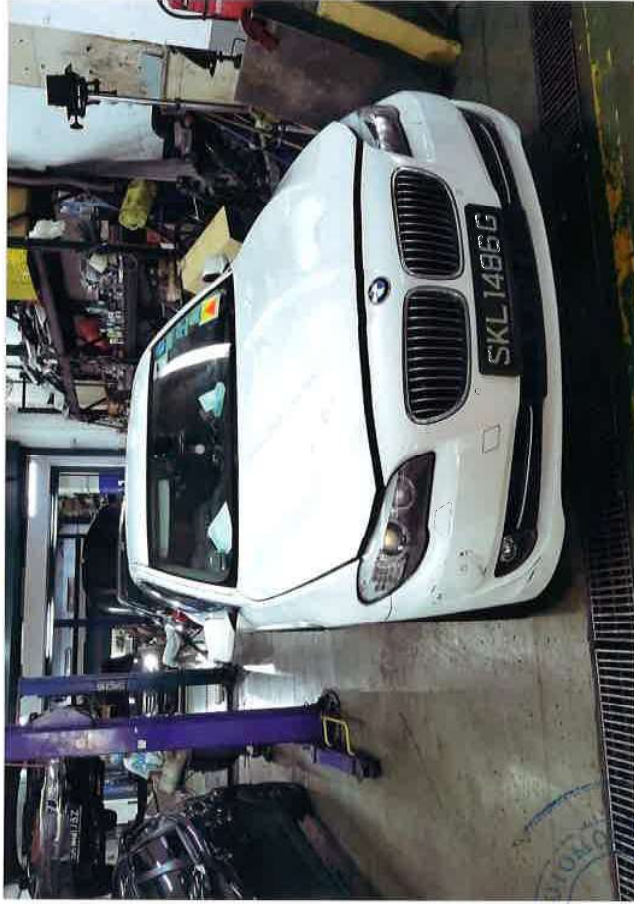
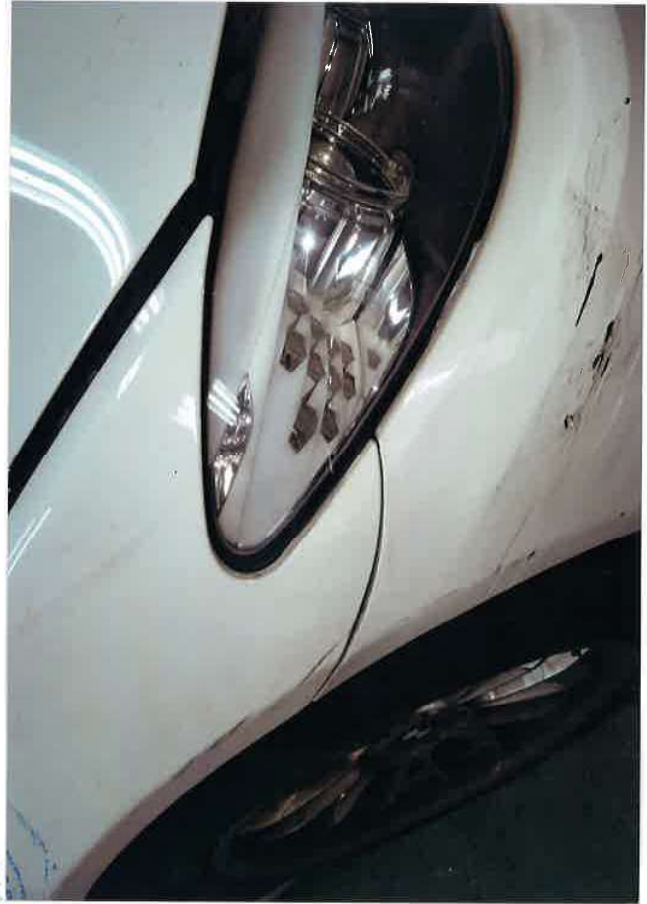
The vehicle sustained damage at the front off side portion.
For details, refer to assessment for repairs and photographs attached.

The impact was confined to the front off side portion of the vehicle.
The damages appeared to be consistent as per the accident report statement.
Please refer the attached schedule and photographs for details.

Enclosed Thirty-Six (36) photographs depicting damage to the vehicle and after repairs.
