PROFESSIONAL SERVICE FEE

Vehicle No. SMK 8366E
Insured Veh. SH 8567L
Claim No. D20003771MFSH
Policy No. D-18088937MFSH
Accident Date 08/08/2020
Inspection Date 11/08/2020

PHOTOGRAPHS FOR VEHICLE NO. SMK 8366E

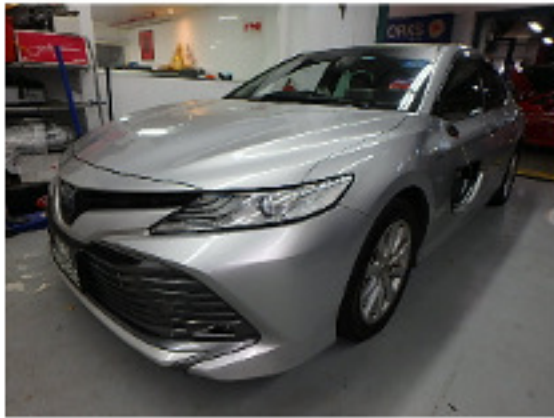
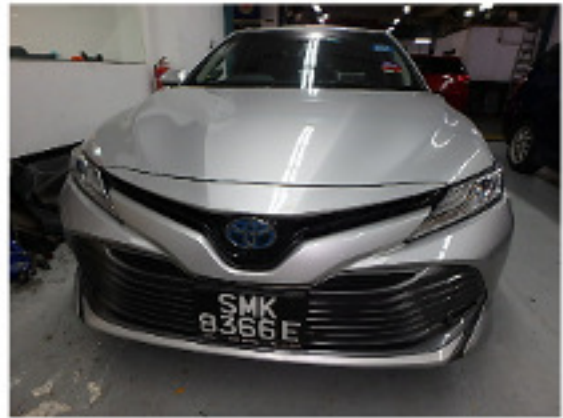
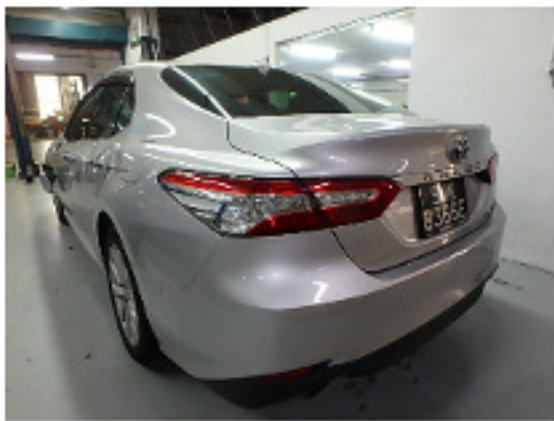
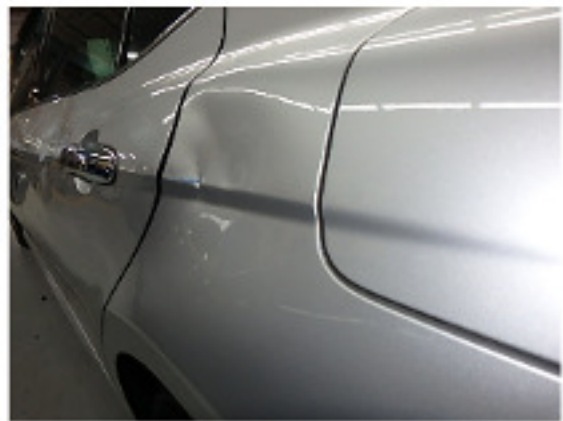
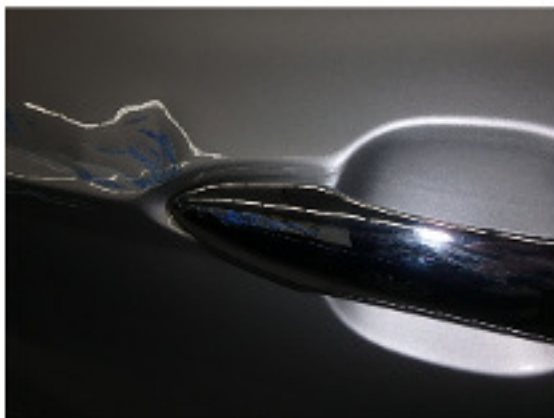
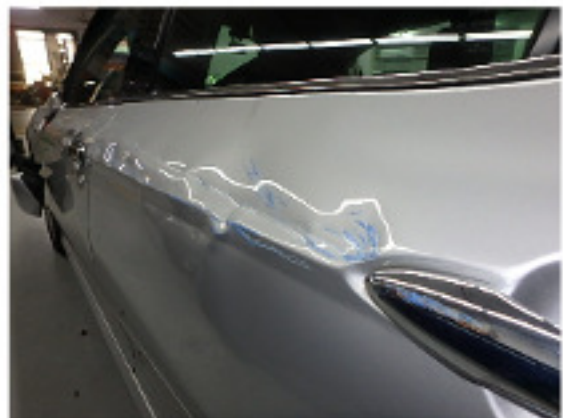
THE VEHICLE SUSTAINED DAMAGES AT THE N/S BODY.
DAMAGES SEE DETAILS.

INSPECTION

Qty	Description of Parts	Condition	Estimate By Workshop (\$)	Our Adjusted (\$)
<u>REPLACEMENT OF PARTS</u>				
1	FRONT LH FENDER	TO REPAIR SEE LABOUR	781.50	-
1	FRONT LH FENDER 'HYBRID'	NECESSARY	85.25	85.25
1	FRONT LH SIDE WINDSCREEN PILLAR	TO REPAIR SEE LABOUR	681.50	-
1	SET FRONT WINDSCREEN MOULDING	NOT NECESSARY	195.58	-
1	FRONT LH SIDE MIRROR	BROKEN	681.52	681.52
1	FRONT LH SIDE MIRROR COVER	MTG CRACKED	181.50	181.50
1	FRONT LH DOOR	BENT	1,781.50	1,658.00
1	FRONT LH DOOR HANDLE (CHROME)	SCRATCHED	381.50	381.50
1	FRONT LH DOOR HANDLE BASE	SERVICEABLE	358.20	-
1	FRONT LH DOOR MOULDING (CHROME)	DENTED	381.25	381.25
1	FRONT LH DOOR FRAME TOP MOULDING (CHROME)	DENTED	358.25	358.25
12	FRONT LH DOOR FRAME TOP MOULDING RIVET @\$8.00	NECESSARY	96.00	96.00
1	FRONT LH DOOR GARNISH	DENTED	195.50	195.50
1	FRONT LH DOOR GLASS	CUT	981.25	981.25
1	FRONT LH DOOR PANEL (TIRM)	DENTED / CUT	1,850.25	1,428.00
1	FRONT LH DOOR INNER RUBBER	CUT	281.50	281.50

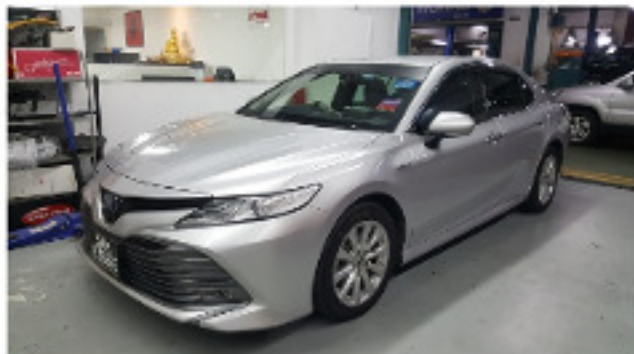
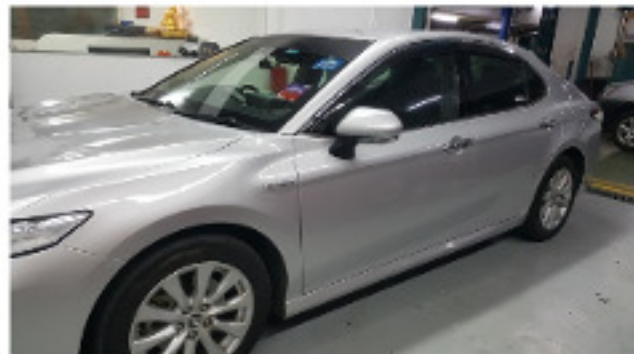
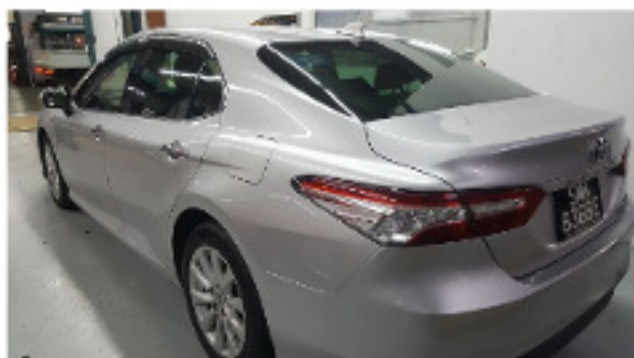
PHOTOGRAPHS FOR VEHICLE NO. SMK 8366E

RE-INSPECTION
