Vehicle No. SFX 9996U  
Insured Veh. SHC 138B  
Claim No. D20003120MFSH  
Policy No. D-20094921MFSH  
Accident Date 07/08/2020  
Inspection Date 13/08/2020

### ADJUSTMENT ON REPAIR COST FOR VEHICLE NO. SFX 9996U

PHOTOGRAPHS FOR VEHICLE NO. SFX 9996U

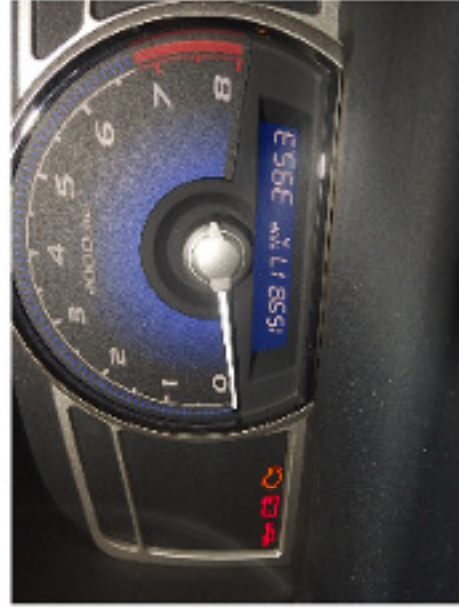
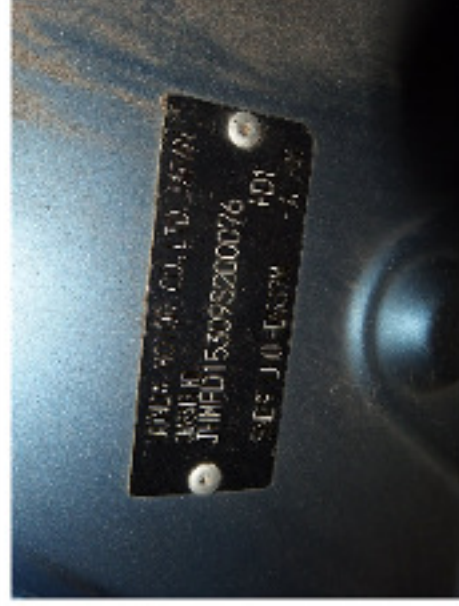
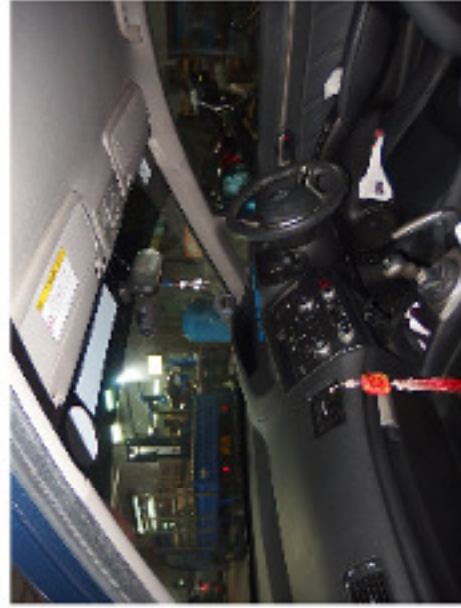
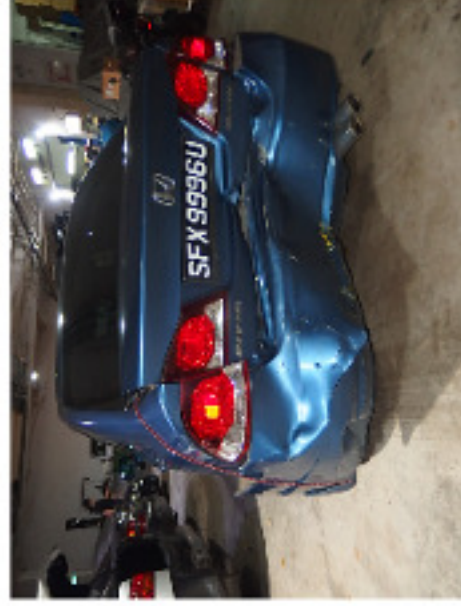
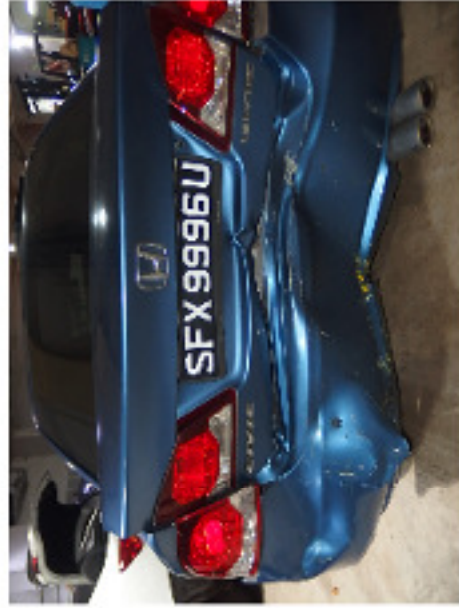
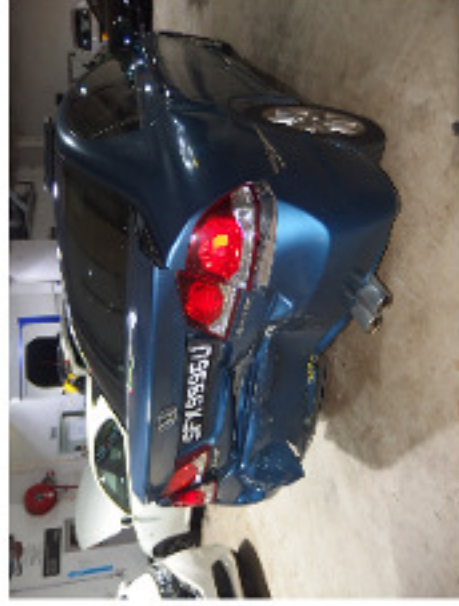
INSPECTION

| THE VEHICLE SUSUATINED DAMAGES AT THE REAR PORTION. THE CHASSIS FRAME AFFECTED DUE TO COLLISION.<br><br>DAMAGES SEE DETAILS. |

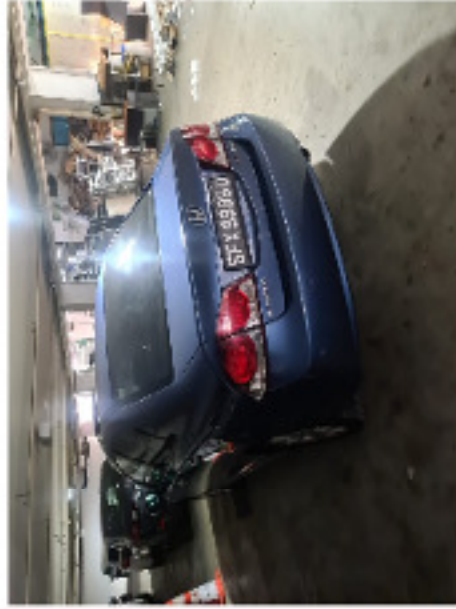
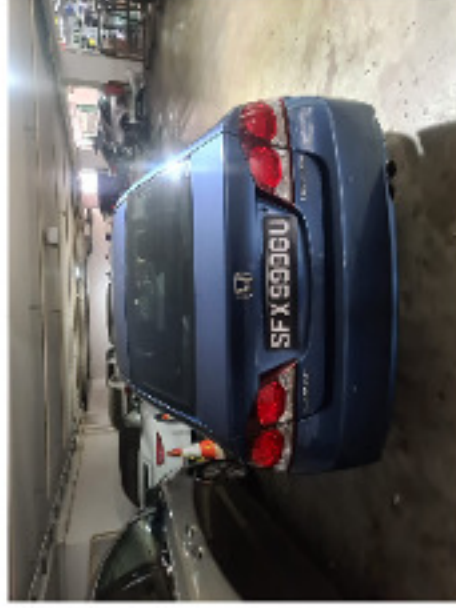
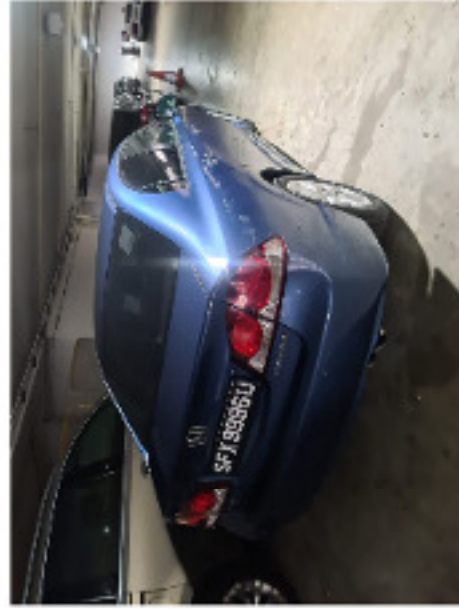
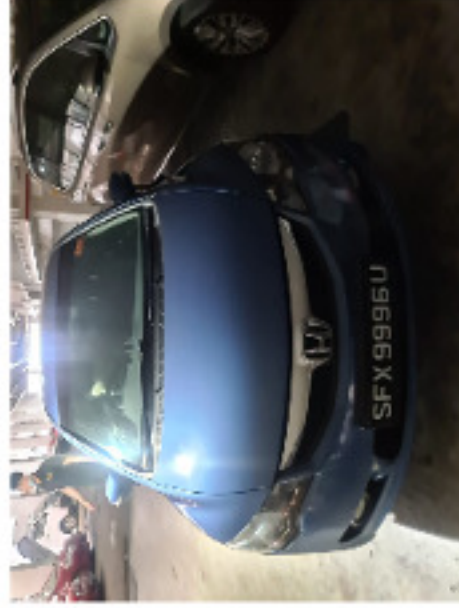
PHOTOGRAPHS FOR VEHICLE NO. SFX 9996U

RE-INSPECTION
