LKK Auto Consultants Pte Ltd

Vehicle No. SJS 3172Z
Insured Veh. SHC 3157B
Claim No. D20003112MFSH/1
Policy No. D-20094922MFSH
Accident Date 05/08/2020
Inspection Date 12/08/2020

ADJUSTMENT ON REPAIR COST FOR VEHICLE NO. SJS 3172Z

PHOTOGRAPHS FOR VEHICLE NO. SJS 3172Z

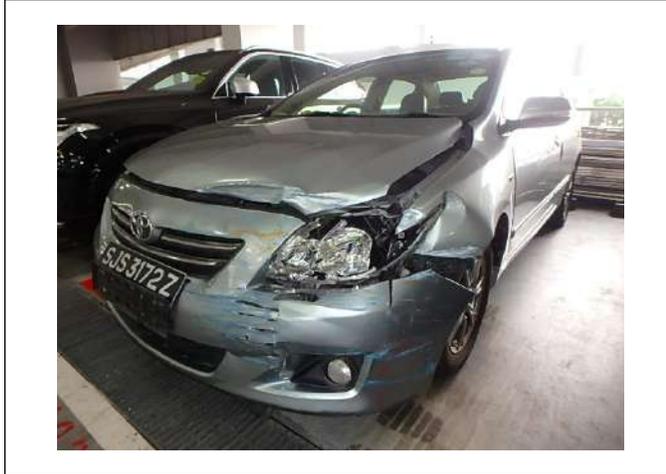
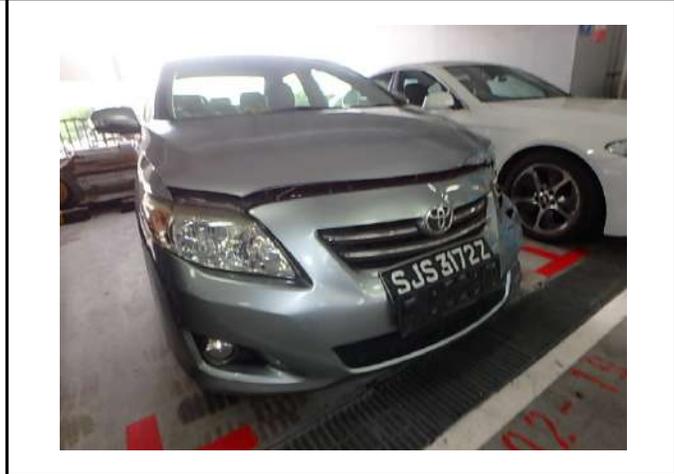
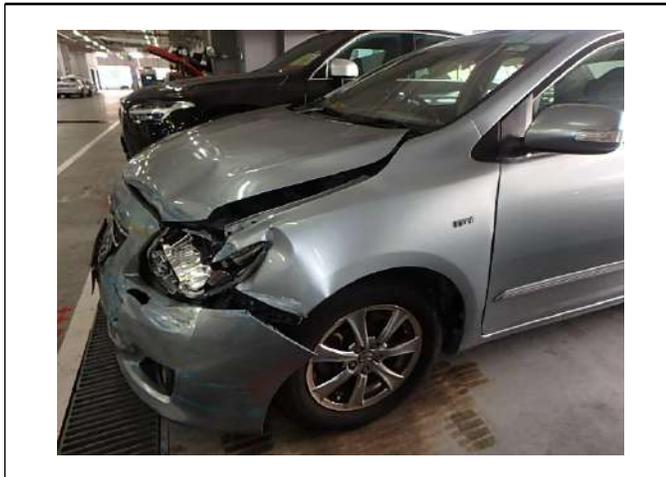
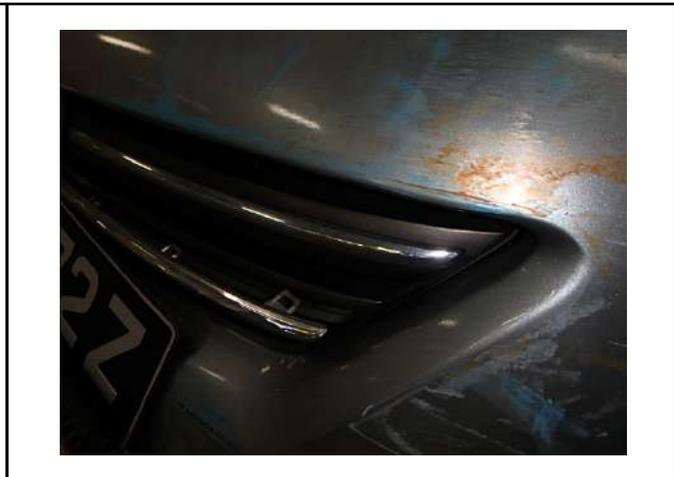
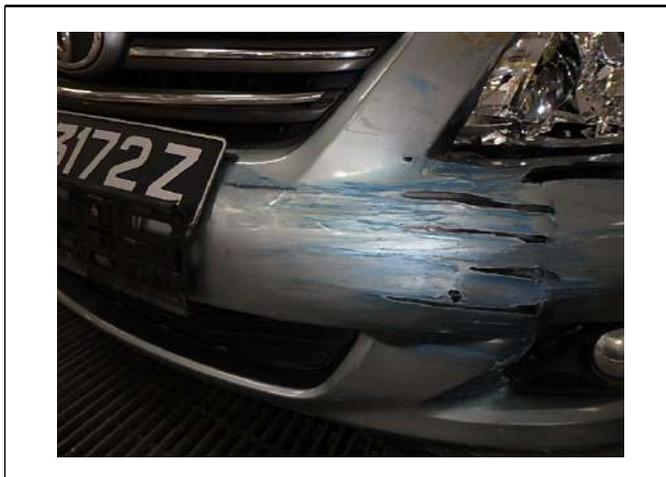
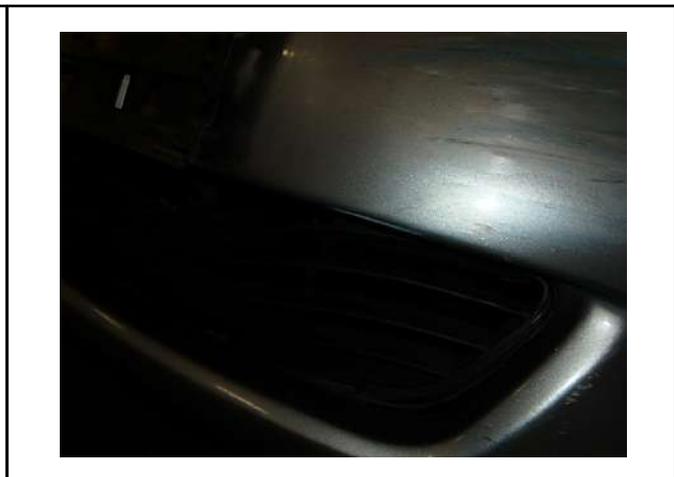
THE VEHICLE SUSTAINED DAMAGES AT THE FRONT N/S PORTION.
DAMAGES SEE DETAILS.

INSPECTION

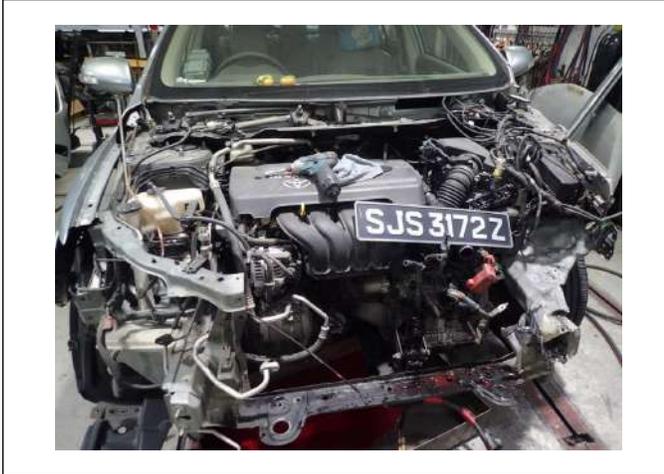
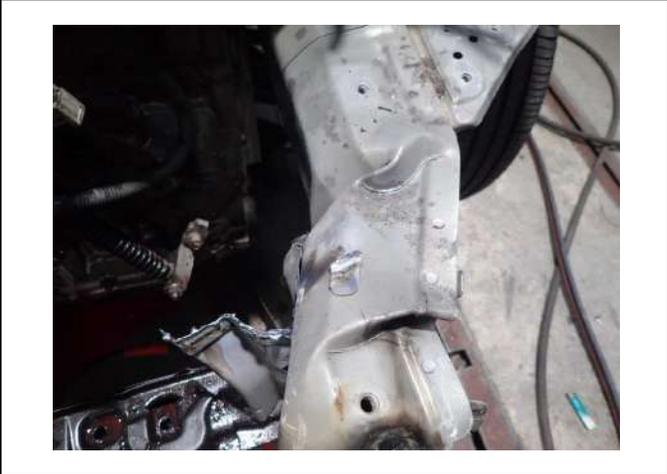
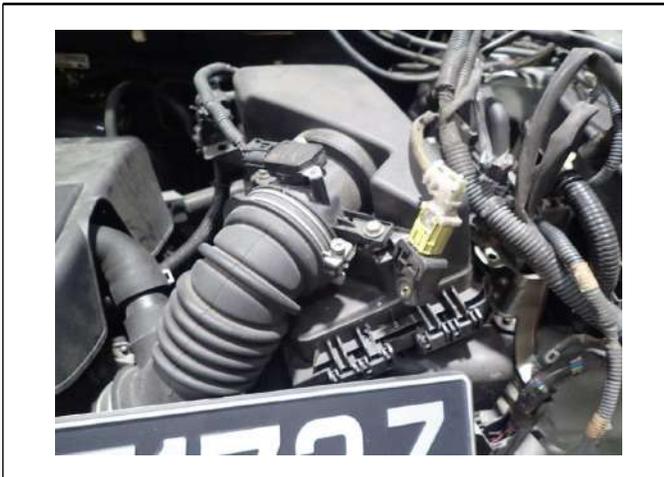
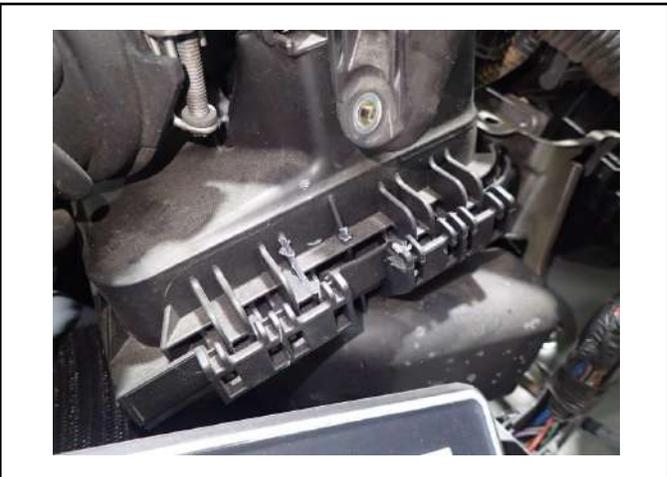
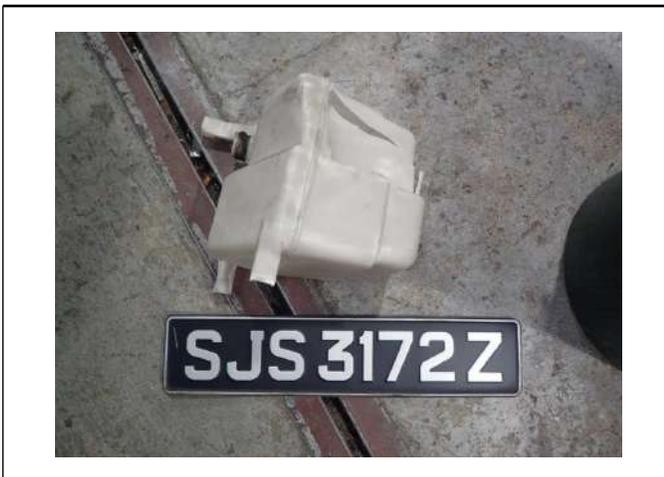
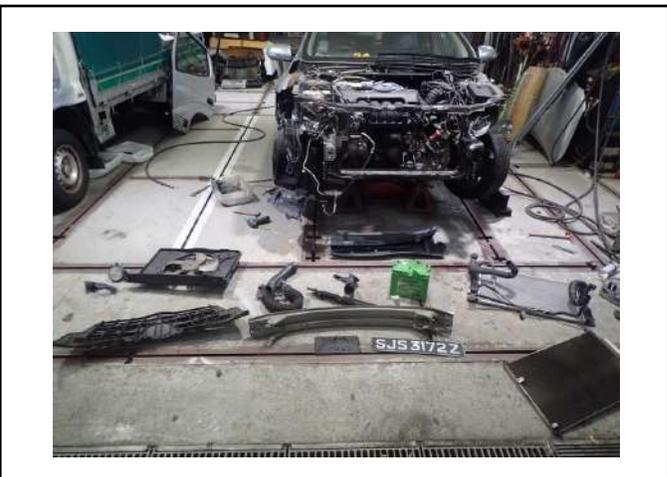
PHOTOGRAPHS FOR VEHICLE NO. SJS 3172Z

RE-INSPECTION
