Vehicle No. SJL 5611Y

ADJUSTMENT ON REPAIR COST FOR VEHICLE NO. SJL 5611Y

PHOTOGRAPHS FOR VEHICLE NO. SJL 5611Y

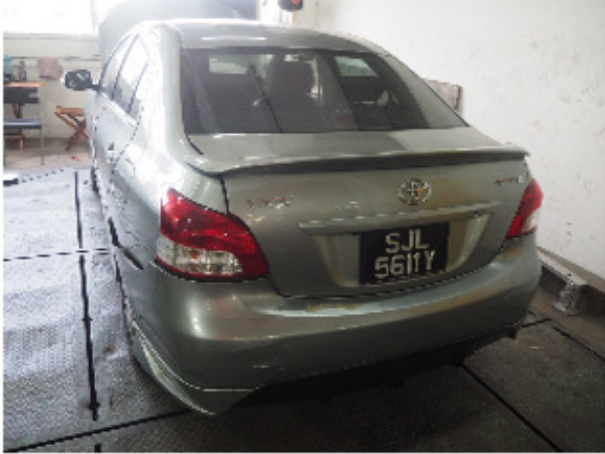
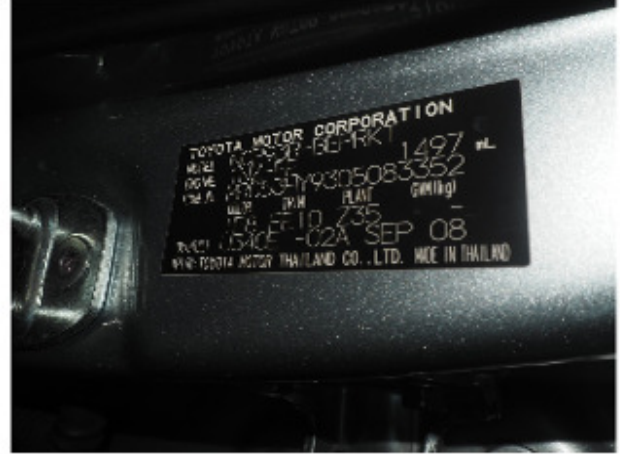
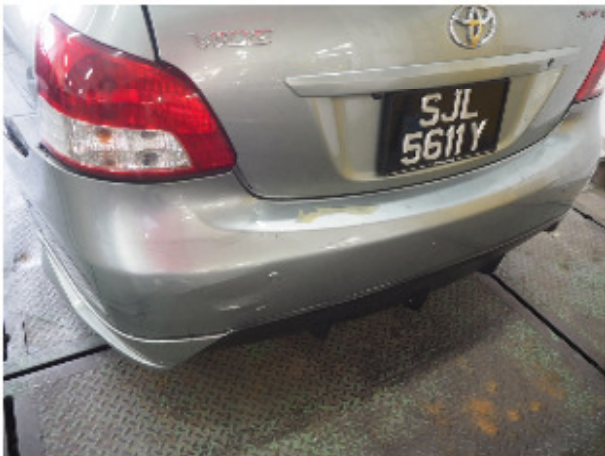
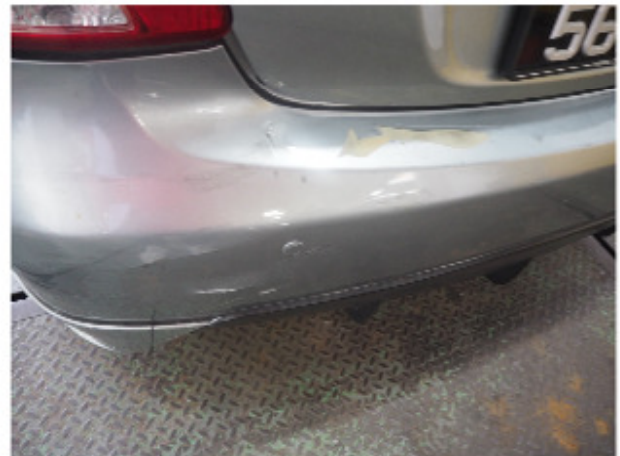
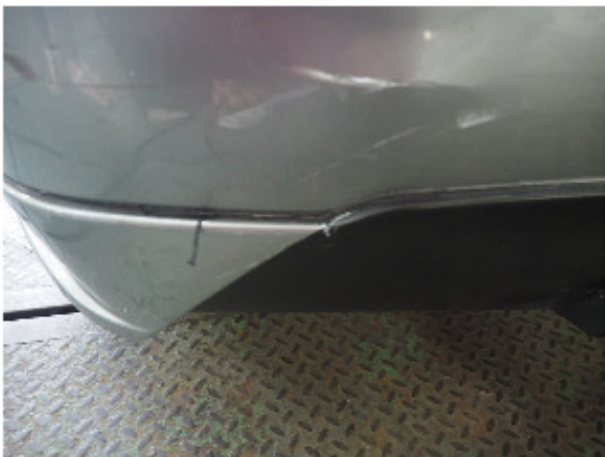
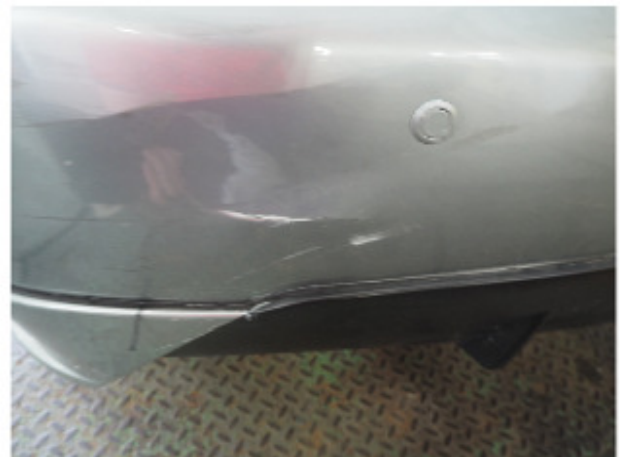
INSPECTION

THE VEHICLE SUSTAINED DAMAGES AT THE REAR PORTION. DAMAGES SEE DETAILS.
--

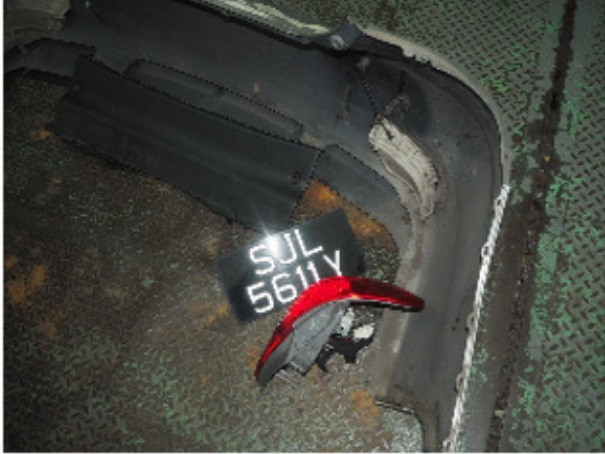
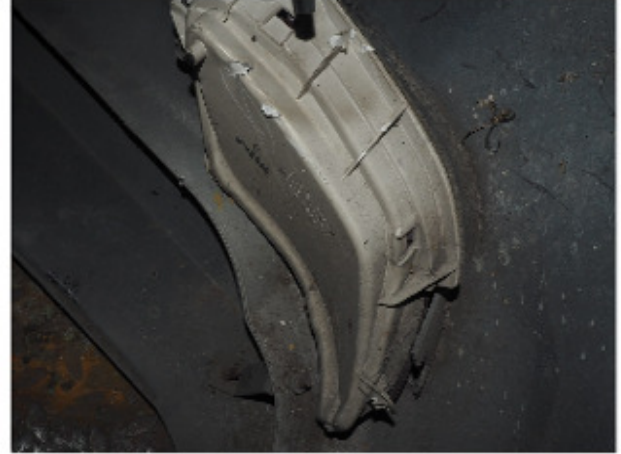
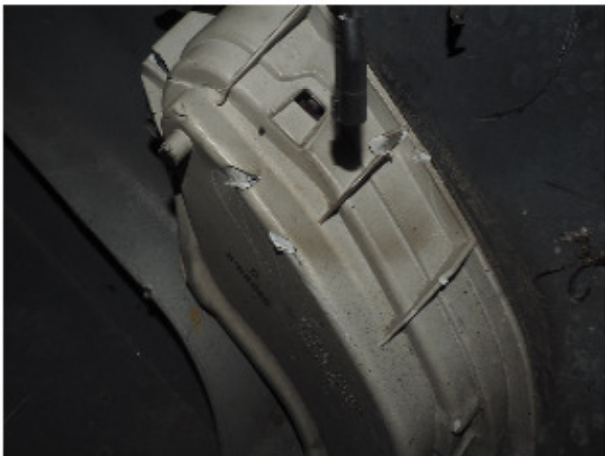
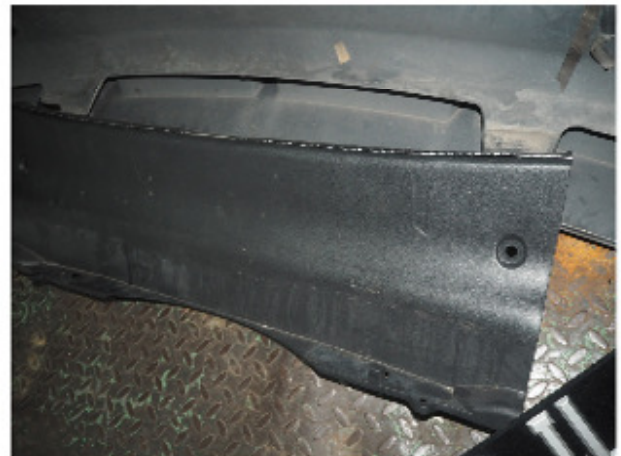
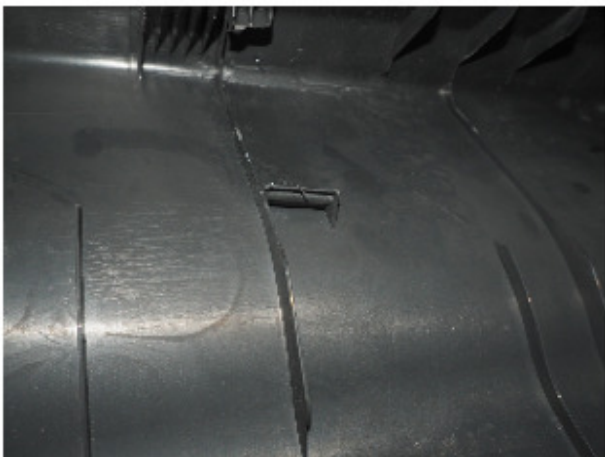
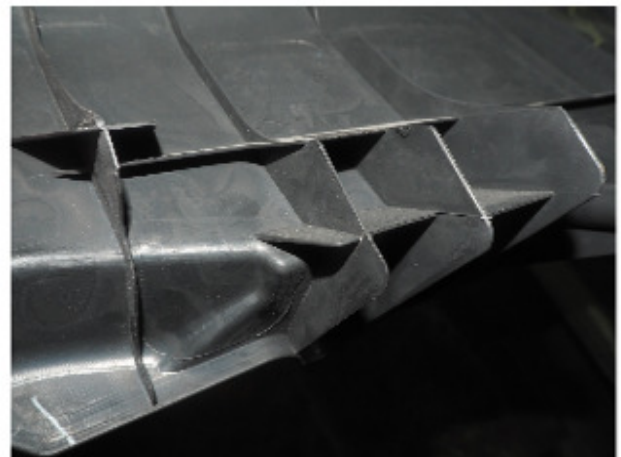
RE-INSPECTION

PHOTOGRAPHS FOR VEHICLE NO. SJL 5611Y
