### ADJUSTMENT ON REPAIR COST FOR VEHICLE NO. SLS 5009B

PHOTOGRAPHS FOR VEHICLE NO. SLS 5009B

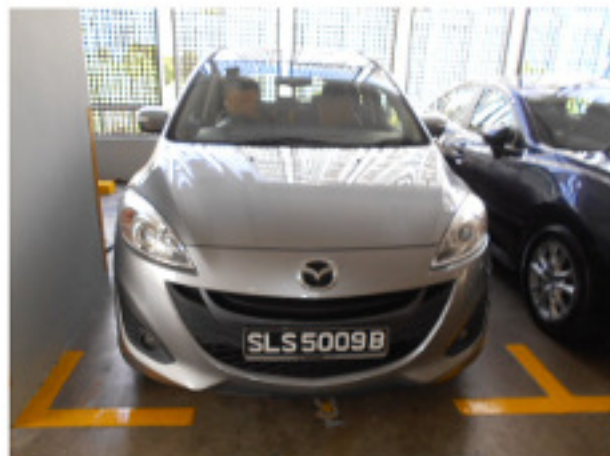
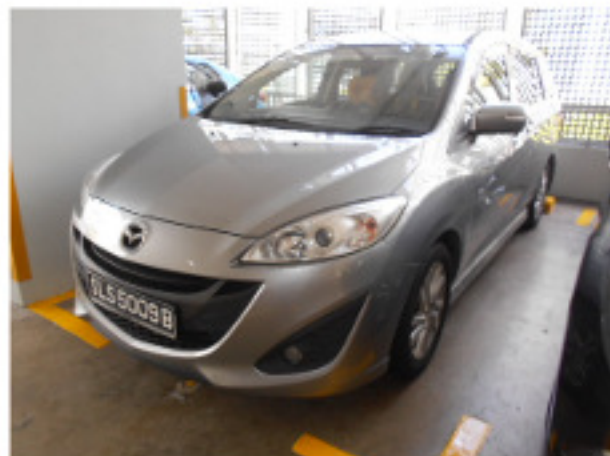
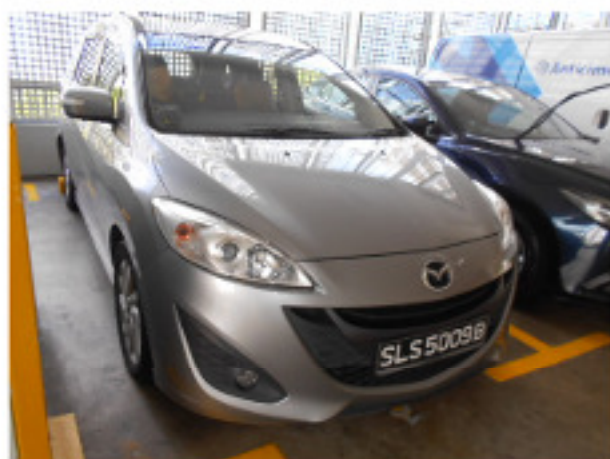
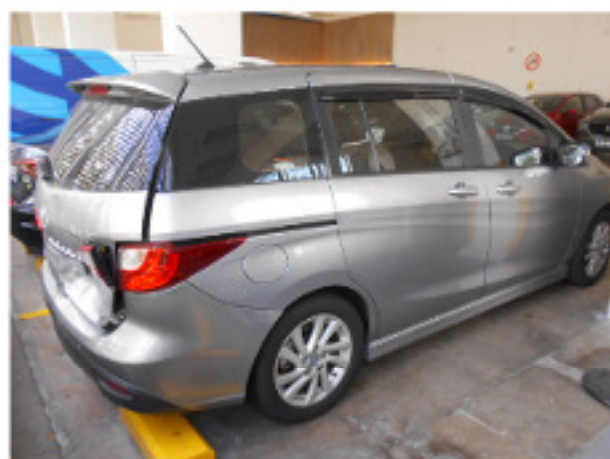
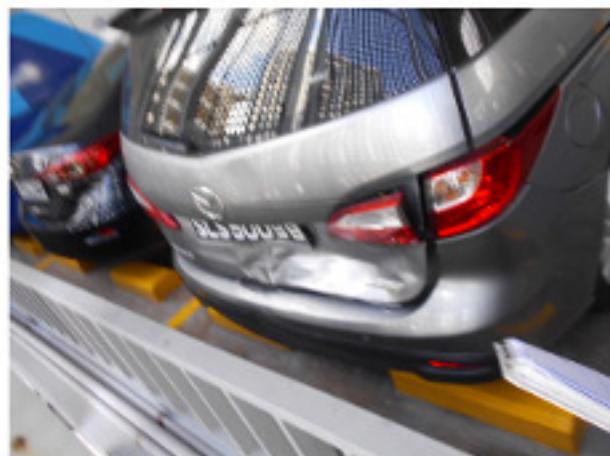
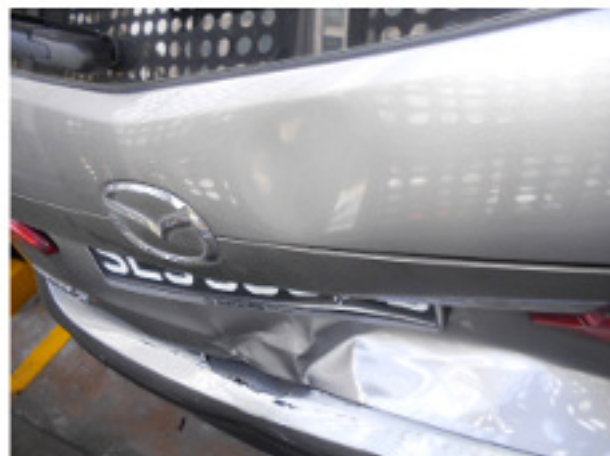
<b>R/H Front Tyre</b>	205/55 R16	MICHELIN	6 mm
	<b>L/H Front Tyre</b>	205/55 R16	MICHELIN	6 mm
	<b>R/H Rear Tyre</b>	205/55 R16	MICHELIN	6 mm
	<b>L/H Rear Tyre</b>	205/55 R16	MICHELIN	6 mm
<b>4. Description of Damages</b>				
	THE VEHICLE SUSTAINED DAMAGES AT THE REAR PORTION. DAMAGES SEE DETAILS.			
<b>5. General Information</b>				
	<b>Accident Date</b>	12/08/2020	<b>Inspection Date</b>	17/08/2020
	<b>Survey held at</b>	ETHOZ PROTECT PTE LTD 30 BUKIT BATOK CRESCENT SINGAPORE 658075		
<b>5a. Remarks</b>				
	A)THE INSPECTION WAS CONDUCTED ON A"WITHOUT PREJUDICE" BASIS. B)IN ACCORDANCE TO YOUR INSTRUCTIONS, WE HAVE NOT AUTHORISED REPAIRS.			
<b>5b. Estimate Days of Repair</b>				
	ESTIMATED NORMAL PERIOD FOR REPAIR:		<b>7 Working Days</b>

INSPECTION

Qty	Description of Parts	Condition	Estimate By Workshop (\$))	Our Adjusted (\$)
<b><u>REPLACEMENT OF PARTS</u></b>				
1	REAR BUMPER	CRACKED	951.40	951.40
1	REAR BUMPER REINFORCEMENT	BENT	311.50	311.50
2	REAR BUMPER RETAINER	SERVICEABLE	150.60	-
2	REAR BUMPER BRACKET	CRACKED	116.60	58.30
10	REAR BUMPER CLIPS	NECESSARY	50.00	50.00
2	REAR BUMPER REFLECTOR	SERVICEABLE	170.80	-
1	END PANEL	BENT	491.10	491.10
1	END PANEL TOP GARNISH	DEFORMED	161.40	161.40
1	TAILGATE ASSY	BENT	1,955.00	1,955.00
1	TAILGATE GARNISH	DEFORMED	659.40	659.40
1	TAILGATE TRIMBOARD	SERVICEABLE	592.80	-
1	REAR LOGO	NECESSARY	86.10	86.10
1	EMBLEM - MAZDA 5	NECESSARY	121.70	121.70
1	EMBLEM - SKYACTIV	NECESSARY	99.80	99.80
1	TAILGATE LOCK	BENT	426.50	426.50
1	TAILGATE WEATHERSTRIPE	NECESSARY	396.00	396.00
1	REAR WINDSCREEN MOULDING	NECESSARY	87.60	87.60
2	TAILGATE LAMP RH/LH	N/S SERVICEABLE / O/S CRACKED	979.80	489.90
2	TAILLAMP RH/LH (N/S NOT NECESSARY)	O/S SERVICEABLE / N/S OLD DAMAGE	1,346.00	-
