TAX INVOICE

ADJUSTMENT ON REPAIR COST FOR VEHICLE NO. SLC 2565R

PHOTOGRAPHS FOR VEHICLE NO. SLC 2565R

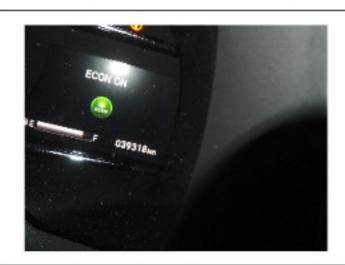
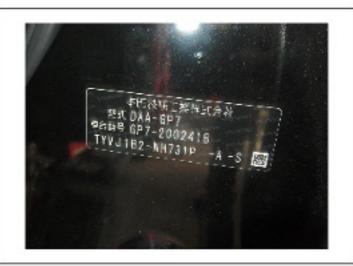
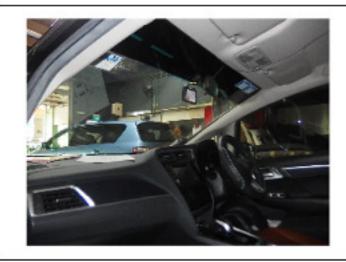
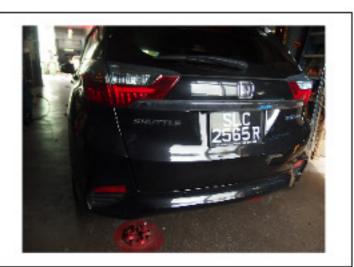
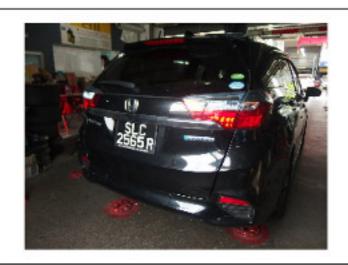
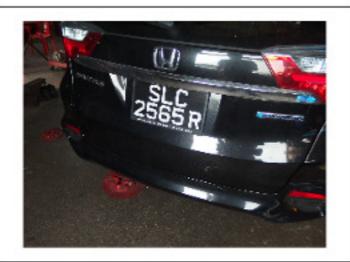
4.		·	on of Damages	
	THE VEHICLE SUS	STAINED DAMAGES AT THE REA	AR PORTION.	
	DAMAGES SEE DI	ETAILS.		
5.		General	Information	
	Accident Date	08/08/2020	Inspection Date	19/08/2020
	Survey held at	T K LEE AUTOMOTIVE PTE LTE)	
		NO. 1 KAKI BUKIT AVE 6 #02-47 AUTOBAY SINGAPORE 417883		
5a.		Re	emarks	
		ON WAS CONDUCTED ON A"WIT CE TO YOUR INSTRUCTIONS, WI		REPAIRS.
5b.	Estimate Days of Repair			
	ESTIMATED NOR	MAL PERIOD FOR REPAIR:	3 Working Days

INSPECTION

415.00	235.00
	<u>LABOUR</u>			
	TO KNOCK OUT DENT, CUT/WELD REAR PANEL AND REPLACE ACCIDENT PARTS. INCLUSIVE OF THE REPAIR OF REAR TAILGATE AND REAR END PANEL.		700.00	400.00
	TO SPRAY PAINTING ON ACCIDENT PORTION.		900.00	580.00
	TO CHECK WIRING.		20.00	20.00
	TO REMOVE,REFIX REAR WINDSCREEN.	NOT NECESSARY	120.00	-
	TO TRANSFER REAR TAILGATE PARTS.	NOT NECESSARY	100.00	-
	TO REMOVE,REFIX INNER TRIM.		60.00	60.00
	TO REMOVE,REPLACE REVERSE SENSOR.		80.00	50.00

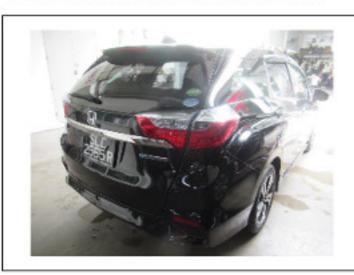
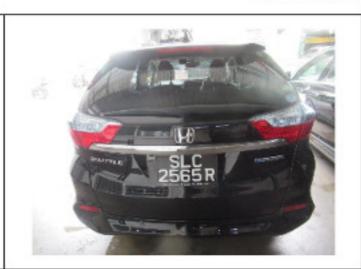
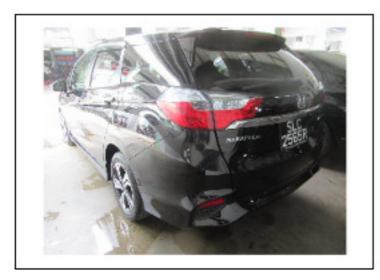
PHOTOGRAPHS FOR VEHICLE NO. SLC 2565R

RE-INSPECTION
