## LKK Auto Consultants Pte Ltd

### PROFESSIONAL SERVICE FEE

Vehicle No. SMM 4921T  
Insured Veh. SHA 9380T  
Claim No. D20003249MFSH  
Policy No. D-20094921MFSH  
Accident Date 14/08/2020  
Inspection Date 19/08/2020

## ADJUSTMENT ON REPAIR COST FOR VEHICLE NO. SMM 4921T

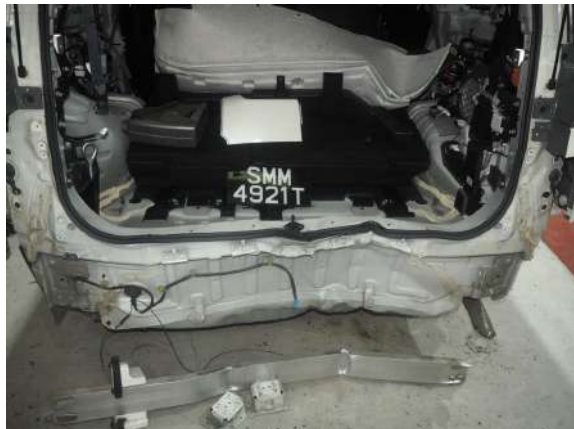
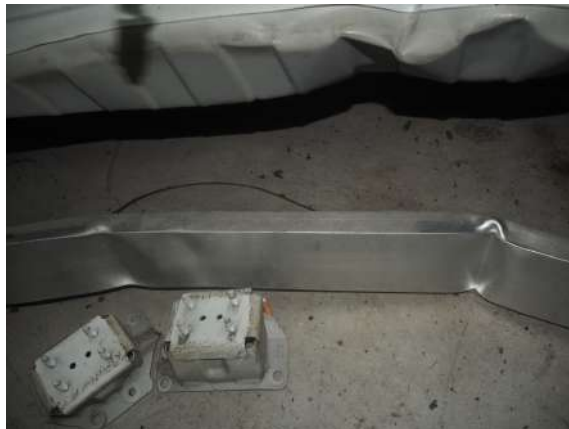
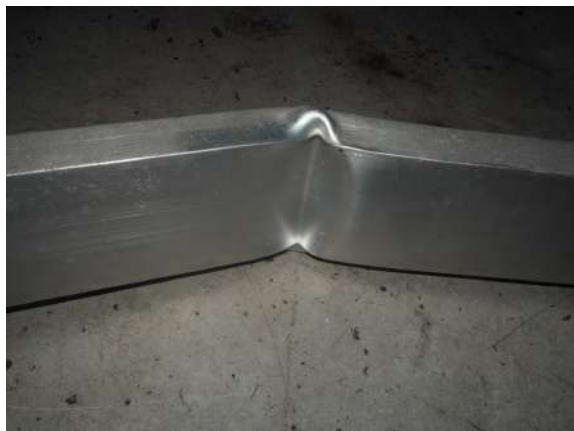
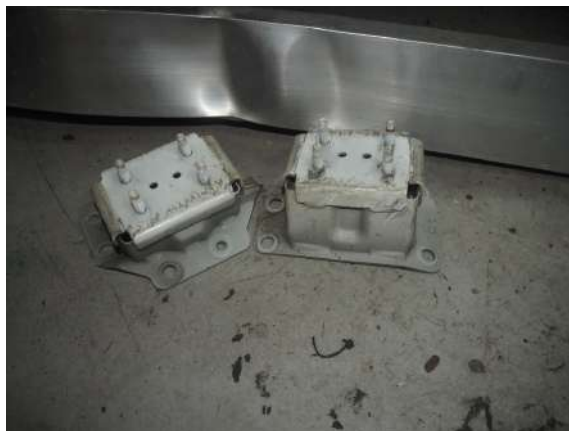
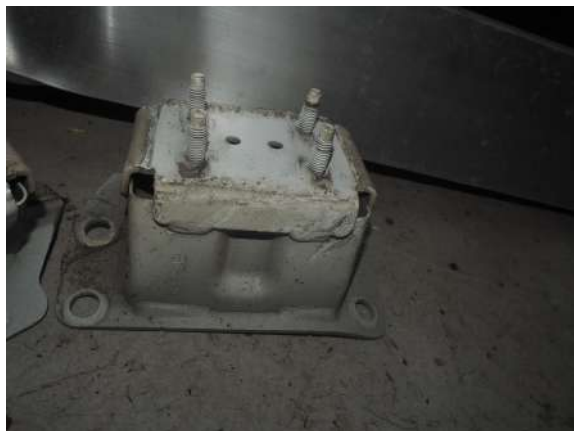
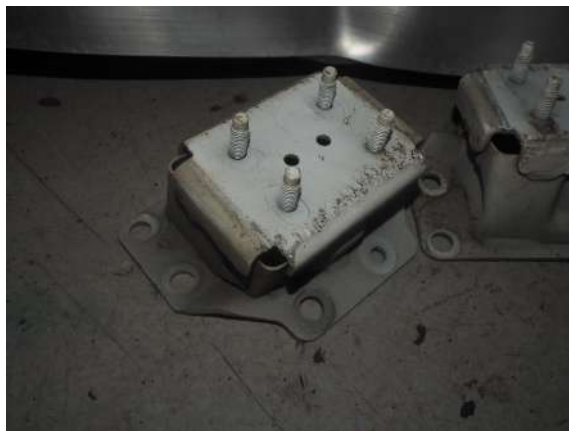
PHOTOGRAPHS FOR VEHICLE NO. SMM 4921T

| Affiliated to Federation Internationale Des Experts En Automobile | | | | |
|---|---|---|---|--|
| THE VEHICLE SUSTAINED DAMAGES AT THE REAR PORTION.<br>DAMAGES SEE DETAILS. | | | | |

RE-INSPECTION
