## LKK Auto Consultants Pte Ltd

### PROFESSIONAL SERVICE FEE

Vehicle No. SHC 5344P  
Insured Veh. SCM 1234G  
Claim No. SNM20D202917C02  
Policy No. DMPCSNA00056512007  
Accident Date 17/08/2020  
Inspection Date 18/08/2020

### ADJUSTMENT ON REPAIR COST FOR VEHICLE NO. SHC 5344P

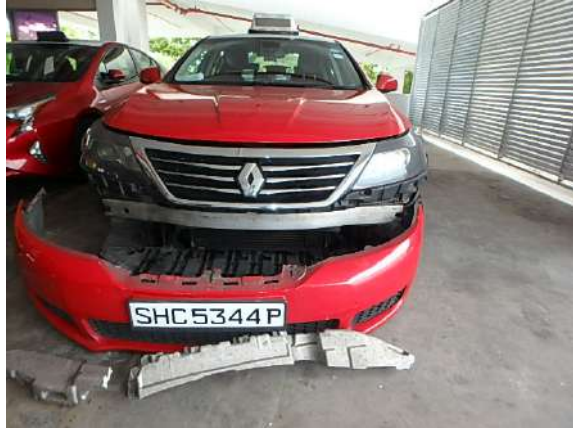
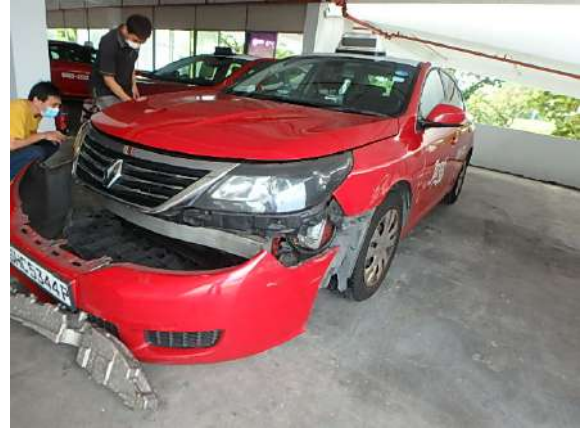
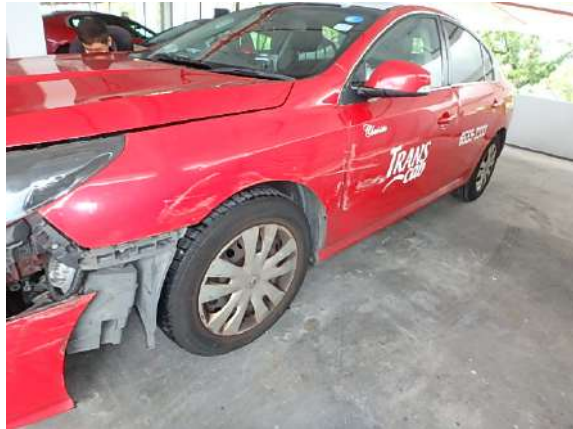
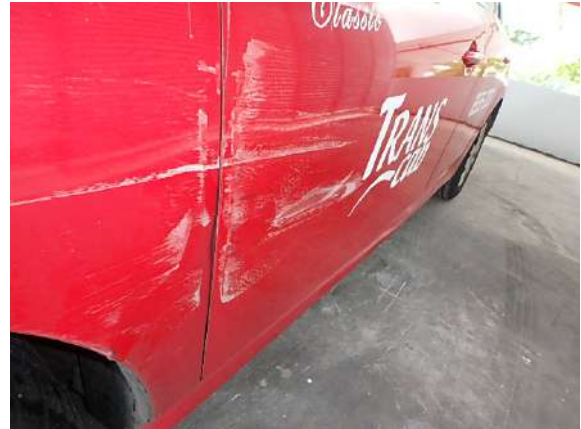
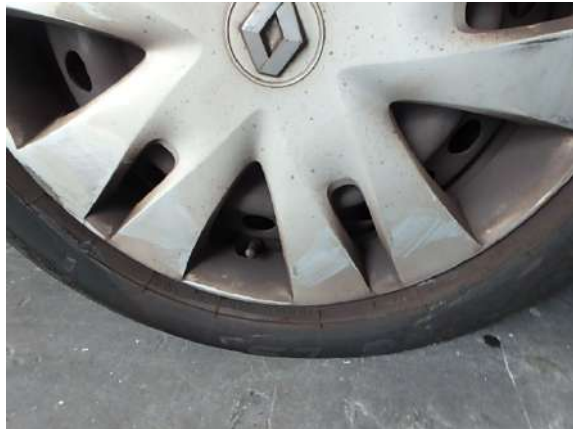
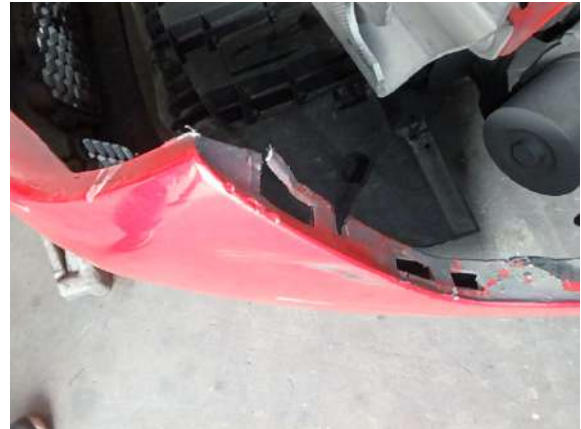
### PHOTOGRAPHS FOR VEHICLE NO. SHC 5344P

| Affiliated to Federation Internationale Des Experts En Automobile | | | | |
|---|---|---|---|--|
| THE VEHICLE SUSTAINED DAMAGES AT THE N/S FRONT BODY.<br>DAMAGES SEE DETAILS. | | | | |

### INSPECTION
