Vehicle No. SMH 2387A

### 4. Description of Damages

## ADJUSTMENT ON REPAIR COST FOR VEHICLE NO. SMH 2387A

PHOTOGRAPHS FOR VEHICLE NO. SMH 2387A

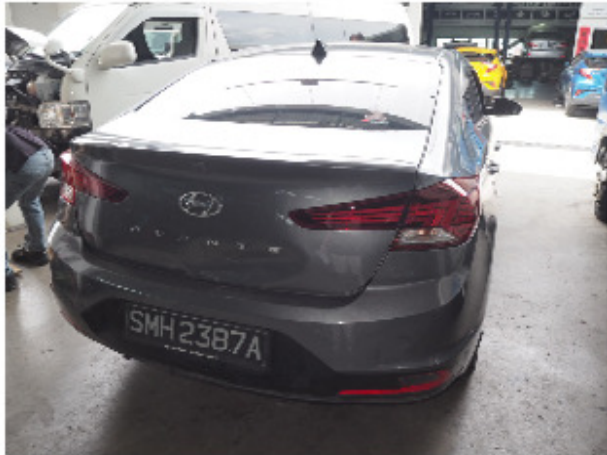
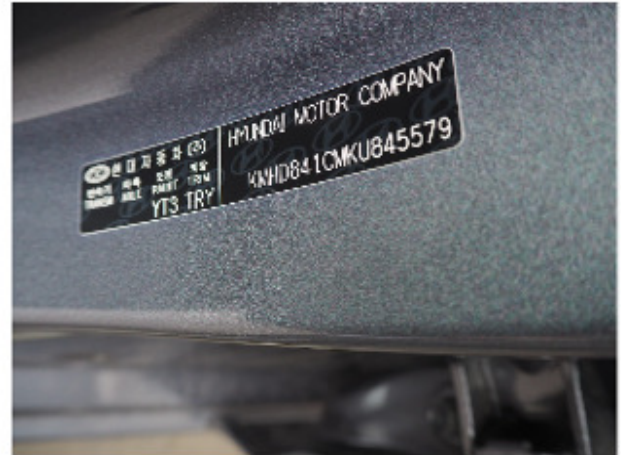
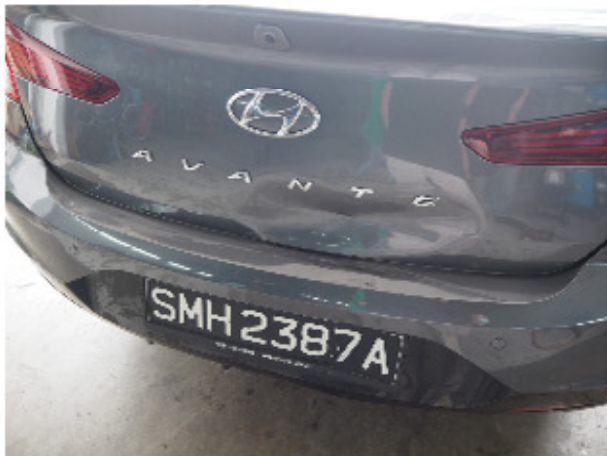
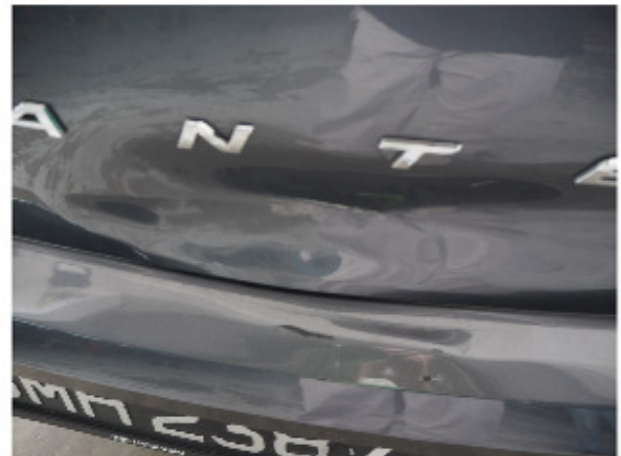
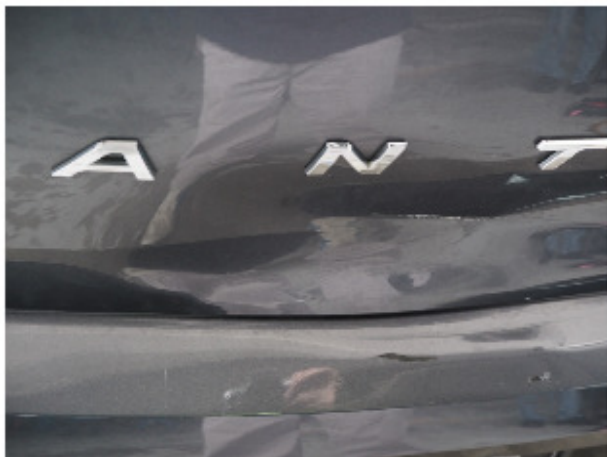
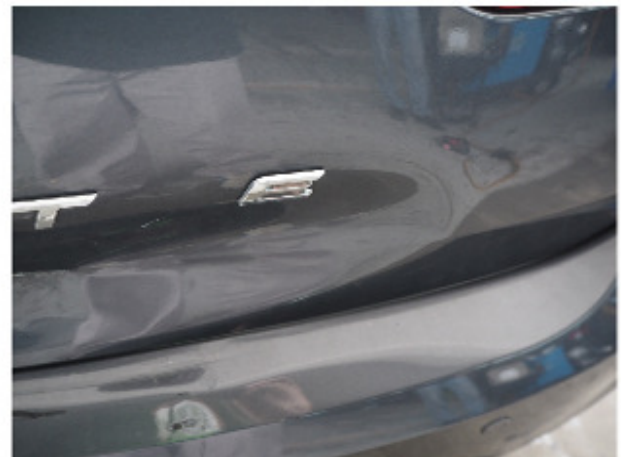
INSPECTION

THE VEHICLE SUSTAINED DAMAGES AT THE REAR PORTION. DAMAGES SEE DETAILS.
--

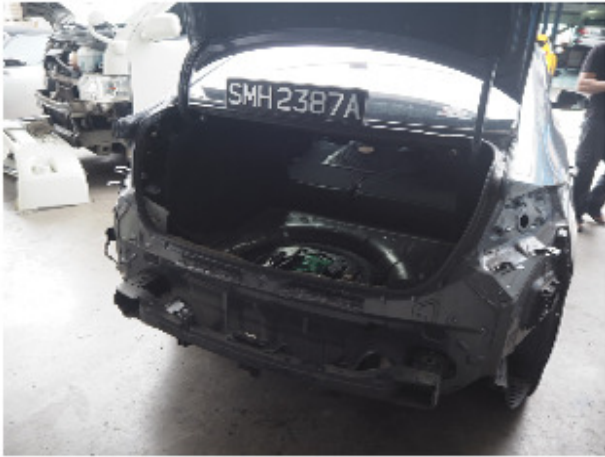
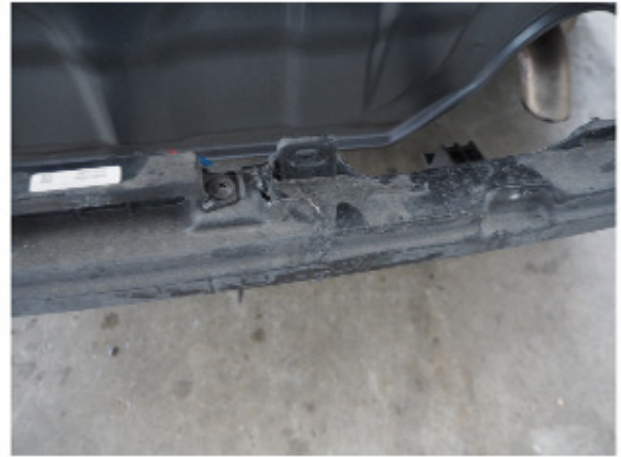
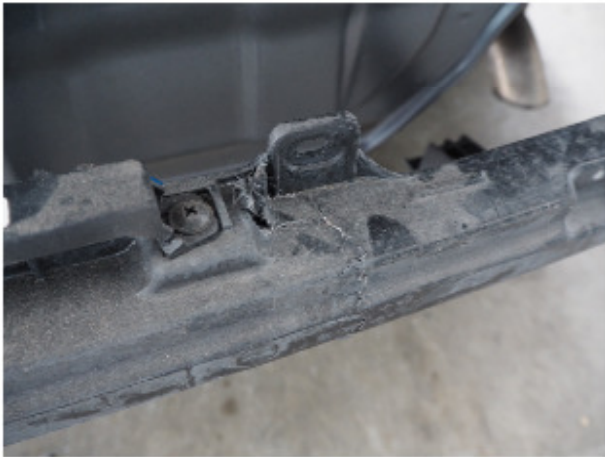
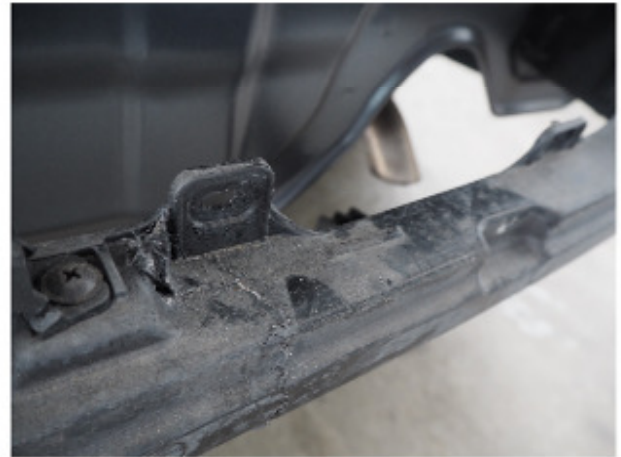
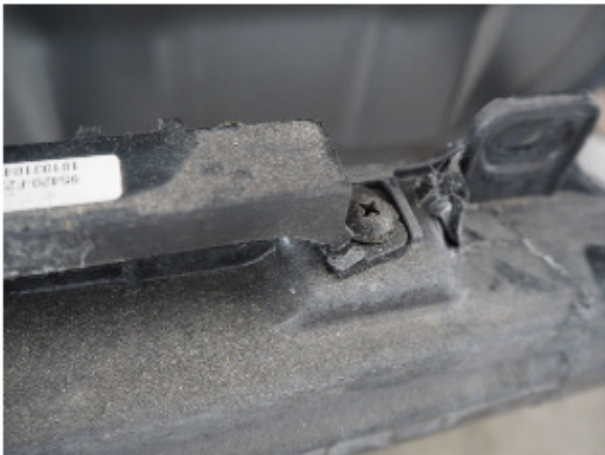
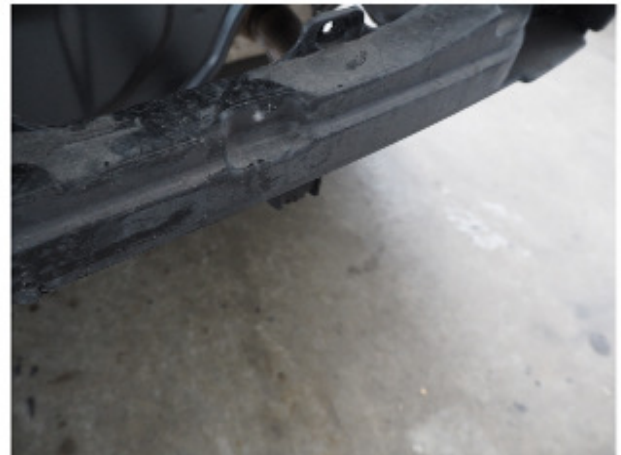
RE-INSPECTION

PHOTOGRAPHS FOR VEHICLE NO. SMH 2387A
