### ADJUSTMENT ON REPAIR COST FOR VEHICLE NO. SMS 8870Z

PHOTOGRAPHS FOR VEHICLE NO. SMS 8870Z

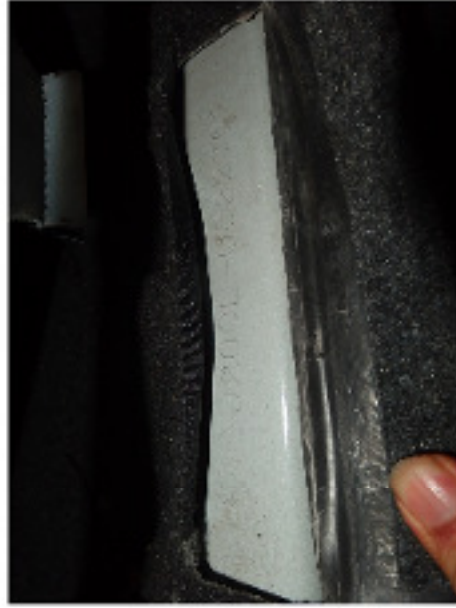
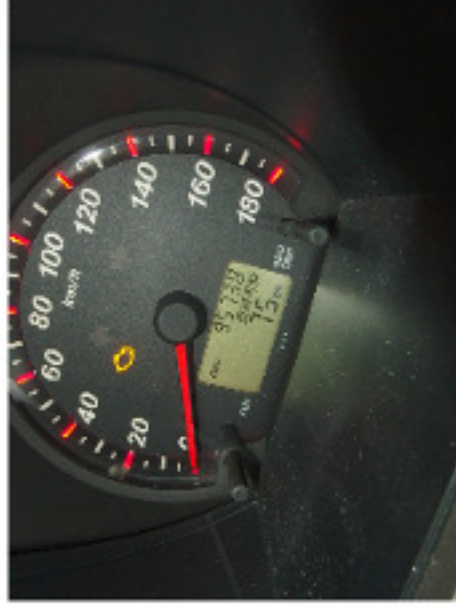
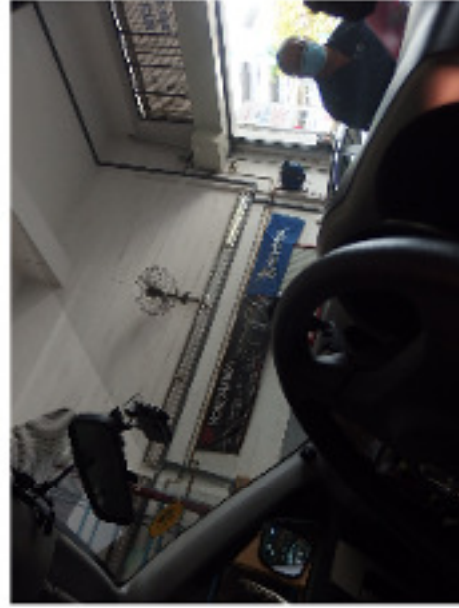
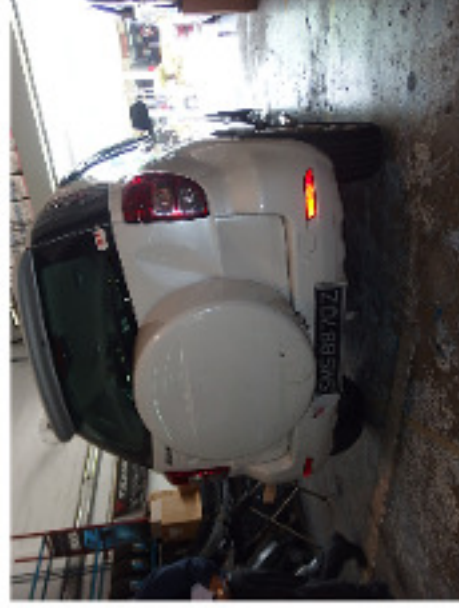
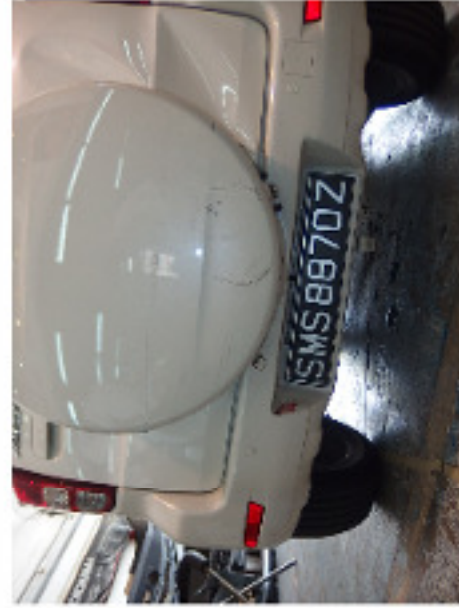
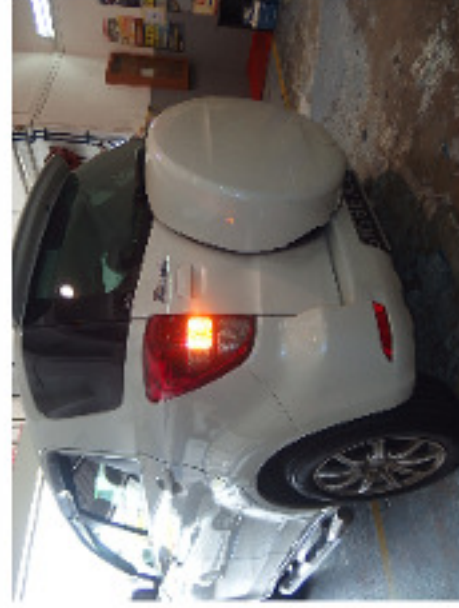
INSPECTION

<b>4. Description of Damages</b>				
THE VEHICLE SUSTAINED DAMAGES AT THE REAR & FRONT PORTION. DAMAGES SEE DETAILS.				
<b>5. General Information</b>				
Accident Date	22/08/2020	Inspection Date	26/08/2020	
Survey held at	CAR CITY AUTO CENTRE PTE LTD BLK 9006 TAMPINES ST 93 #01-198 SINGAPORE 528840			
<b>5a. Remarks</b>				
A)THE INSPECTION WAS CONDUCTED ON A"WITHOUT PREJUDICE" BASIS. B)IN ACCORDANCE TO YOUR INSTRUCTIONS, WE HAVE NOT AUTHORISED REPAIRS.				
<b>5b. Estimate Days of Repair</b>				
ESTIMATED NORMAL PERIOD FOR REPAIR:		<b>5 Working Days</b>
