## LKK Auto Consultants Pte Ltd

## ADJUSTMENT ON REPAIR COST FOR VEHICLE NO. SHB 1432A

### PHOTOGRAPHS FOR VEHICLE NO. SHB 1432A

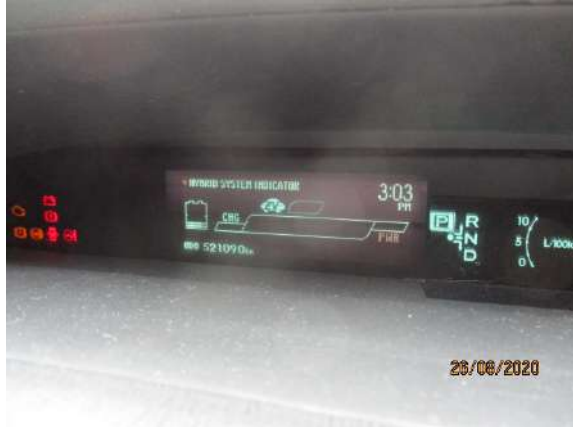
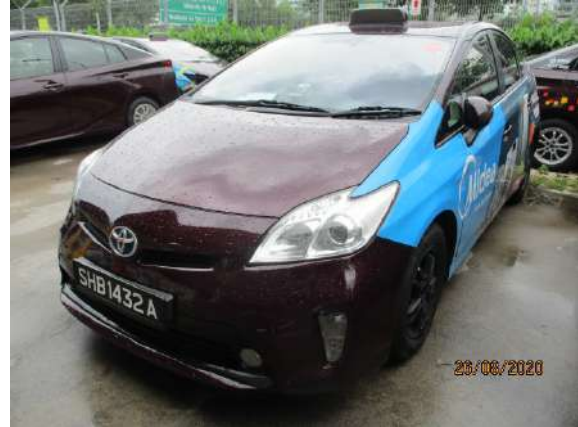
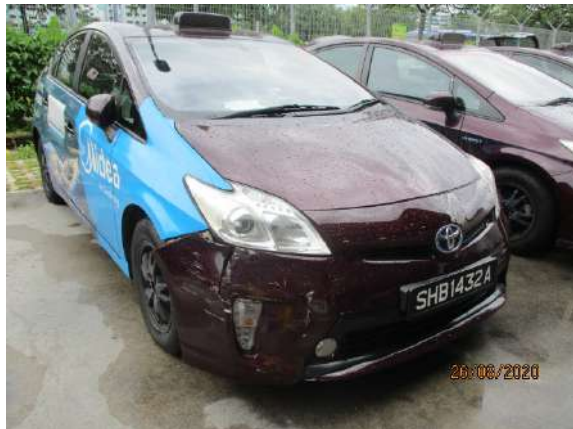
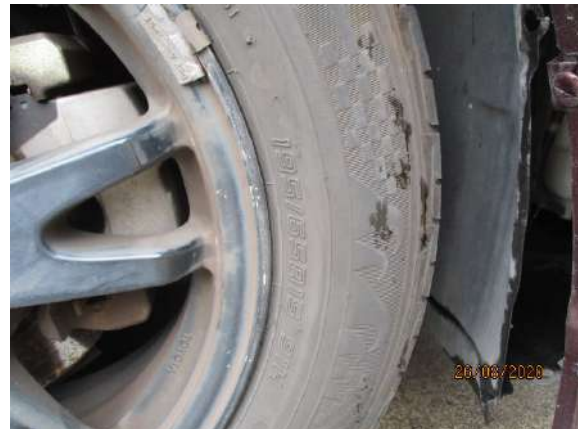
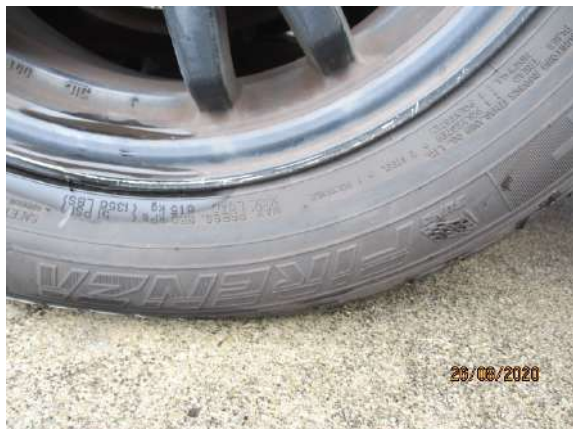
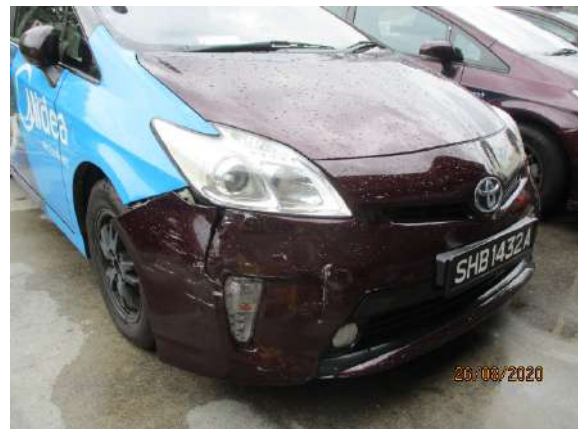
### INSPECTION

| Affiliated to Federation Internationale Des Experts En Automobile | | | | |
|---|---|---|---|--|
| THE VEHICLE SUSTAINED DAMAGES AT THE FRONT O/S PORTION.<br>DAMAGES SEE DETAILS. | | | | |

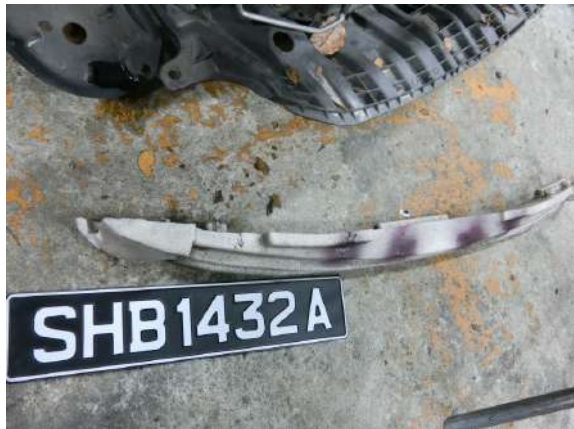
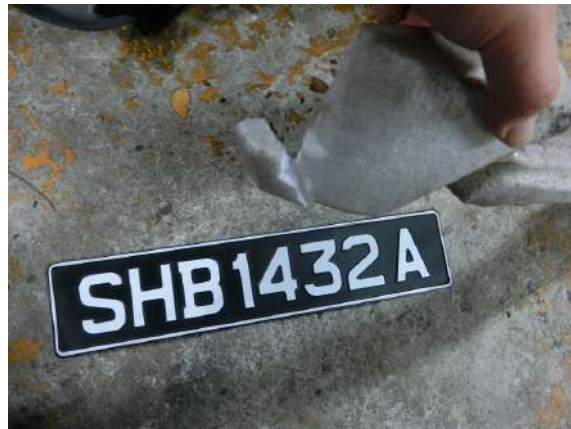
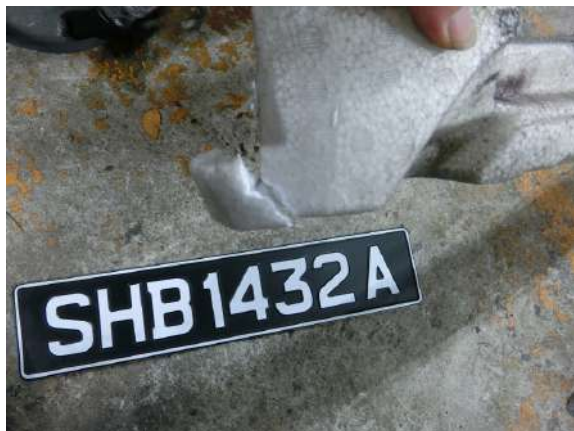
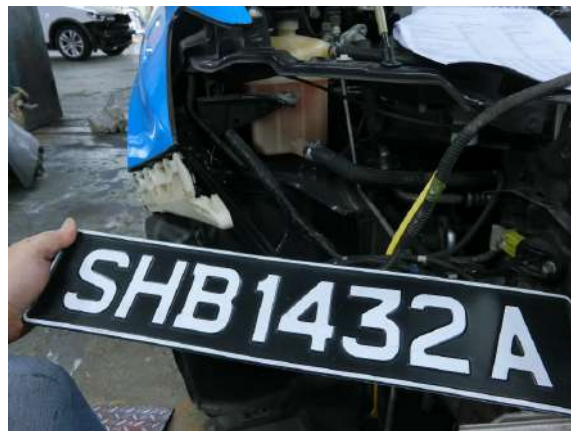
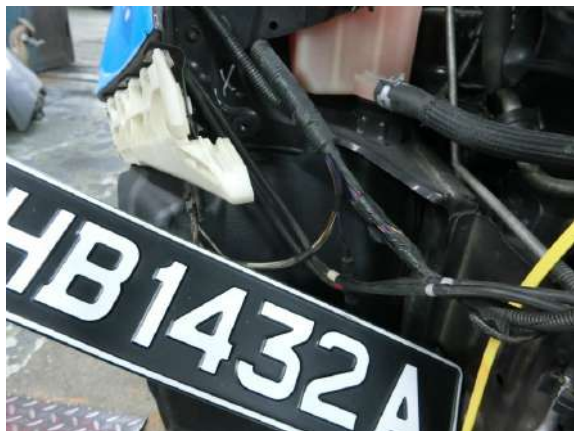
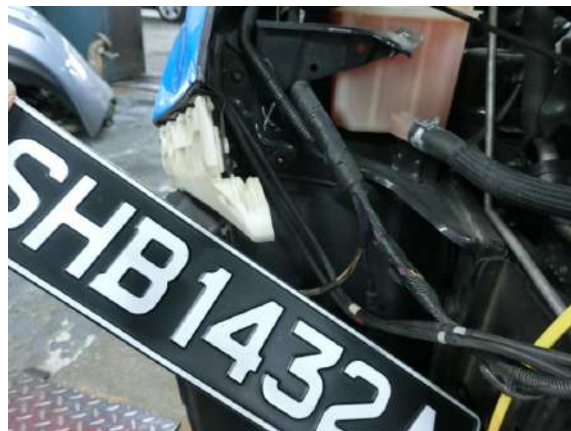
RE-INSPECTION

PHOTOGRAPHS FOR VEHICLE NO. SHB 1432A
