Date : 10-Feb-20  
Model : Mercedes Benz CLA180

# MC-COY

Report Reference : **TP / 19019-12/MY / 2019**  
Date of Report : **10 Feb 2020**

**THIRD PARTY SURVEY**  
**ACCIDENT HAPPENED ON 4 Dec 2019**

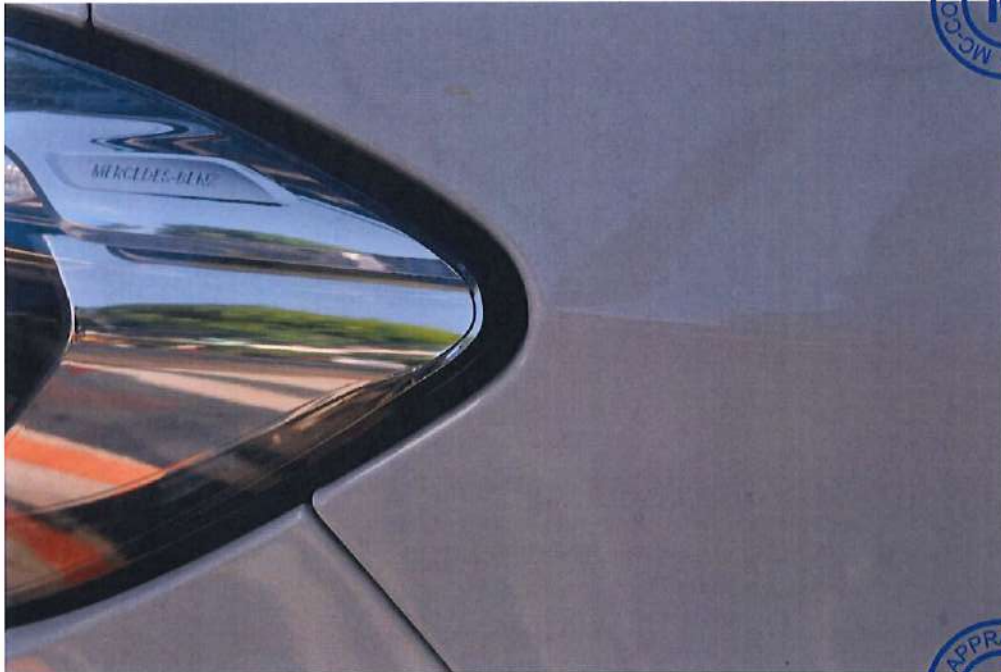
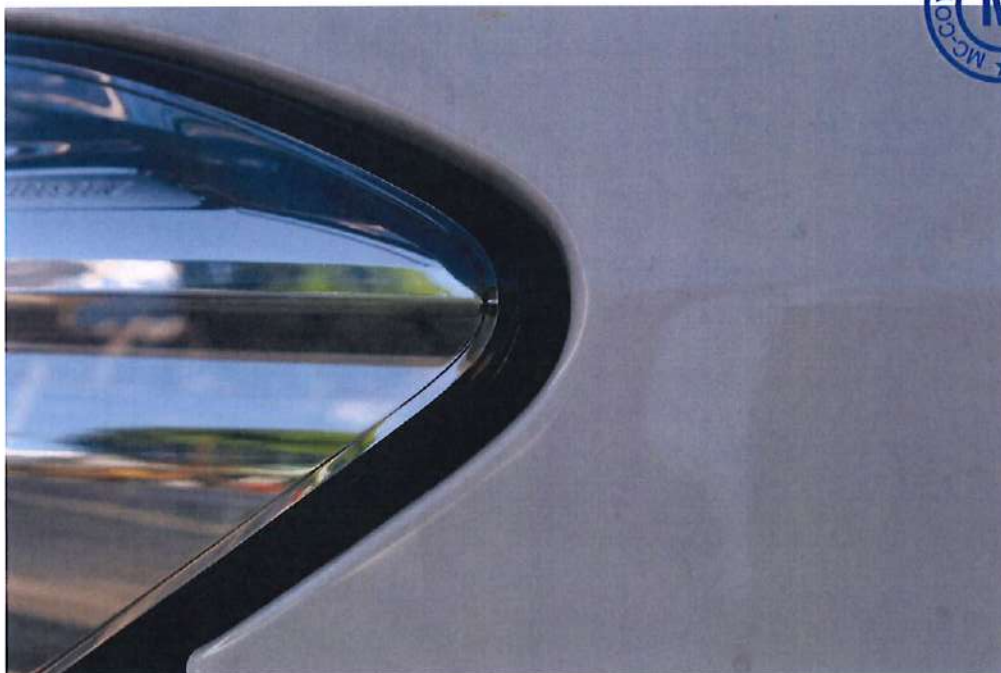
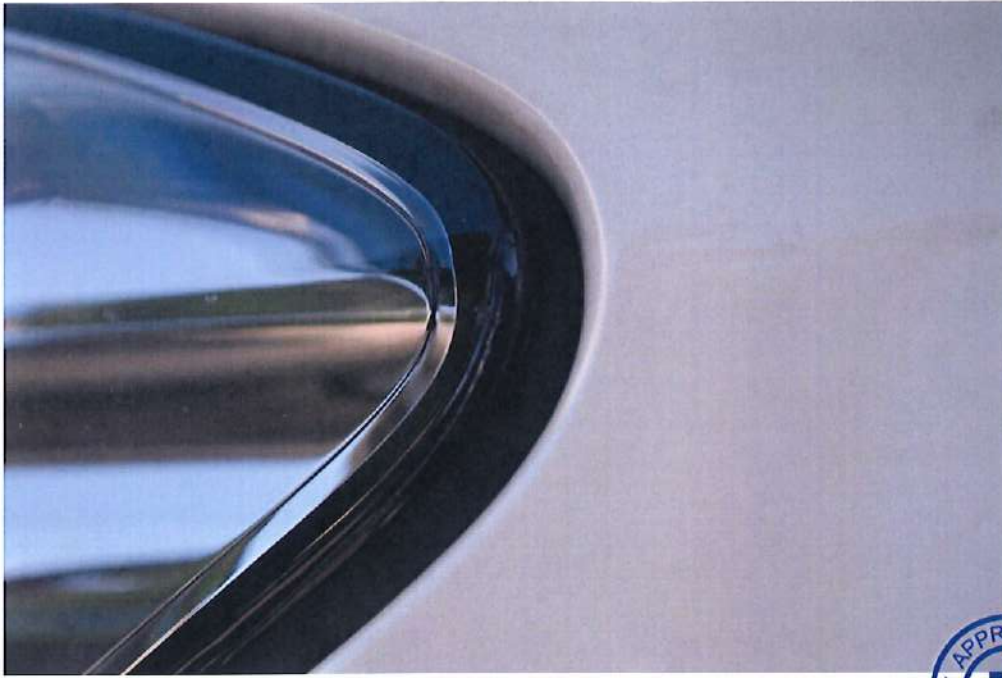
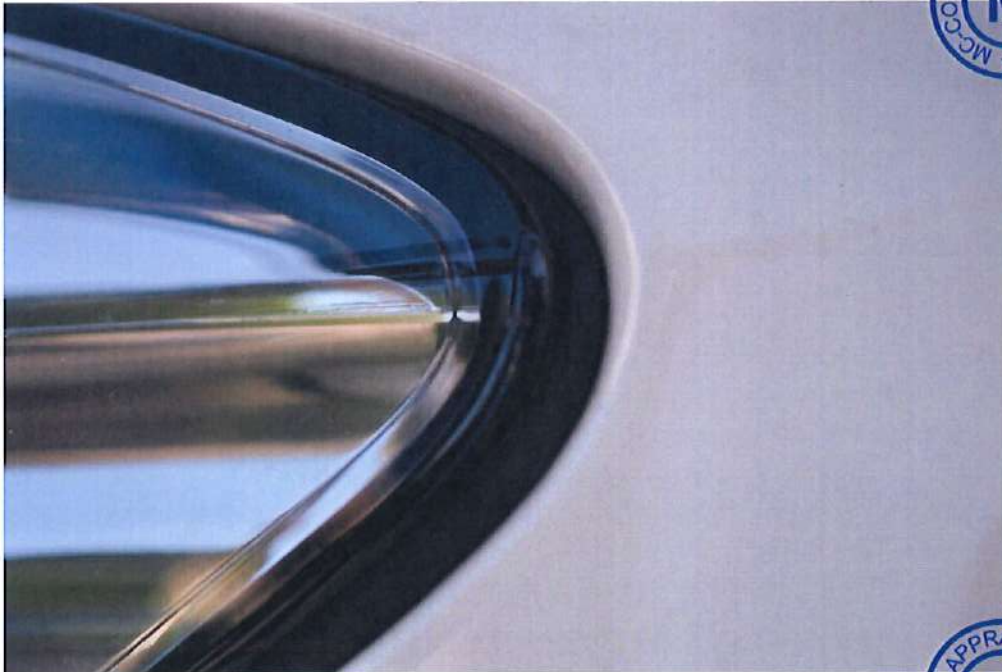
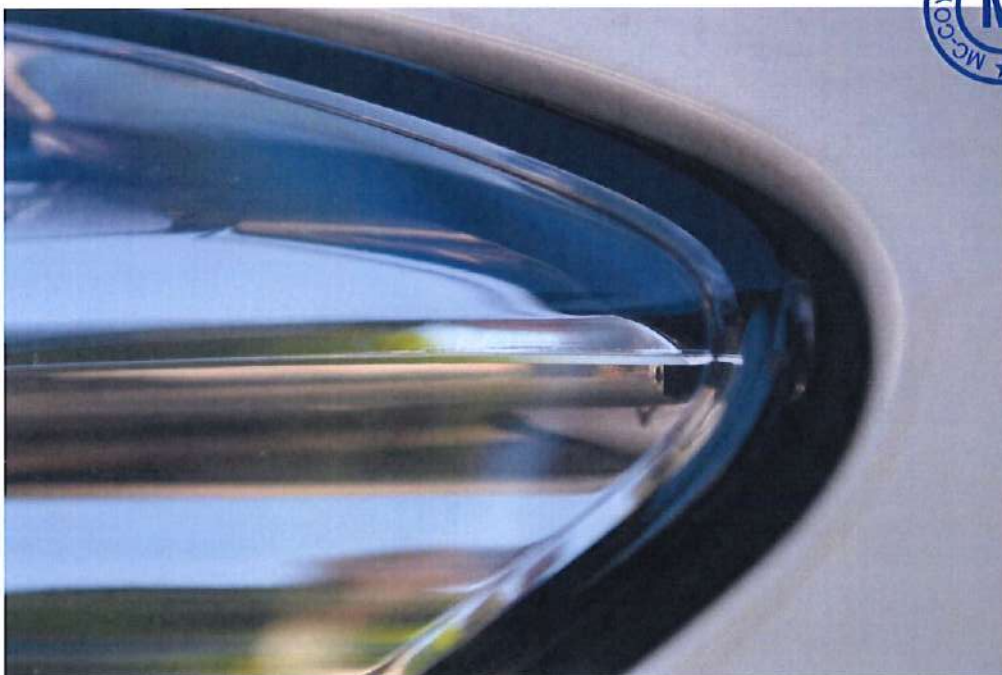
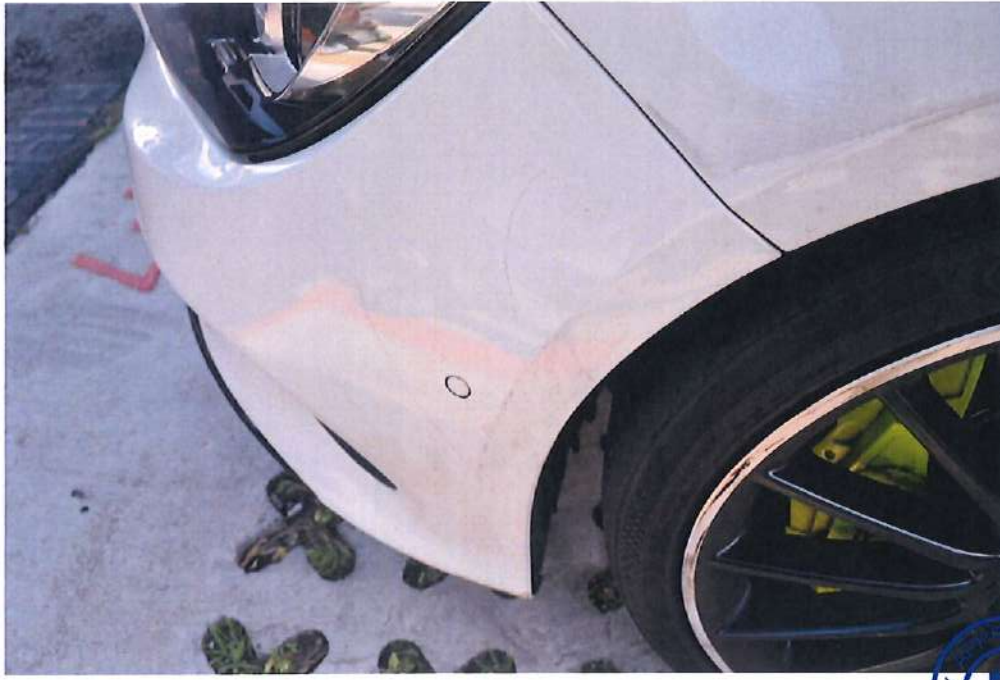
At the time of inspection, we noted that the vehicle has sustained an impact damages on the front n/s portion(s). For more detail of the damages, please see photograph attached.
