LKK Auto Consultants Pte Ltd

THE VEHICLE SUSTAINED DAMAGES AT THE REAR PORTION. DAMAGES SEE DETAILS.
--

ADJUSTMENT ON REPAIR COST FOR VEHICLE NO. SMF 9635Z

PHOTOGRAPHS FOR VEHICLE NO. SMF 9635Z

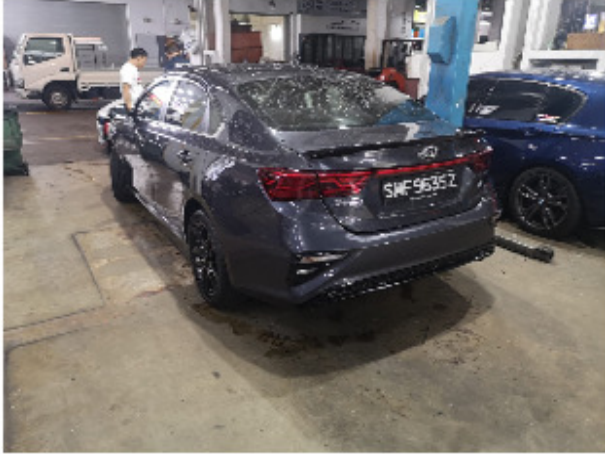
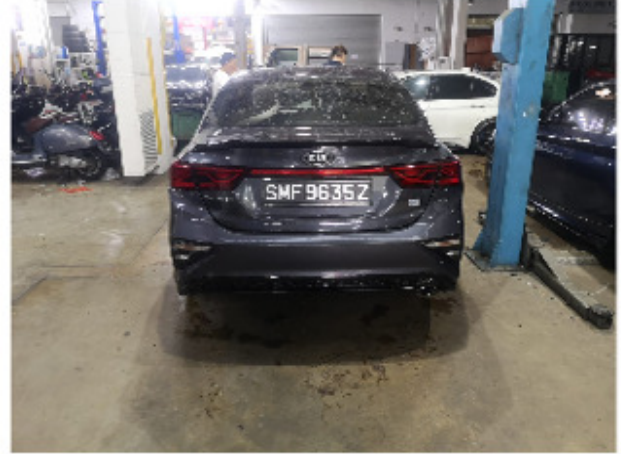
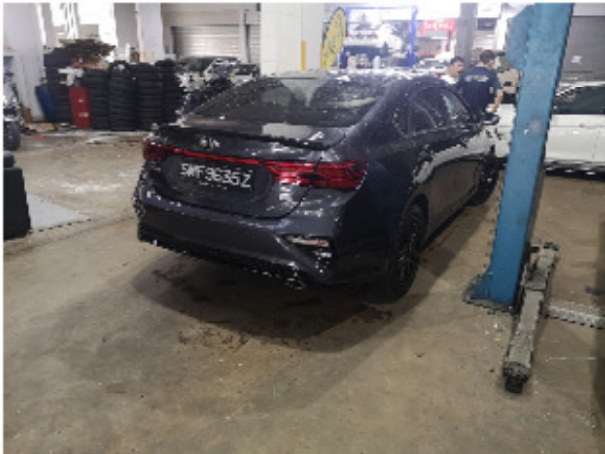
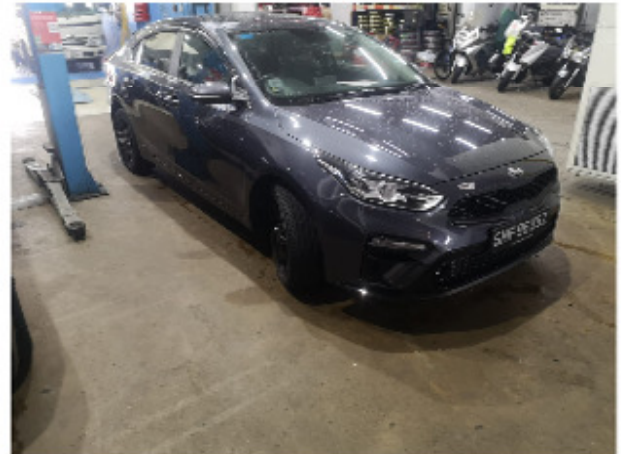
PHOTOGRAPHS FOR VEHICLE NO. SMF 9635Z

RE-INSPECTION
