## LKK Auto Consultants Pte Ltd

### ADJUSTMENT ON REPAIR COST FOR VEHICLE NO. FBP 9607H

PHOTOGRAPHS FOR VEHICLE NO. FBP 9607H

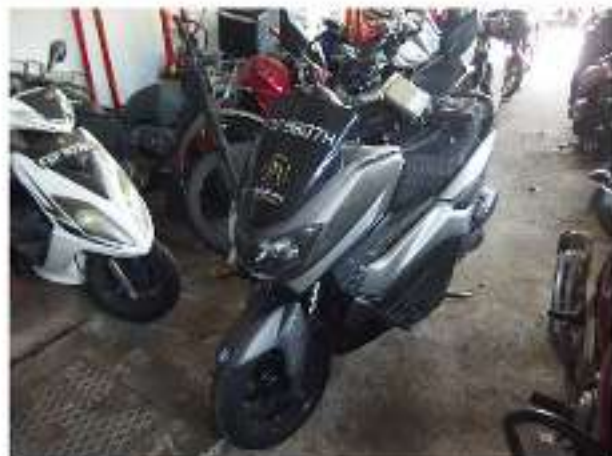
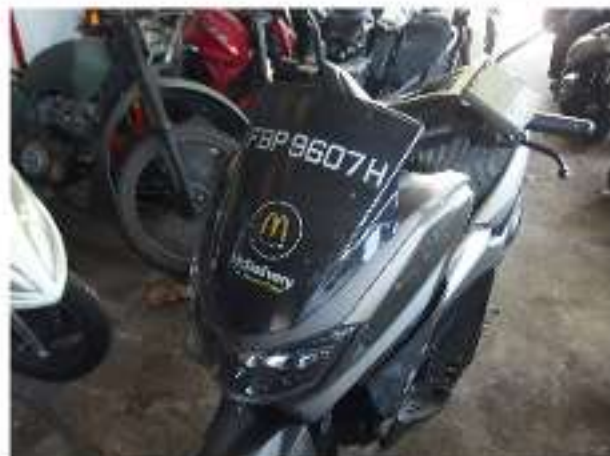
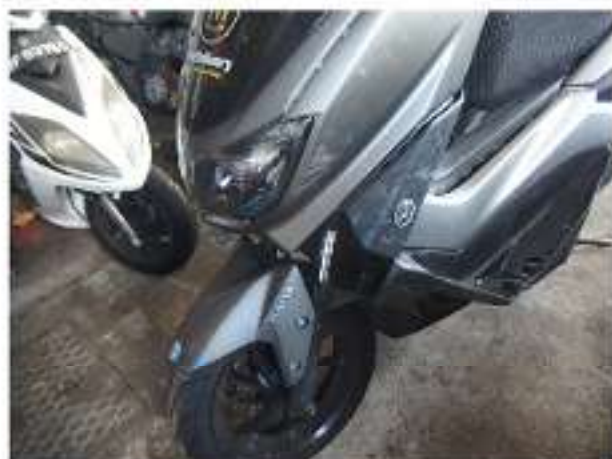
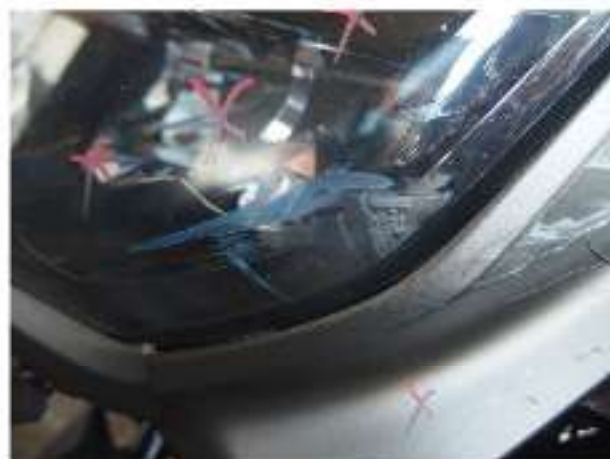
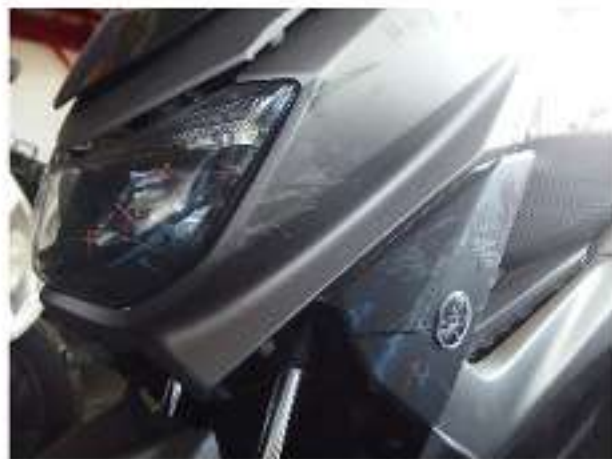
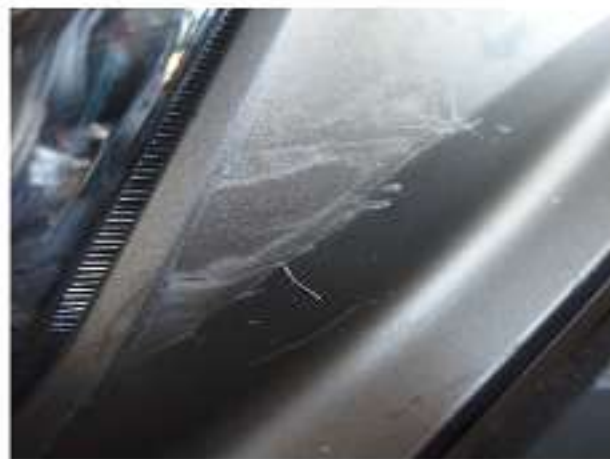
| THE VEHICLE SUSTAINED DAMAGES AT THE N/S AND O/S BODY.<br>DAMAGES SEE DETAILS. |

INSPECTION
