Vehicle No. SDT 8141X  
Insured Veh. YM 8518G  
Claim No. 20/20/20/VC05/023616  
Policy No. Z/20/VC05/005198-001  
Accident Date 01/09/2020  
Inspection Date 11/09/2020

## ADJUSTMENT ON REPAIR COST FOR VEHICLE NO. SDT 8141X

### PHOTOGRAPHS FOR VEHICLE NO. SDT 8141X

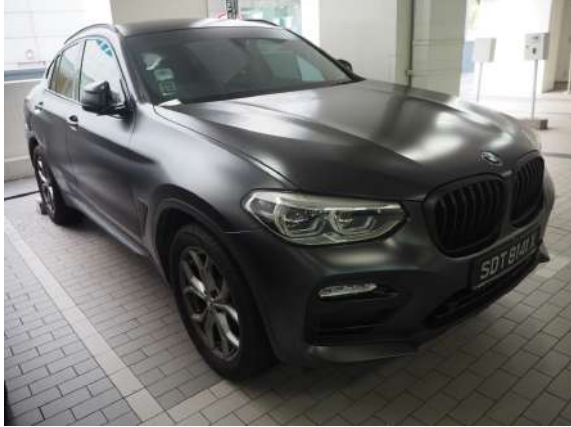
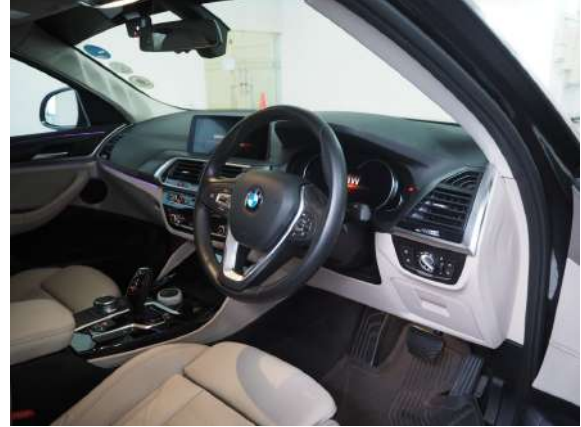
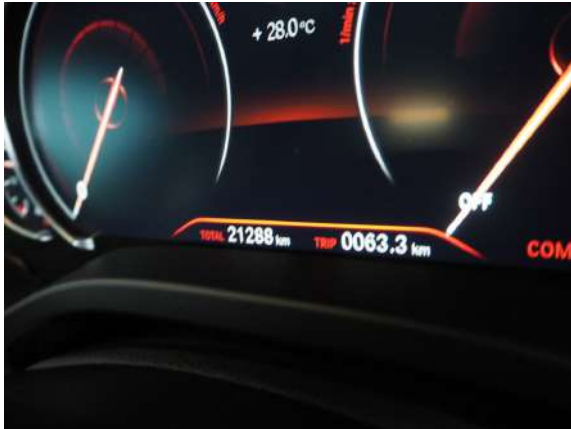
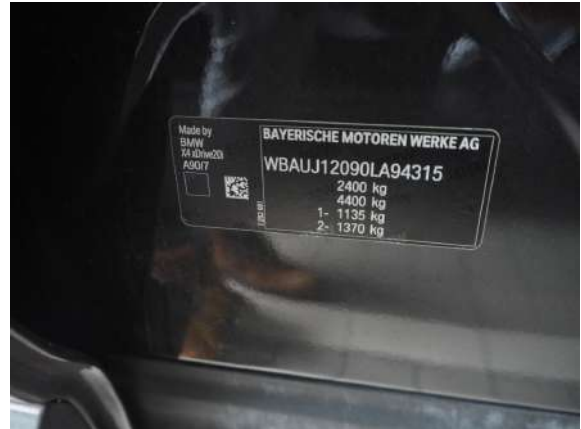
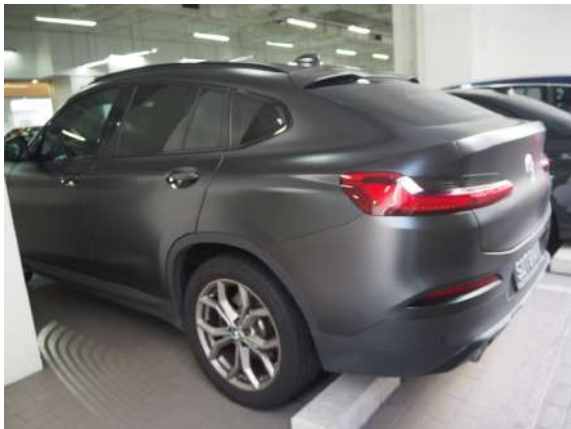
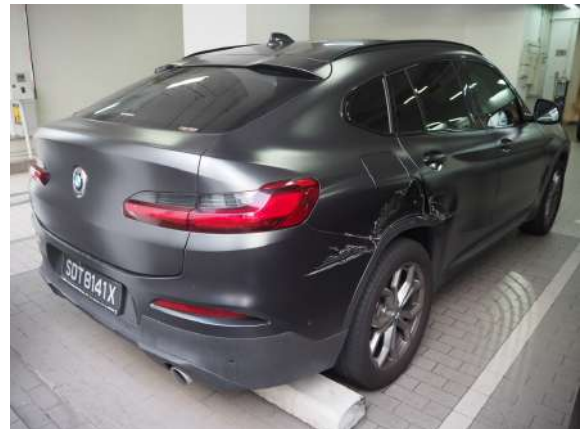
### INSPECTION

| Affiliated to Federation Internationale Des Experts En Automobile | | | | |
|---|---|---|---|--|
| THE VEHICLE SUSTAINED DAMAGES AT THE REAR O/S PORTION.<br><br>DAMAGES SEE DETAILS. | | | | |

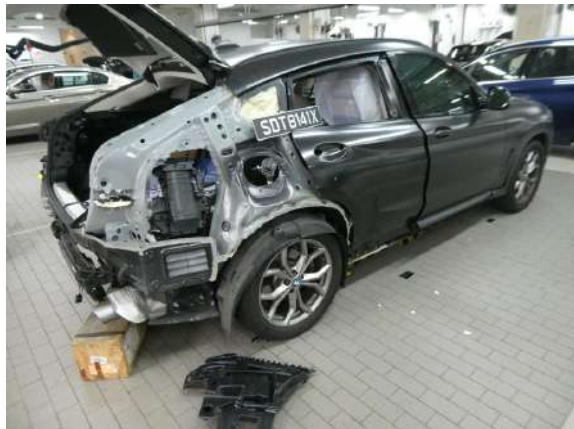
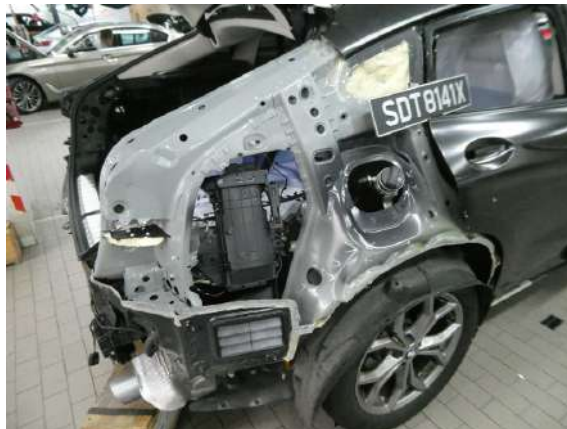
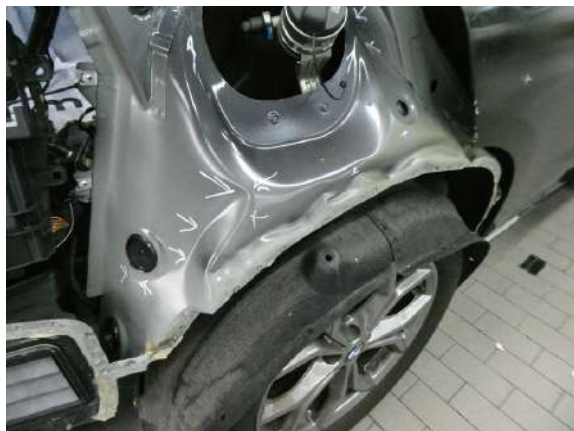
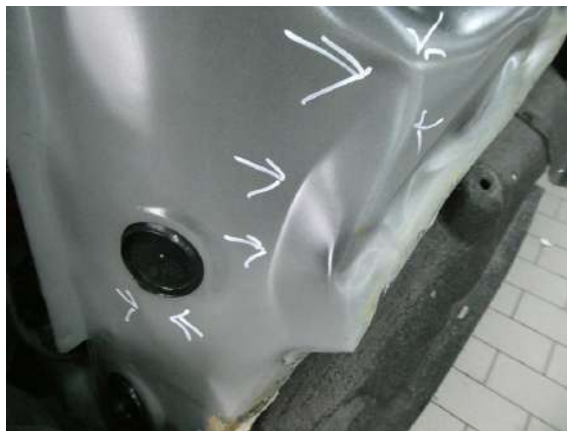
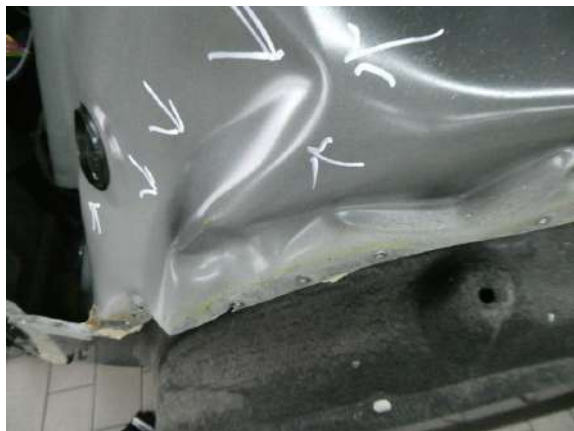
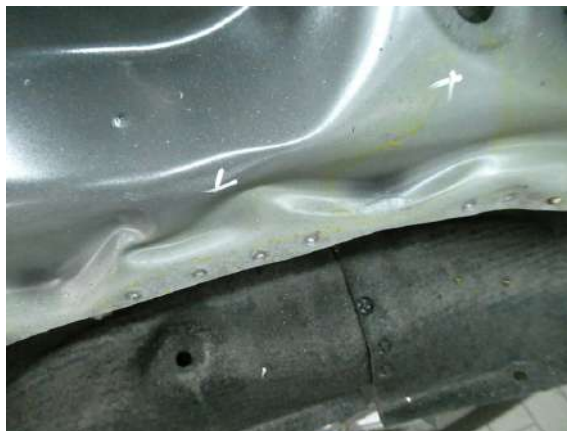
RE-INSPECTION

PHOTOGRAPHS FOR VEHICLE NO. SDT 8141X
