LKK Auto Consultants Pte Ltd

PROFESSIONAL SERVICE FEE

Vehicle No. SLW 9366Y

ADJUSTMENT ON REPAIR COST FOR VEHICLE NO. SLW 9366Y

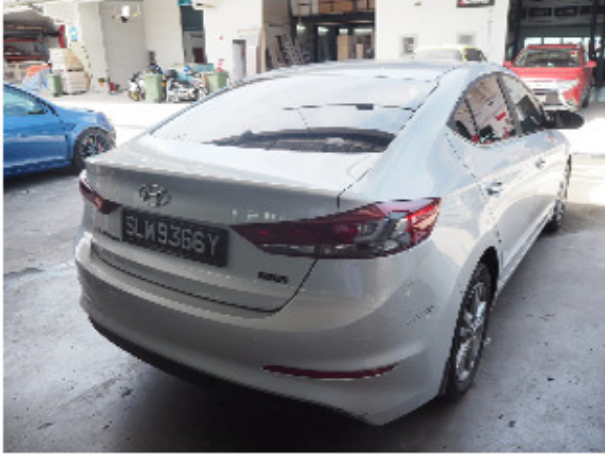
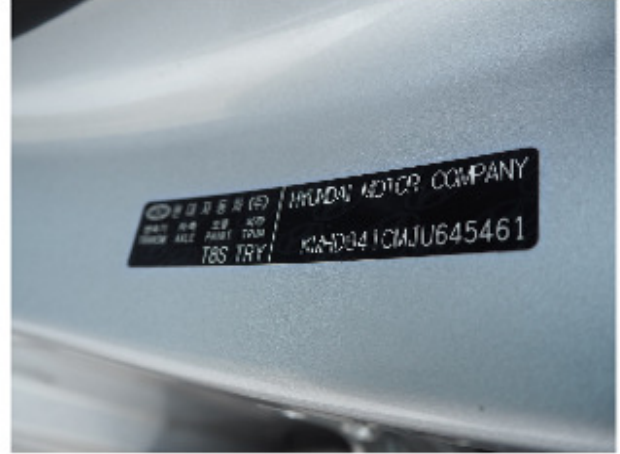
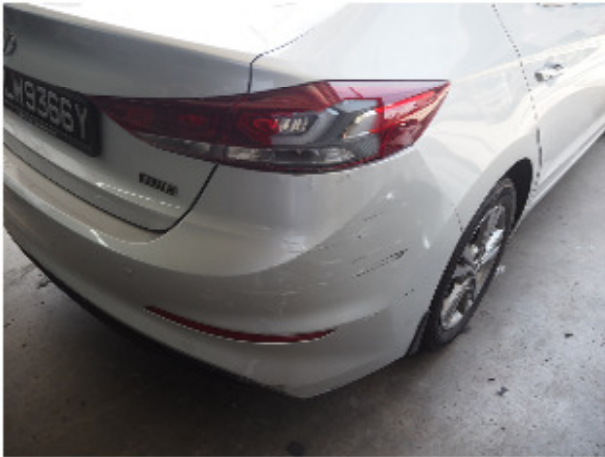
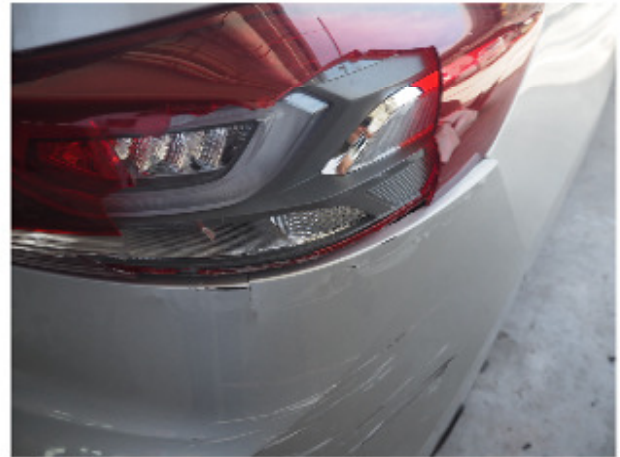
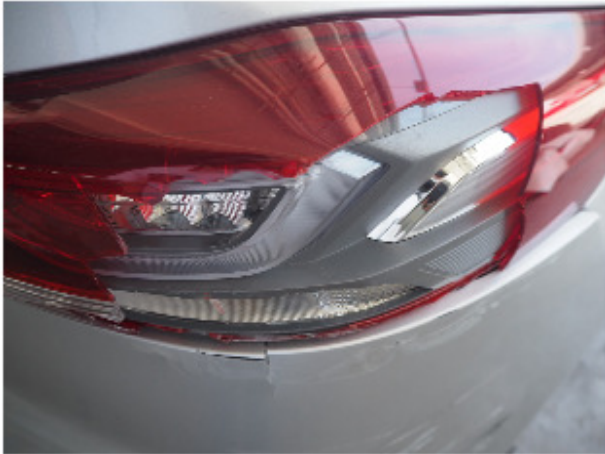
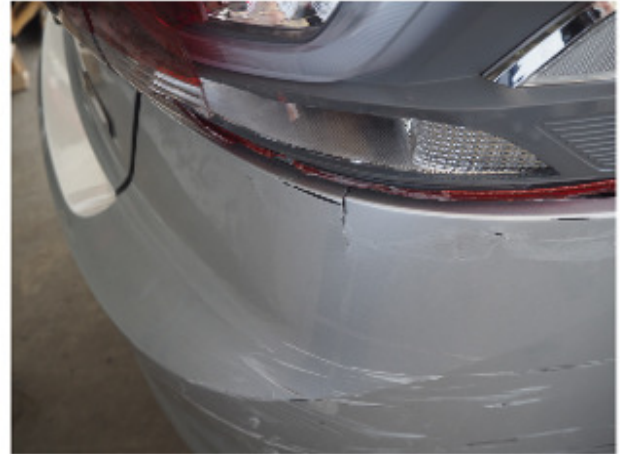
PHOTOGRAPHS FOR VEHICLE NO. SLW 9366Y

4. Description of Damages			
THE VEHICLE SUSTAINED DAMAGES AT THE REAR O/S PORTION. DAMAGES SEE DETAILS.			
5. General Information			
Accident Date	05/09/2020	Inspection Date	09/09/2020
Survey held at	VISION AUTOWORK PTE LTD 8 KAKI BUKIT AVE 4, #08-09 PREMIER @ KAKI BUKIT SINGAPORE 415875		
5a. Remarks			
A)THE INSPECTION WAS CONDUCTED ON A"WITHOUT PREJUDICE" BASIS. B)IN ACCORDANCE TO YOUR INSTRUCTIONS, WE HAVE NOT AUTHORISED REPAIRS.			
5b. Estimate Days of Repair			
ESTIMATED NORMAL PERIOD FOR REPAIR:		5 Working Days

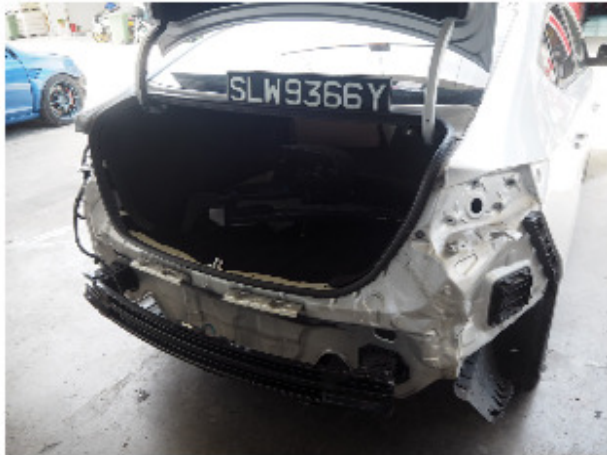
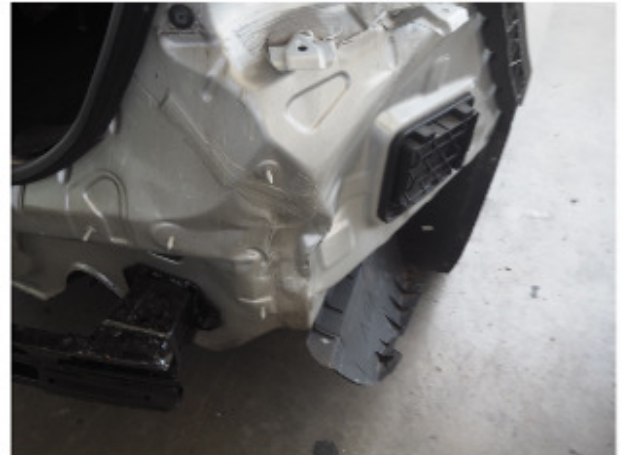
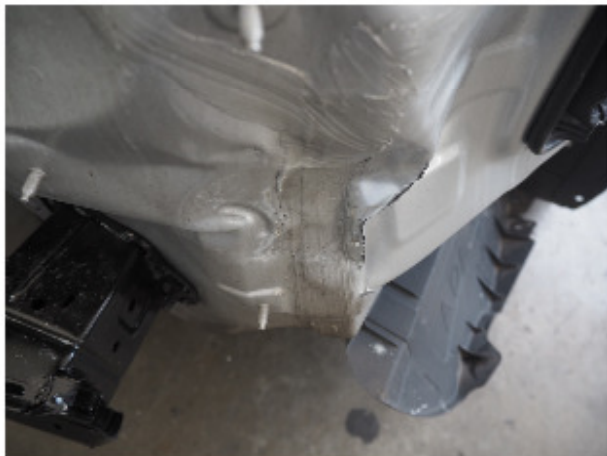
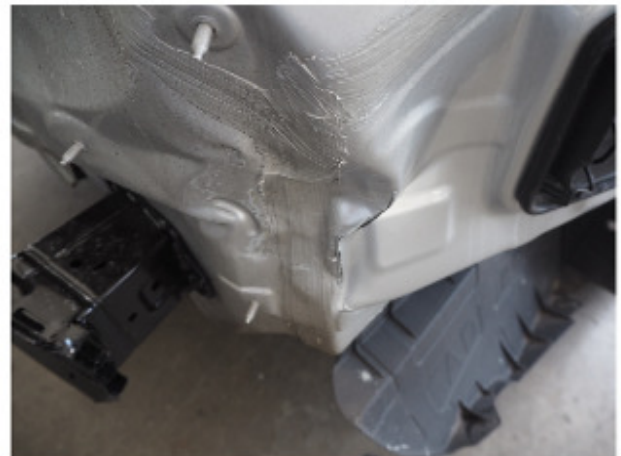
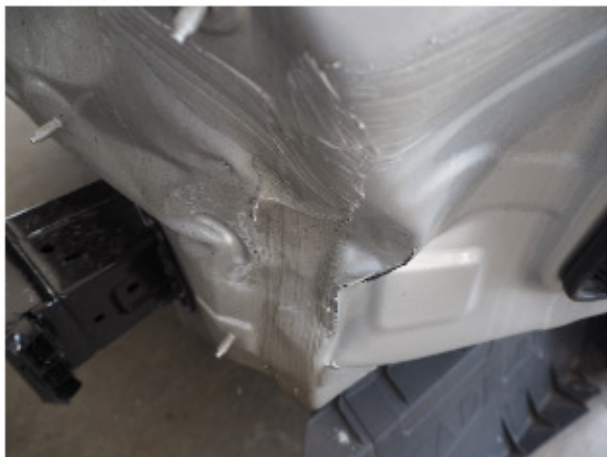
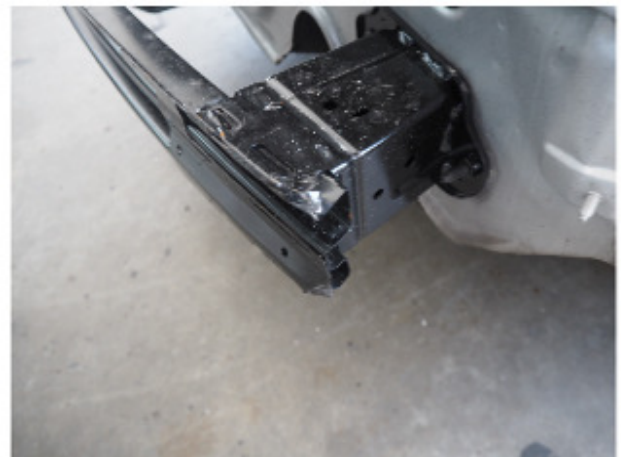
RE-INSPECTION

PHOTOGRAPHS FOR VEHICLE NO. SLW 9366Y
