## LKK Auto Consultants Pte Ltd

## ADJUSTMENT ON REPAIR COST FOR VEHICLE NO. SMT 2214C

PHOTOGRAPHS FOR VEHICLE NO. SMT 2214C

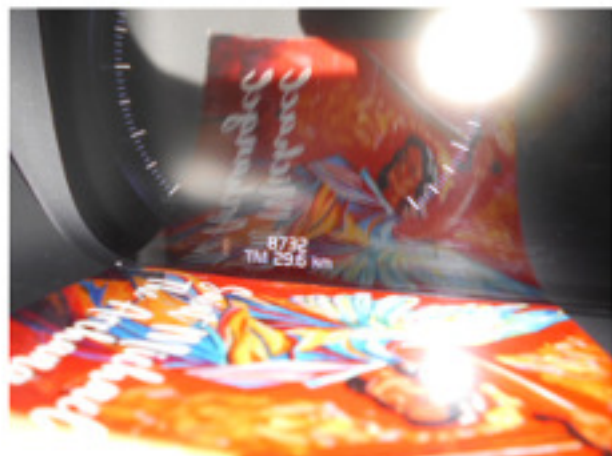
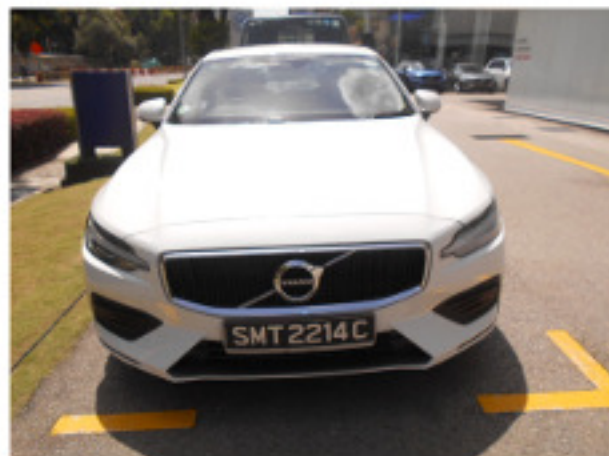
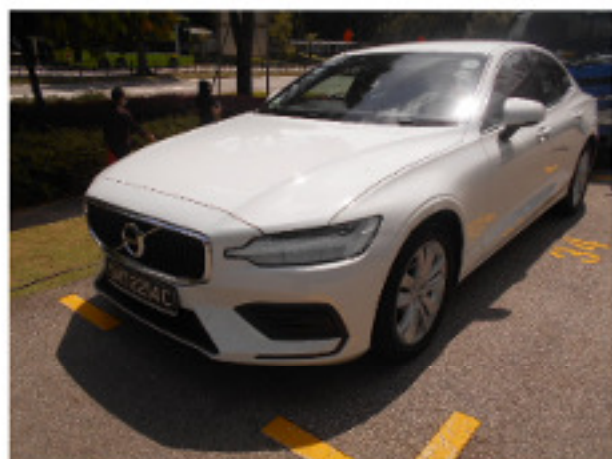
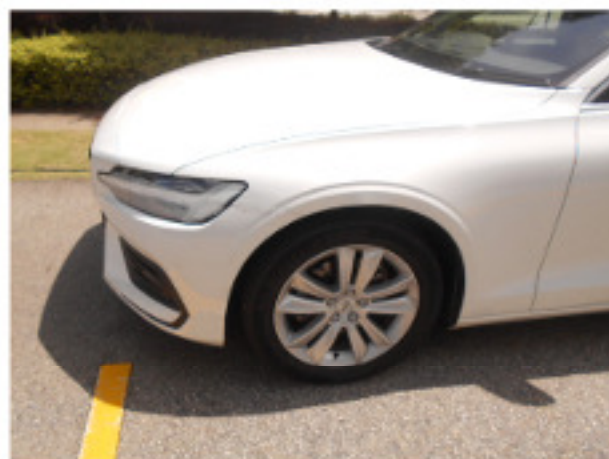
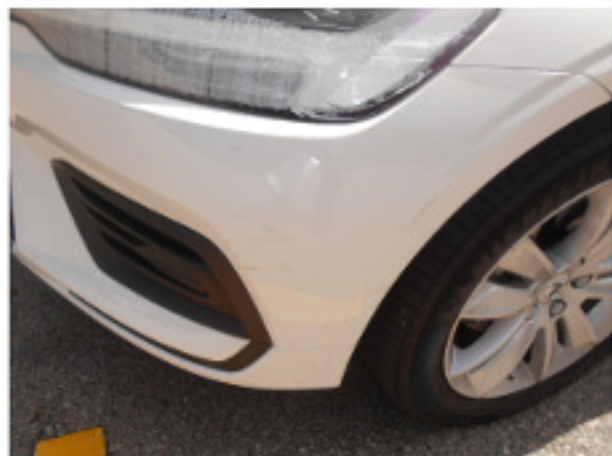
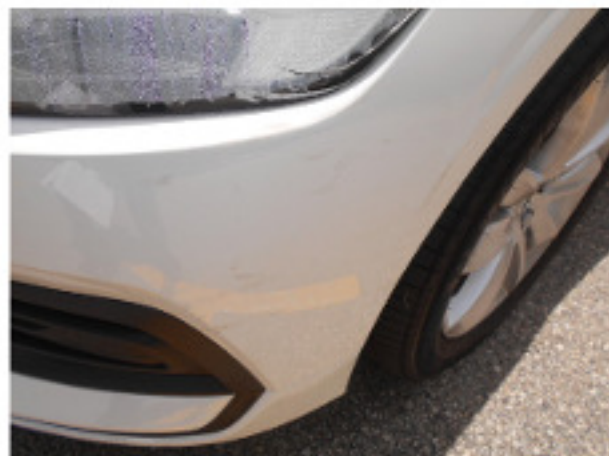
INSPECTION

THE VEHICLE SUSTAINED DAMAGES AT THE N/S FRONT PORTION. DAMAGES SEE DETAILS.
---------------------------------------------------------------------------------

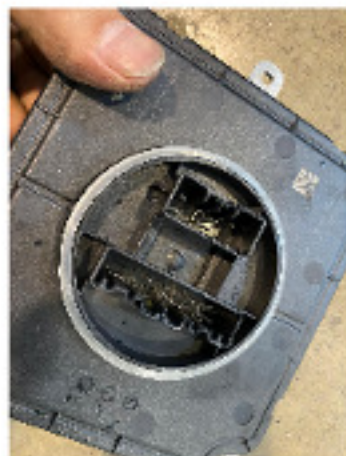
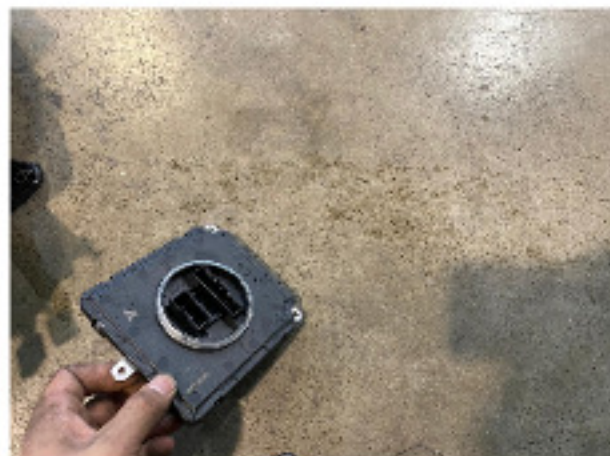
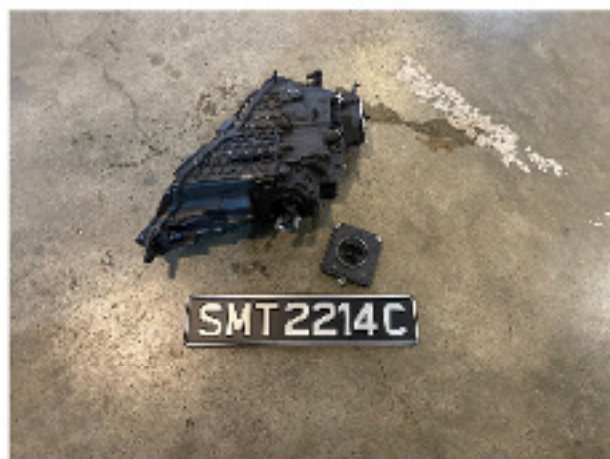
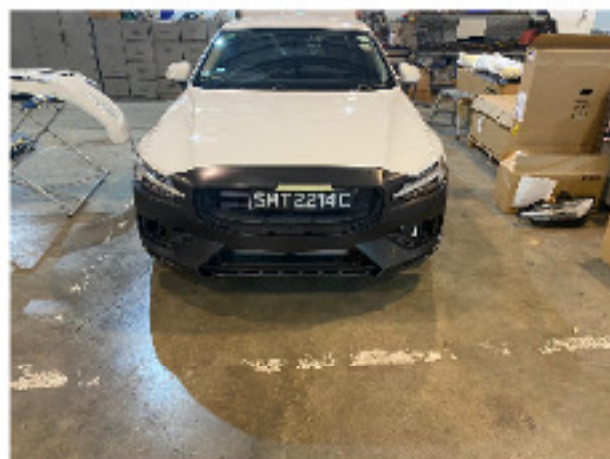
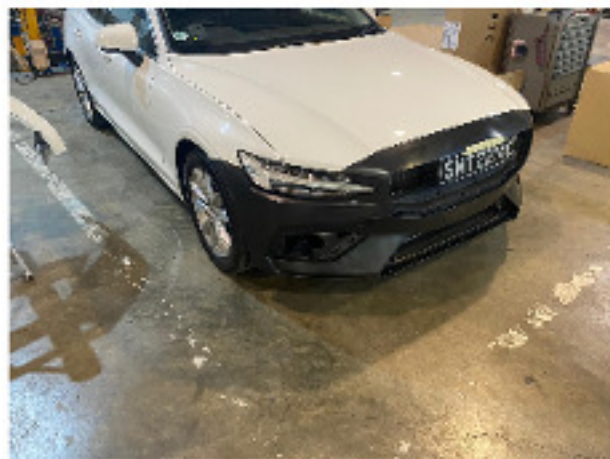
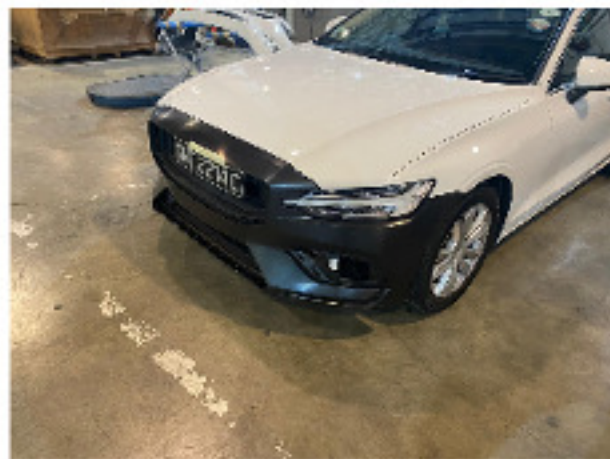
PHOTOGRAPHS FOR VEHICLE NO. SMT 2214C

RE-INSPECTION
