LKK Auto Consultants Pte Ltd

Affiliated to Federation Internationale Des Experts En Automobile			
LONPAC INSURANCE BHD 300 BEACH ROAD #17-04/07 THE CONCOURSESINGAPORE 199555		Ref: CC4/LPC20009635/Kgs3q2 Date: 17/02/2021 Code: LPC2

ADJUSTMENT ON REPAIR COST FOR VEHICLE NO. GBD 2653H

PHOTOGRAPHS FOR VEHICLE NO. GBD 2653H

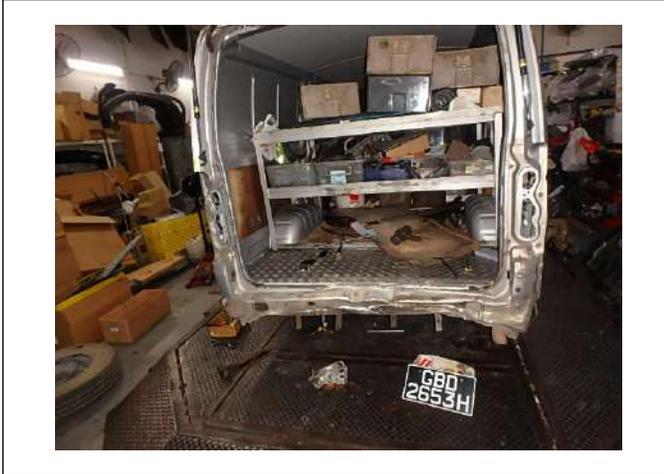
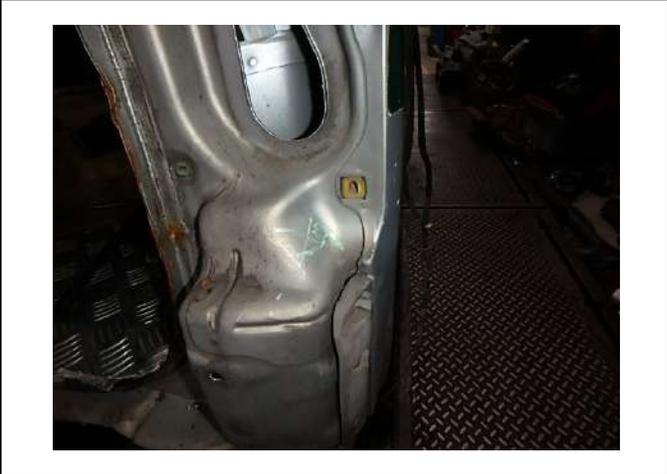
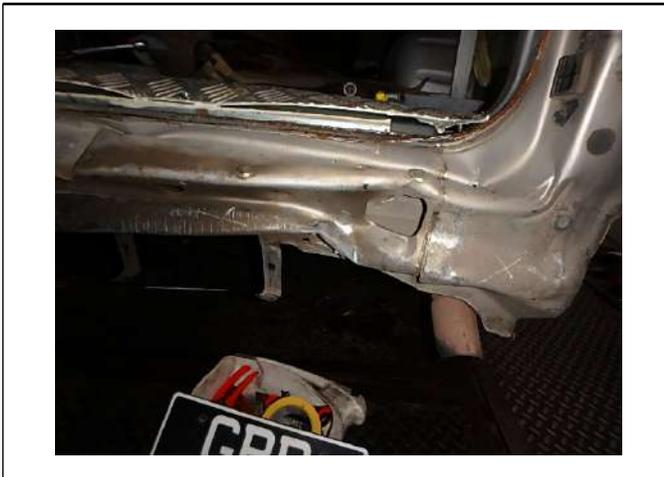
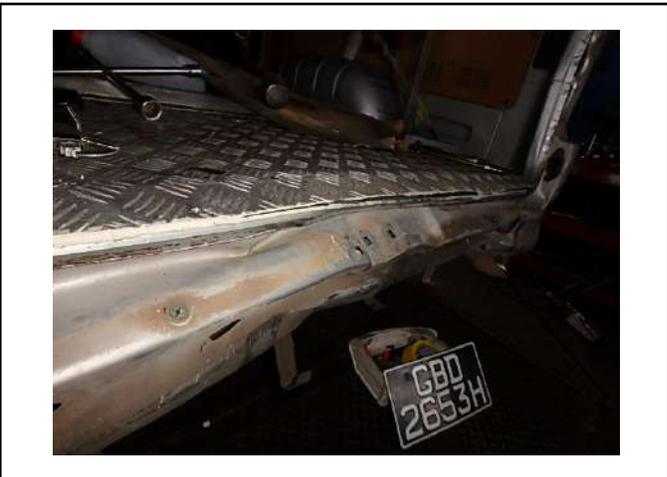
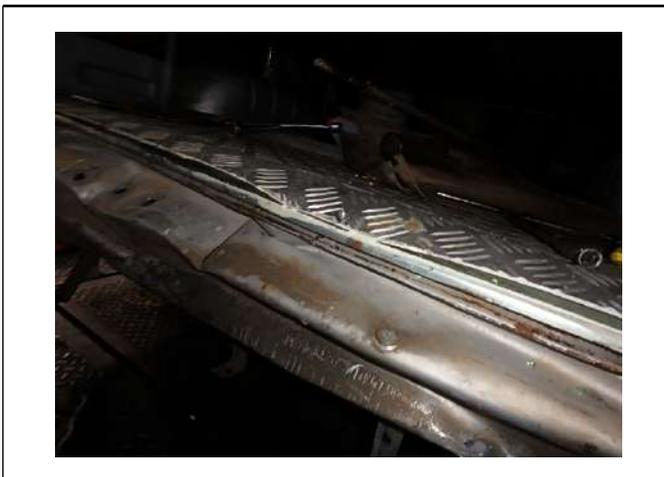
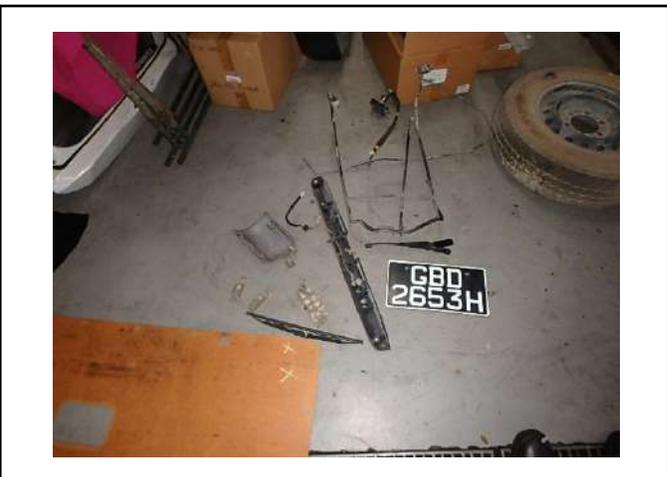
4. Description of Damages			
THE VEHICLE SUSTAINED DAMAGES AT THE REAR PORTION. DAMAGES SEE DETAILS.			
5. General Information			
Accident Date	05/09/2020	Inspection Date	08/09/2020
Survey held at	COMPLETE VMS PTE LTD BLK 176 SIN MING DRIVE #03-14 SIN MING AUTOCARE COMPLEX SINGAPORE 575721		
5a. Remarks			
A)THE INSPECTION WAS CONDUCTED ON A"WITHOUT PREJUDICE" BASIS. B)IN ACCORDANCE TO YOUR INSTRUCTIONS, WE HAVE NOT AUTHORISED REPAIRS.			
5b. Estimate Days of Repair			
ESTIMATED NORMAL PERIOD FOR REPAIR:		7 Working Days
